ES_LPC43S50/S30/S20

Errata sheet LPC43S50, LPC43S30, LPC43S20

Rev. 1.8 — 20 September 2019

Errata sheet

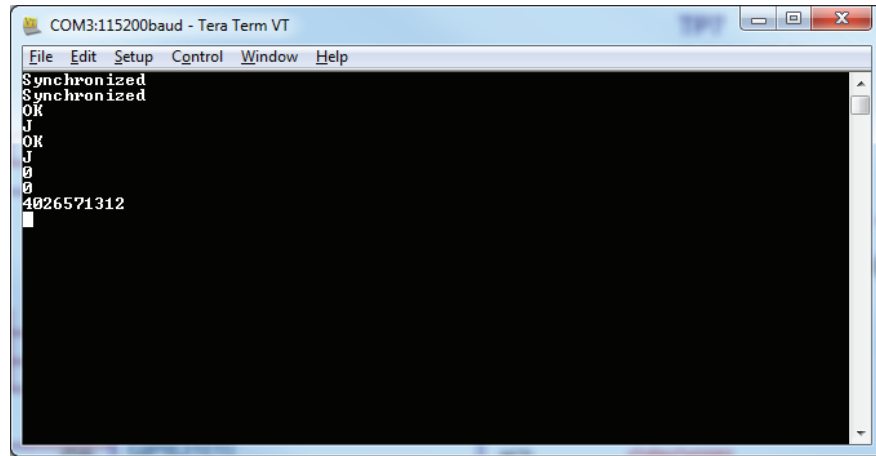
Incorrect example:

The 'J' command in ISP mode should return an error code, followed by an ASCII string representation of the part ID, followed by a 0. However what is actually returned is the error code, followed by a 0, followed by an ASCII string representation of the part ID. The problem is the last two items returned are swapped.

There is no work-around for this problem.

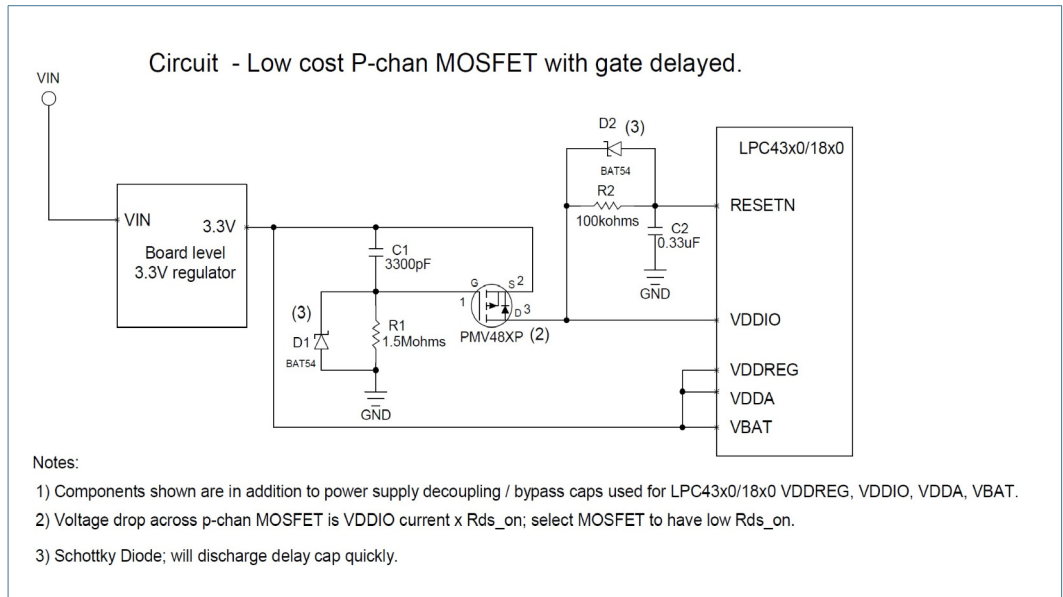
On all packages, repeated power cycling of the device may cause erroneous programming of the OTP banks. During ramp-up, the VDDREG supply voltage does not have enough time to settle and initialize the OTP controller before valid programming voltage is reached on the VPP pin. This may cause accidental programming of the OTP banks. Accidental programming of the OTP banks does not occur during Power-down of the supply voltage.

The following circuit diagram is an example that shows the P-channel MOSFET with the gate delayed and the R-C delay circuit connected to the RESETN pin.

- When OTP programming is not required, the VPP pin should be left as No-Connect (NC) because the VPP and VDDIO pins are separate.
- When OTP programming is required, do not tie VPP pin to VDDREG, VDDIO and VDDA pins. The voltage on the VPP pin should be delayed by 2 ms after the power supply on the VDDREG, VDDA, and VDDIO pins reaches the operating voltage level.

- Do not tie VDDIO to VDDREG and VDDA pins. The power supplied to the VDDIO pin should be delayed by 2 ms after the power supply on the VDDREG and VDDA pins stabilizes at the operating voltage level. The signal to the RESETN pin must also be delayed by 2 ms after the power supply on the VDDIO pin stabilizes at the operating voltage level.

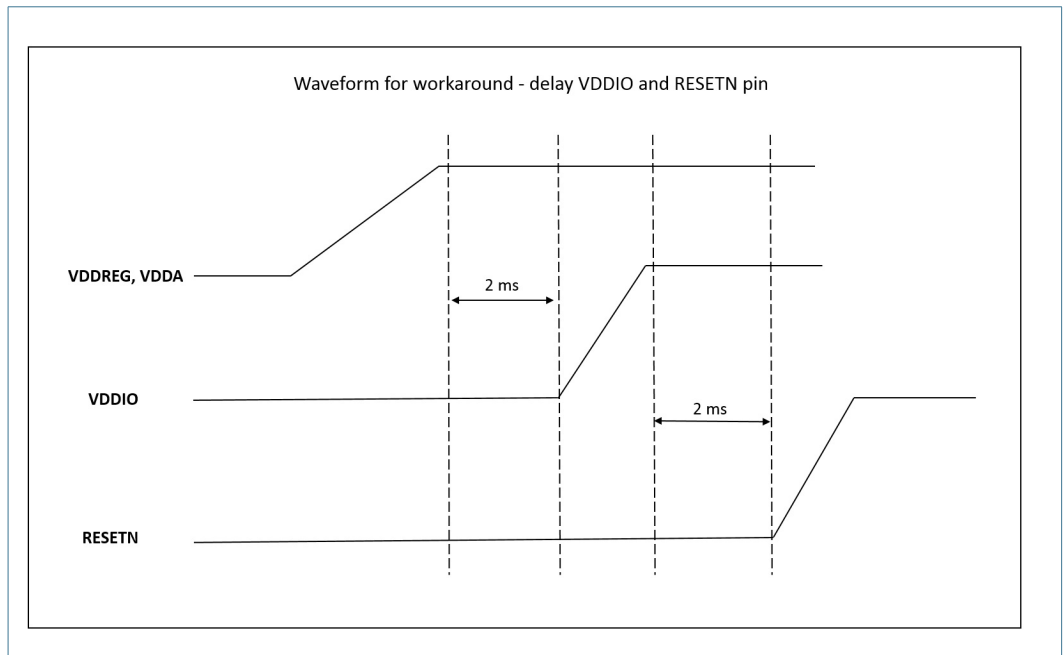
The following diagram shows the waveform for the work-around.

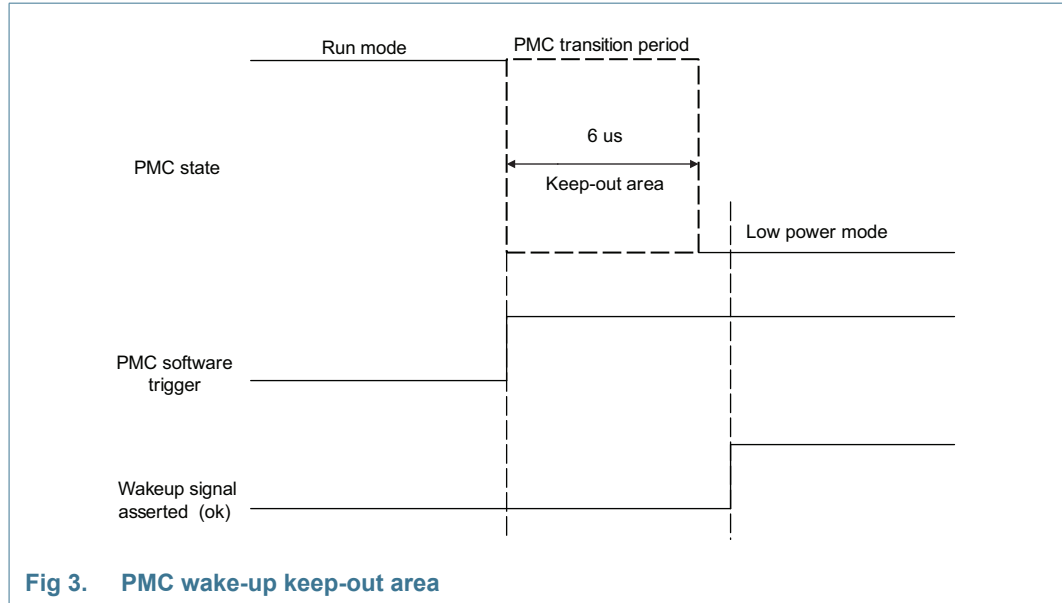
Fig 3. PMC wake-up keep-out area

When the chip is in a transition from active to Deep Sleep, Power Down, or Deep Power Down, wake-up events are not captured and they will block further wake-up events from propagating. The time window for this transition is 6 μ s and is not affected by the chip clock speed. After a wake-up event is received during the PMC transition, the chip can only recover by using an external hardware reset or by cycling power.

Make sure that a wake-up signal is not received during the Deep Sleep, Power Down, or Deep Power Down transition period. An example circuit to work around this could include an external 6 μ s one shot which could be triggered via software using a GPIO line when entering Deep Sleep, Power Down, or Deep Power Down mode. The one-shot's output could be used to gate the wake-up signal(s) to prevent receiving a wake-up signal during the PMC transition period. Depending on the system design, it may also be needed to latch the wake-up signal(s) so that they will still be present after the one-shot's 6 μ s time-out.

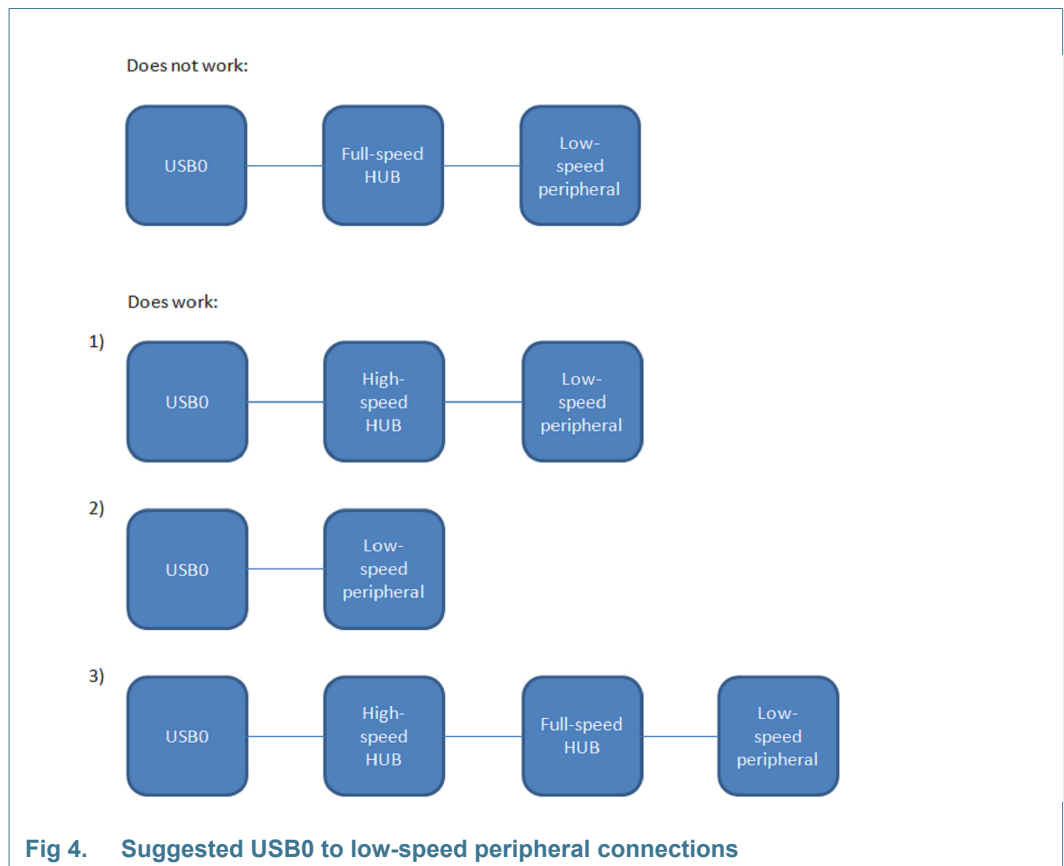
Fig 4. Suggested USB0 to low-speed peripheral connections

The USB controller called USB0 is unable to communicate with a low-speed USB peripheral in host mode when there is a full-speed hub directly connected to the USB0 port and a low-speed peripheral is connected in the tree somewhere below this full-speed hub. Only USB0 has this problem; the other USB controller, USB1 does not.

There is no work-around for this problem. It is suggested that the low-speed USB peripheral is either connected directly to USB0 or a high-speed hub is placed between that peripheral and USB0.
