Mask Set Errata for Mask 0M45H

This mask set errata applies to the mask 0M45H for these products:

- MC9S08RE16
- MC9S08RE8
- MC9S08RD16
- MC9S08RD8
- MC9S08RC16
- MC9S08RC8

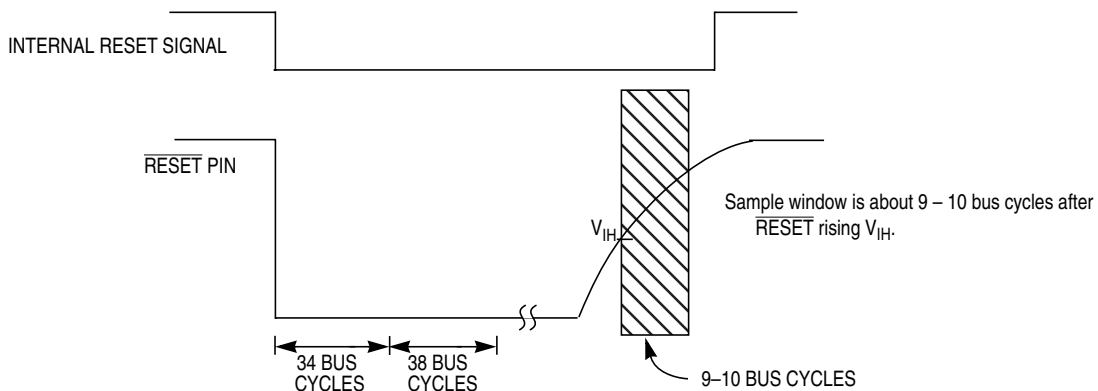
If a falling edge is detected on the external reset pin at either of two sample points, the MCU will cease operation and will recover only after a power-on reset.

Case 2 — After remaining in reset for an extended period of time due to an externally applied low level on $\overline{\text{RESET}}$, the internal reset circuit will sample the pin level about 9 to 10 bus cycles after the pin raises above its V_{IH} level.

Workaround — Case 2

In addition to RC filtering, avoid spurious edges on the $\overline{\text{RESET}}$ pin caused by external active circuitry such as low voltage detectors and watchdog components. Do this by ensuring that external circuitry cannot drive $\overline{\text{RESET}}$ low within 10 bus cycles of the release of $\overline{\text{RESET}}$.
