Revision history

Errata 1: In the 16-bit mode, the DMA counter does not reach zero.

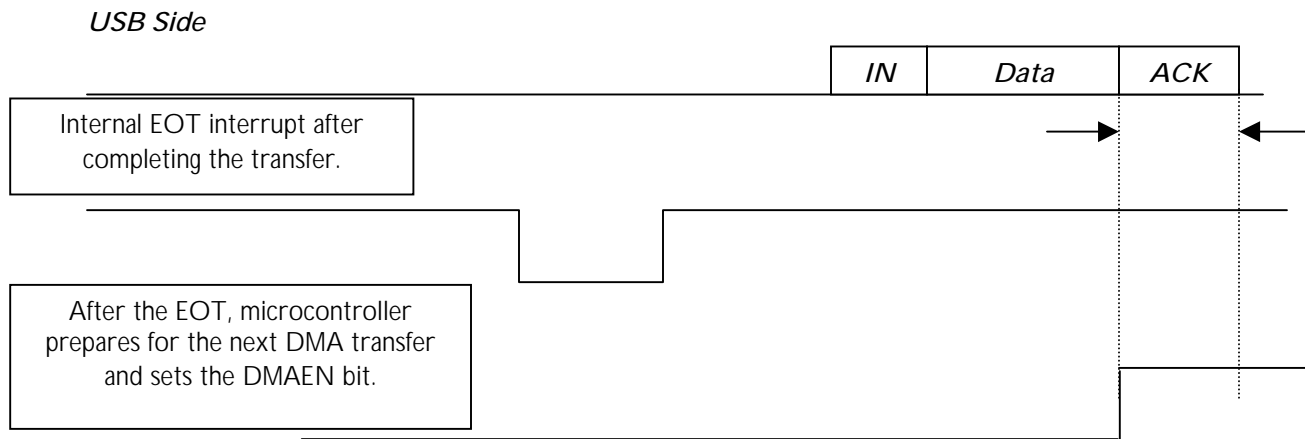
In the DMA mode, for an IN token sometimes an empty packet is generated and sent to the host because an empty packet is written to the buffer when the following two events occur at the same time:

When these two events occur at the same time, an empty packet is automatically written to the internal buffer, which in turn will be sent out for the next IN token.

The events are given in the following diagram:

The preceding events occur inside the ISP1181A. The dotted lines indicate the coincidence of these events.

To avoid the coincidence of the two events, the firmware must check whether the corresponding DMA IN endpoint is empty (in the case of double buffering, check whether both

the buffers are empty) before setting the DMAEN bit in the DMA Configuration register. This ensures that the data from the IN endpoint is already sent to the Host Controller, and the ACK from the Host Controller is received well before the DMAEN bit is set.

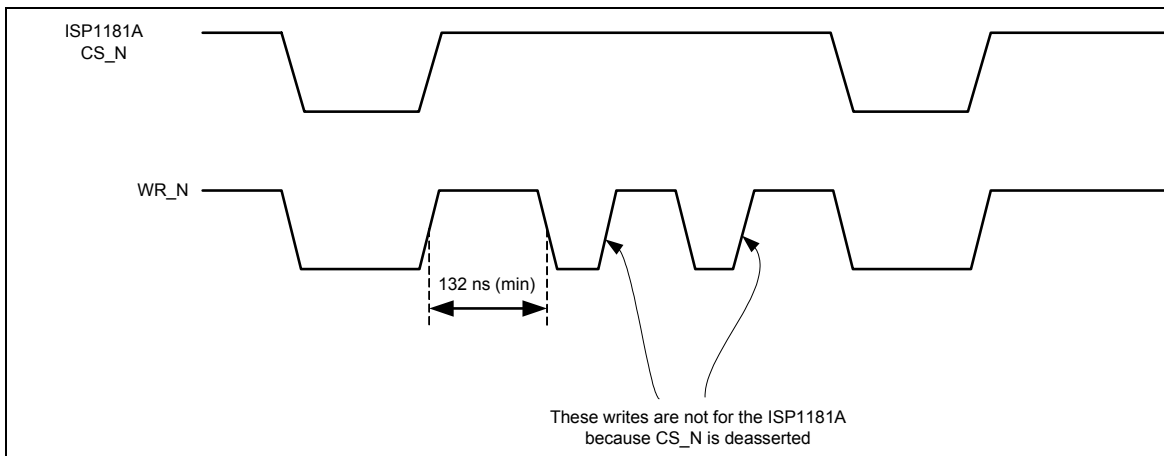
After a data write operation, the ISP1181A Peripheral Controller requires a 132 ns (min) delay before a write assertion can be issued for other devices. This must be fulfilled even after CS_N is deasserted (See Figure 1 and Figure 2).

Will lead to data corruption if the timing requirements in Figure 1 and Figure 2 are not handled.

Make sure that the system can handle the write timing requirements as given in Figure 1 and Figure 2. If the system is really fast and needs immediate write accesses to other devices, then it is better to qualify WR_N with respect to CS_N and provide the resultant write signal to the ISP1181A (see Figure 3).
