Errata 1: During the DMA transfer, empty packets are sometimes sent for an IN token.

Errata 2: Data corruption during write operation to the ISP1181B Peripheral Controller.

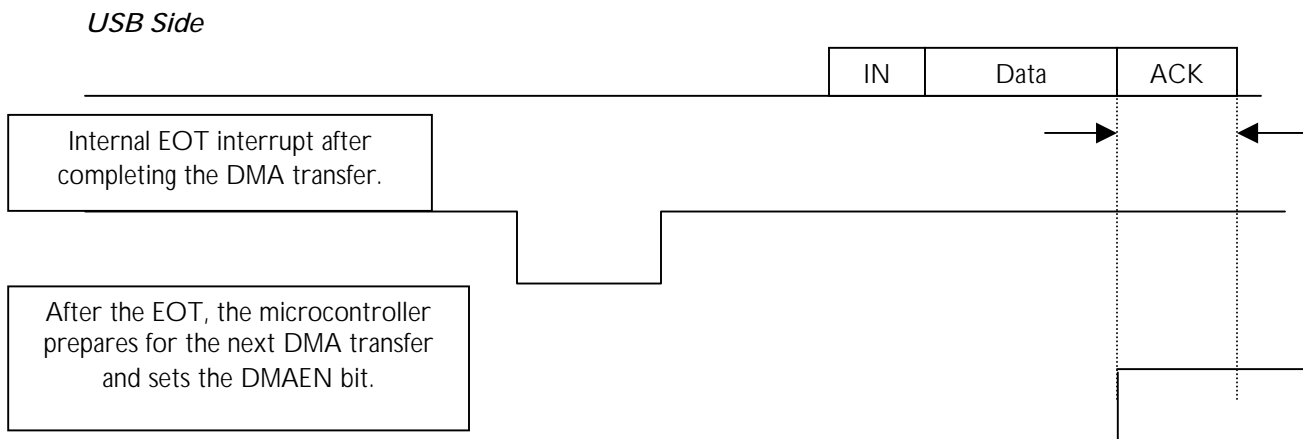
In the DMA mode, for an IN token sometimes an empty packet generated and sent to the host because an empty packet is written to the buffer when the following two events occur at the same time:

- The ISP1181B receives an ACK from the Host Controller and
- The microcontroller sets the DMAEN bit in the DMA Configuration register.

When these two events occur at the same time, an empty packet is automatically written to the internal buffer, which in turn will be sent out during the next IN token.

The preceding events occur inside the ISP1181B. The dotted lines indicate the coincidence of these events.

The implication is serious in certain applications in which the empty packet is considered as an error condition or termination of the transfer. For example, in certain mass storage implementations, the empty packet is considered as an error condition and the Host Controller will try to send a command to rectify the error, which cannot be seen by the firmware. This is because the microcontroller has already set the DMAEN bit, activating the DMA transfer and has also disabled endpoint interrupts to reduce the overhead. In view of this, whatever the Host Controller sends for error recovery will not be seen and the system stops responding.

To avoid the coincidence of these two events, the firmware must check whether the corresponding DMA IN endpoint is empty (in the case of double buffering, check whether both the buffers are empty) before setting the DMAEN bit in the DMA Configuration register. This ensures that the data from the IN endpoint is already sent to the Host Controller, and the ACK from the Host Controller is received well before the DMAEN bit is set.

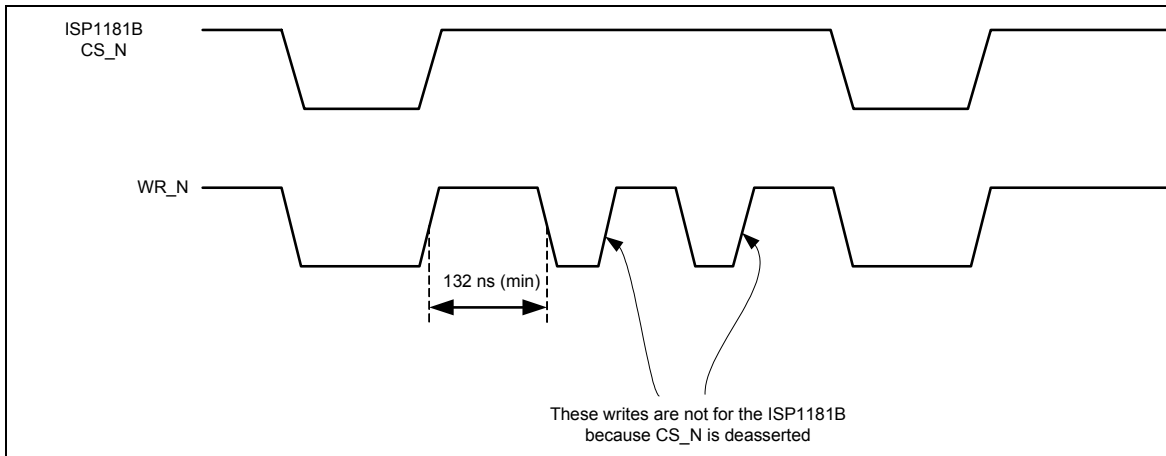
After a data write operation, the ISP1181B Peripheral Controller requires a 132 ns (min) delay before a write assertion can be issued for other devices. This must be fulfilled even after CS_N is deasserted (See Figure 1 and Figure 2).

Will lead to data corruption if the timing requirements in Figure 1 and Figure 2 are not handled.

Make sure that the system is able to handle the write timing requirements as given in Figure 1 and Figure 2. If the system is really fast and needs immediate write accesses to other devices, then it is better to qualify WR_N with respect to CS_N and provide the resultant write signal to the ISP1181B (see Figure 3).
