Errata sheet LPC18S5x, LPC18S3x, flash-based devices

Rev. 1.4 — 24 September 2019

Info	Content
Keywords	LPC18S57JET256; LPC18S57JBD208; LPC18S37JBD144; LPC18S37JET100; ARM Cortex-M3 flash-based devices A, B errata
Abstract	This errata sheet describes both the known functional problems and any deviations from the electrical specifications known at the release date of this document.
	Each deviation is assigned a number and its history is tracked in a table.

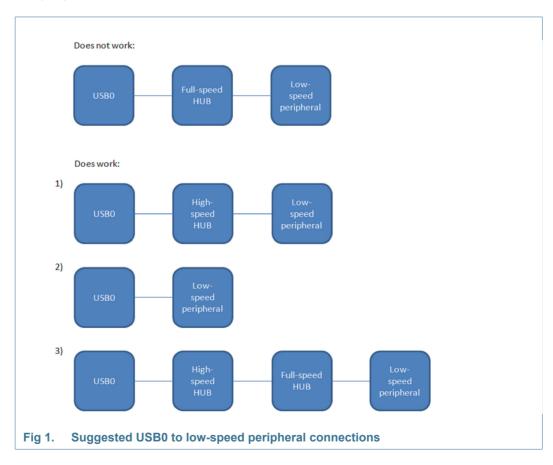
3.5 USB.1

The USB controller called USB0 is unable to communicate with a low-speed USB peripheral in host mode when there is a full-speed hub directly connected to the USB0 port and a low-speed peripheral is connected in the tree somewhere below this full-speed hub. Only USB0 has this problem; the other USB controller, USB1 does not.

There is no work-around for this problem. It is suggested that the low-speed USB peripheral is either connected directly to USB0 or a high-speed hub is placed between that peripheral and USB0.
