MPC7450, MPC7451, MPC7441 Chip Errata

This document details all known silicon errata for the MPC7451, MPC7450, and MPC7441. The MPC7450 has the same functionality as the MPC7451 and MPC7441, and any differences between the other microprocessors are noted in the document. The MPC7451, MPC7450, and MPC7441 are PowerPC™ microprocessors. [Table 1](#) provides a revision history for this chip errata document.

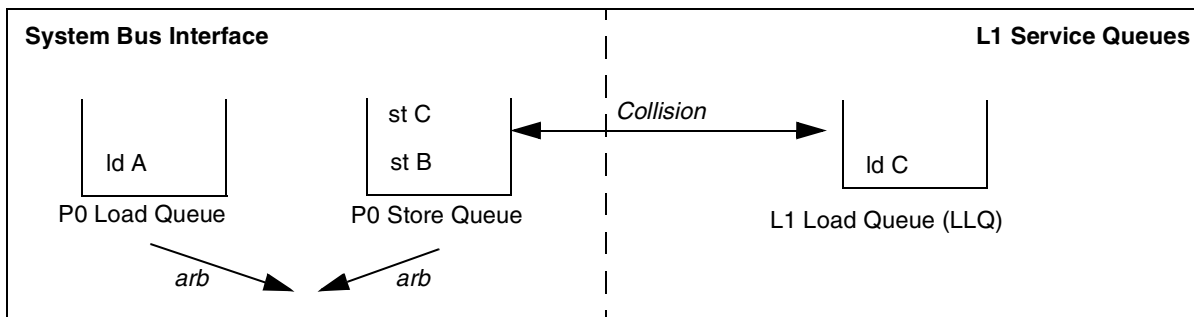
Figure 1. Example 1 with Condition 2

The MPC7450 will encounter a hang condition in some systems in either 60x or MPX bus modes due to the bus store queue gaining and keeping high priority arbitration over the bus load queue.

Example 1: The processor may make a load request to address 'A,' which gets retried. As a result of one of the conditions stated above, the high priority mechanism within the processor engages, and the processor goes to the external bus with a store queue request to address 'B.' The system must be able to process the store queue request to 'B' (and potentially several other store queue operations as described for condition 2), because the store queue may not relinquish control until 'B' (and others) successfully completes its (their) address tenure(s). This is shown [Figure 1](#), where condition 2 has caused the high priority mechanism to be engaged.

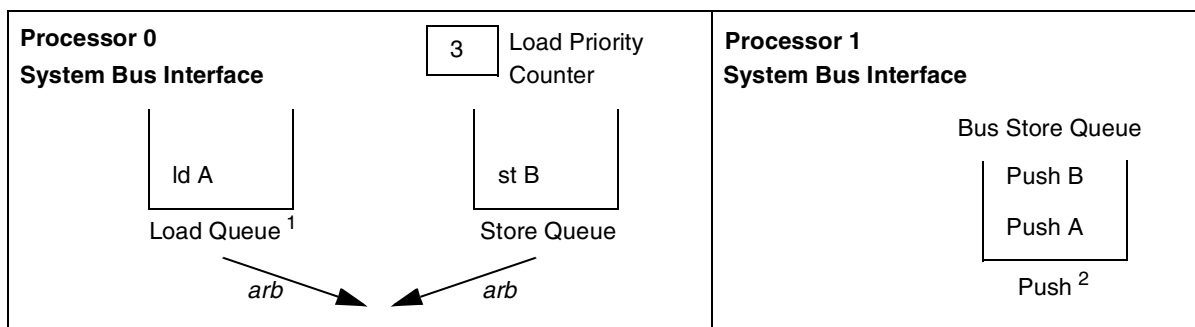
Figure 2. Example 2 with Condition 1

Example 2: In both 60x and MPX modes, the MPC7450 can cause push requests to the external bus, even if external intervention is enabled in MPX mode. In a multiprocessor system, a state can be entered where one processor (processor 0) has a load request to 'A' and a store request to 'B,' wherein the store request has gained high priority over the load request. A second processor (processor 1) has a push request queued for address 'A' followed by a push request to address 'B.' Processor 1 retries the store to 'B,' requests the window-of-opportunity, and attempts to push address 'A.' Although this is legal under the 60x/MPX specification, the MPC7450 is the first PowerPC processor to attempt this. As a result, some system controllers, including the Tundra Tsi106™ PowerPC host bridge or the Tundra Tsi107™ PowerPC host bridge, retry the push to 'A' because it requires a push to 'B,' since this is the address for which the window-of-opportunity was taken. A system that would not allow the push to 'A' to complete, would hang. This is shown in Figure 2, where condition 1 has caused the high priority mechanism to be engaged.
