# ES\_LPC177x/8x

Errata sheet LPC177x/8x

Rev. 4.2 — 11 January 2022

Errata sheet

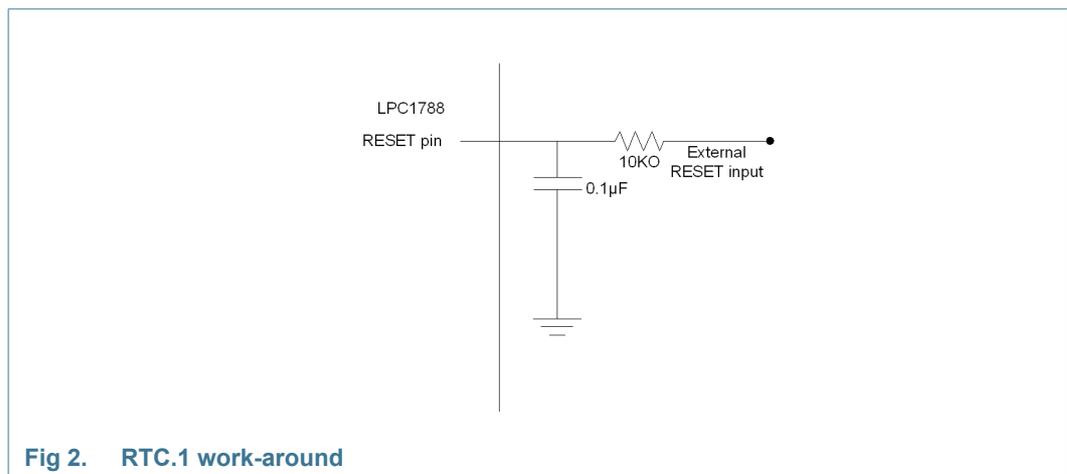
Fig 2. RTC.1 work-around

RTC temporarily pauses and loses fractions of a second during the rising and falling edges of RESET. This occurs only in the LQFP packages with certain voltage swings and ramp rates. The problem is exacerbated by low temperatures. Reducing the voltage swing and/or ramp rate of the reset pulse will eliminate this loss of time counts. When this issue occurs, the impact on RTC accuracy is expected to be one second every several thousand reset events.

Adding an RC filter between the reset pin and the external reset input to control the reset signal voltage ramp rate can prevent this problem.
