## MPC8306 Chip Errata

This document details all known silicon errata for the MPC8306. The following table provides a revision history for this document.

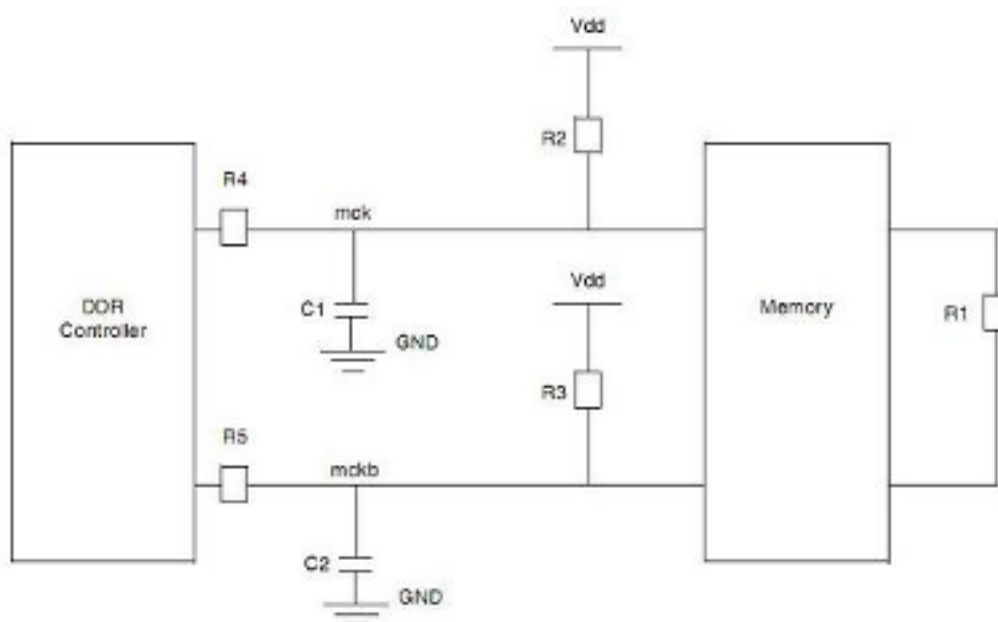
**Figure 1. Recommended connections for DDR controller and memory**

## DDR21: MCK/ $\overline{\text{MCK}}$ AC differential crosspoint voltage outside JEDEC specifications

**Description:** The crossover points of the MCK and  $\overline{\text{MCK}}$  signals of the DDR controller are not meeting JESD79-2C specifications, which indicates that the crossover points should lie within  $\pm 125$  mV range of reference voltage.

**Impact:** Disagreement with the JESD79-2C standard.

**Workaround:** To meet the JESD79-2C crosspoint voltage specifications, we recommend implementing the following connections between the DDR controller and DDR2 memory:

Effect of different circuit components on MCK and  $\overline{\text{MCK}}$  signals:

1. Increasing R2 and R3 shifts signal levels up (used as pull up).
2. Increasing C1 increases rise/fall time of mck signal.
3. Increasing C2 increases rise/fall time of mckb signal.
4. Reducing R1 can help in shifting the signals up.
5. R4 and R5 can be used to make termination proper.

R4, R5, C1, C2 near to SOC, R1, R2, and R3 have been placed at the end of clock transmission lines.

We recommend varying termination resistor R1 first. Lowering R1 can help increase the voltage levels up. The only disadvantage is that it may add up more reflections. Therefore, the user must decide accordingly. If it does not give sufficient margin, the user can add the pull-up resistor (R3 and R4) option to further increase the voltage levels.
