MPC8360E Chip Errata

This document details all known silicon errata for the MPC8360. The following table provides a revision history for this document.

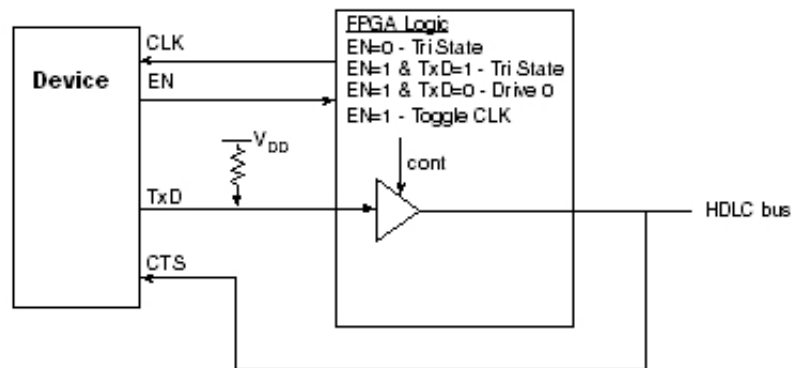
Figure 1. External Logic To Generate Gated Clock for the UCC

Impact: HDLC bus mode is not supported through the TDM interface.

Workaround: Program the UCC to NMSI mode and use external logic to generate the gated clock for the UCC at the assigned time slot, see Figure 1 below.

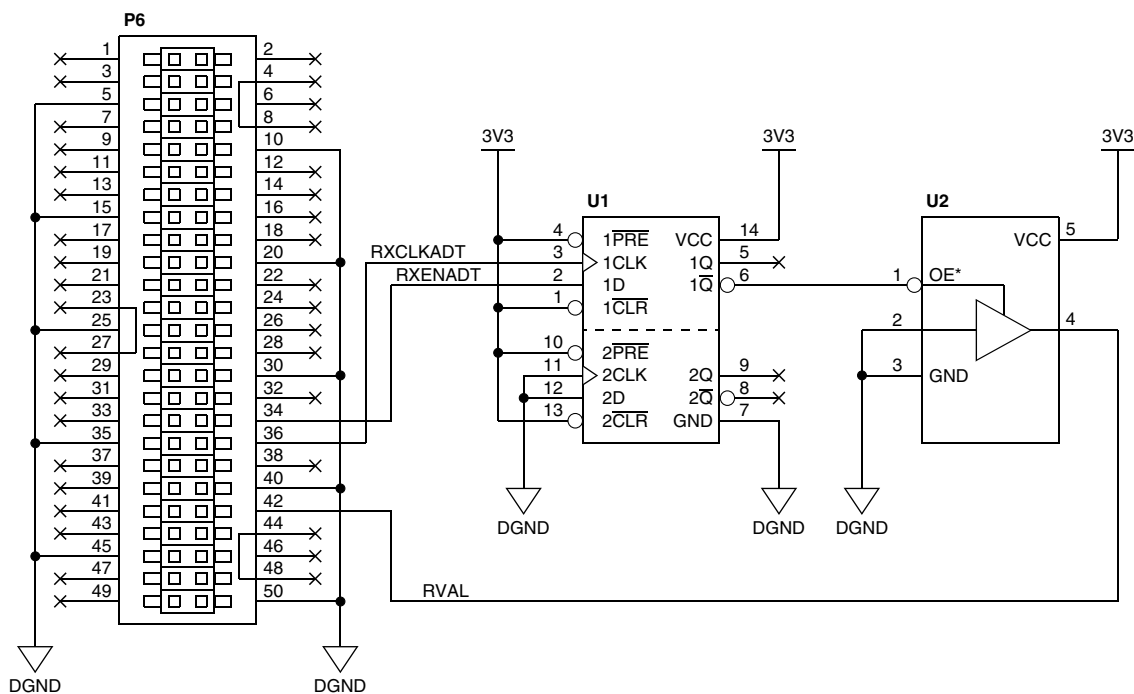
Figure 2. Example Schematic Drawing

According to the PL2 specification, the PHY Layer device (QE POS Slave) shall tri-state REOP, RSOP and RVAL signals when RENB is de-asserted. The QE POS controller (UPC) does not ignore these tri-state signals when RENB is de-asserted as it should. When the RVAL signal is tri-stated it may be sampled as active by the UPC which will result in an error. In this case, the UPC will signal a protocol violation event by setting UCCE[PV].

Impact: Corrupted data may be received in the receive buffer or the UPC peripheral may hang.

Workaround: The customer system should drive RVAL low within one POS interface clock after RENB negation (a high value). This can be achieved, for example, by connecting the inverted, one clock delayed sample of RENB (Master output) to the device RVAL pin (Master input), instead of the POS Slave RVAL output signal as illustrated in the following figure.
