Freescale Semiconductor Mask Set Errata

MSE908AP64_2L47P Rev. 3, 1/2007

Mask Set Errata for Mask 2L47P

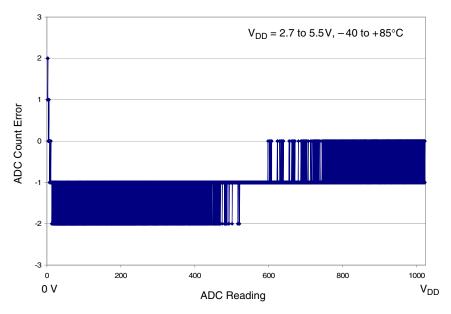
Figure 1. Typical ADC Error Count

The 10-bit ADC conversion result for 0V input (zero input reading) is \$000, \$001, \$002, or \$003; not the specified \$00 or \$01. With inputs of $5\,\text{mV}$ and above, the ADC is within the specified accuracy of $\pm 1.5\,\text{LSB}$ (see Figure 1).
