Mask Set Errata for Mask 2M44C

This mask set errata applies to the mask 2M44C for these products:

- MC9RS08KA2
- MC9RS08KA1

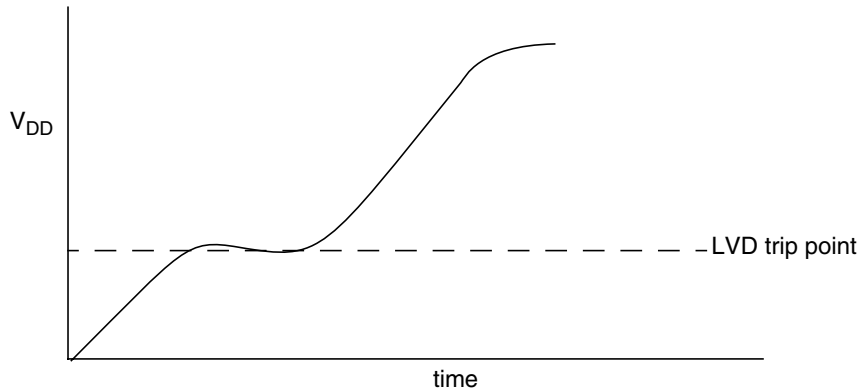
Case 1 If there is a pullup on PTA0 when V_{DD} of the MC9RS08KA2 is driven with a very slow and nonlinear power-up sequence, the part can enter a non-functional static condition where the MCU is not executing code.

Figure 1. Observed Slow and Nonlinear V_{DD} Ramp

There are two suggested workarounds. The first is to ensure that PTA0 is low until the voltage on V_{DD} is above a level of 2.4 V. This can be accomplished with a pulldown on the pin or a small capacitor to slow the rise of the PTA0 pin during power up.

A faster rise time on V_{DD} , faster than 2 V/ms, can prevent both of the issues.

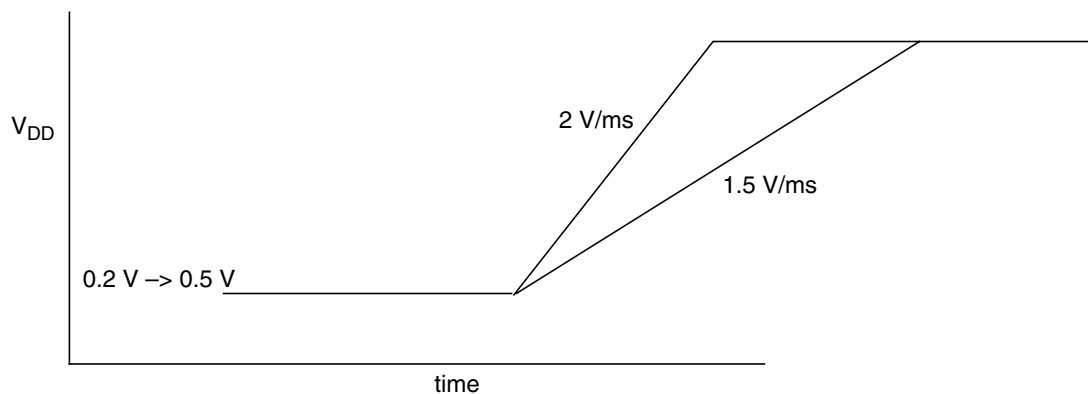
Case 2 It has been observed that when V_{DD} of the MCU is driven with a voltage ramp of 1.5 V/ms to 2.0 V/ms from a residual voltage on V_{DD} between 0.2 to 0.5 V, the MCU begins to execute code and enters one of two states.

- a) If LVD is enabled (default), the part will repeatedly start to run code followed by a reset from the LVD.
- b) If LVD is disabled by the user code, the code will run only for a short time and then stall.

Figure 2. Observed V_{DD} Ramp Conditions that Cause Inconsistent Startup

The second workaround is to not allow a residual voltage between 0.2 to 0.5 V on V_{DD} followed by a ramp of V_{DD} from 1.5 V/ms to 2 V/ms. The addition of a discharge resistor in parallel with the bypass capacitors will allow the V_{DD} to be discharged. The specific component values to use depend upon the circuit's operation during V_{DD} ramp conditions.
