# AN10608

## XTAL1 clock and IOW pulse synchronization issue

Rev. 01 — 23 April 2007

Application note

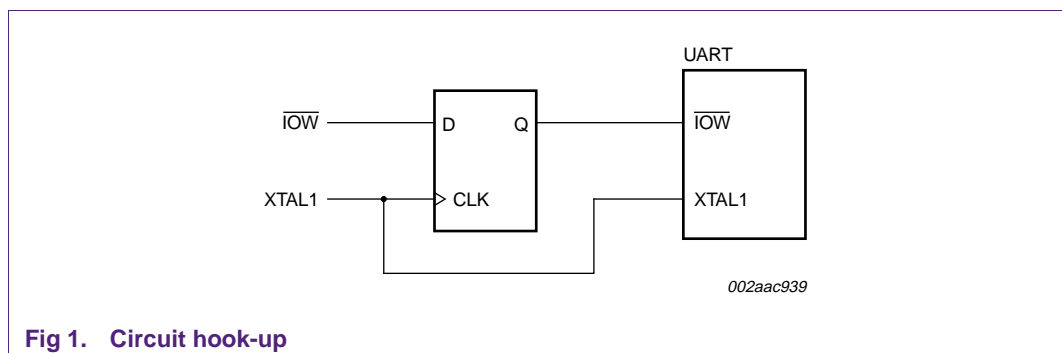
Fig 1. Circuit hook-up

There is an internal signal that indicates the availability of a new character in the transmitter FIFO, and that signal is clocked by the processor  $\overline{\text{IOW}}$  pulse. In the non-B UART design, that signal is not synchronized to the XTAL1 clock before it is being used in the transmitter state machine; there exists a race condition between the XTAL1 clock and the  $\overline{\text{IOW}}$  pulse. If the  $\overline{\text{IOW}}$  pulse happens during the time the state machine's input flip-flops are being switched, then the state machine will get into the wrong state. The state machine should be in the start state, but it wrongly jumps to the transmit bit 4<sup>th</sup> state. The transmitter then wrongly sends out the last four bits of the old character without a start bit, and the rest of the characters in the transmit FIFO.

1. Replace the non-B revision with the B revision devices.
2. The hardware work-around for this issue requires an external flip-flop to synchronize the  $\overline{\text{IOW}}$  pulse to the XTAL1 clock. XTAL1 is used to clock the D flip-flop. The  $\overline{\text{IOW}}$  signal from the processor is connected to the D input of the flip-flop, and the Q output of the D flip-flop is connected to the  $\overline{\text{IOW}}$  input of the UART. See [Figure 1](#) for the circuit hook-up example.
