## *Mask Set Errata 1*

# **M68HC912D60 Microcontroller Unit**

This mask-set errata provides information pertaining to the following 68HC912D60 MCU mask set devices:

- 1F68K

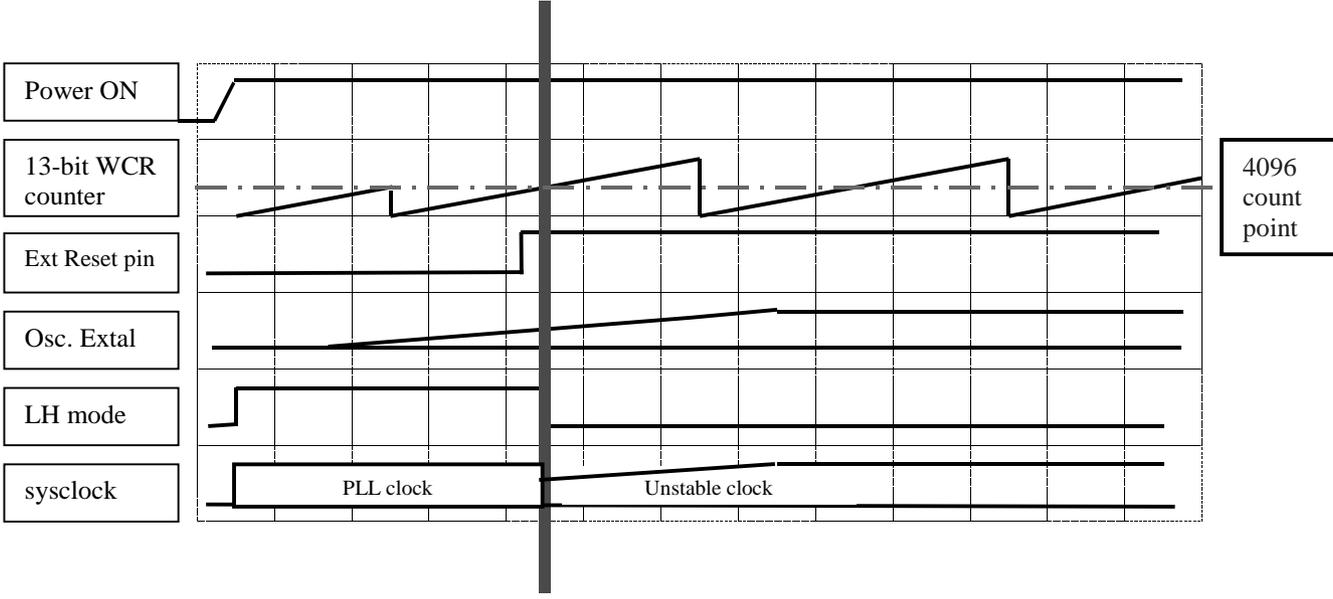
The device can prematurely indicate that the oscillator has stabilized releasing the part from Limp Home clock mode to the oscillator clock mode with an unstable oscillator. This can cause unpredictable behavior of the MCU. This situation can arise with short external power-on reset periods and / or crystal oscillator circuits that exhibit slow startup characteristics. If the PLL is not being used (Vddpll connected to Vss) Limp Home mode is disabled and this issue does not apply.

Figure 2. Representation of unreliable start-up mode with slow crystal

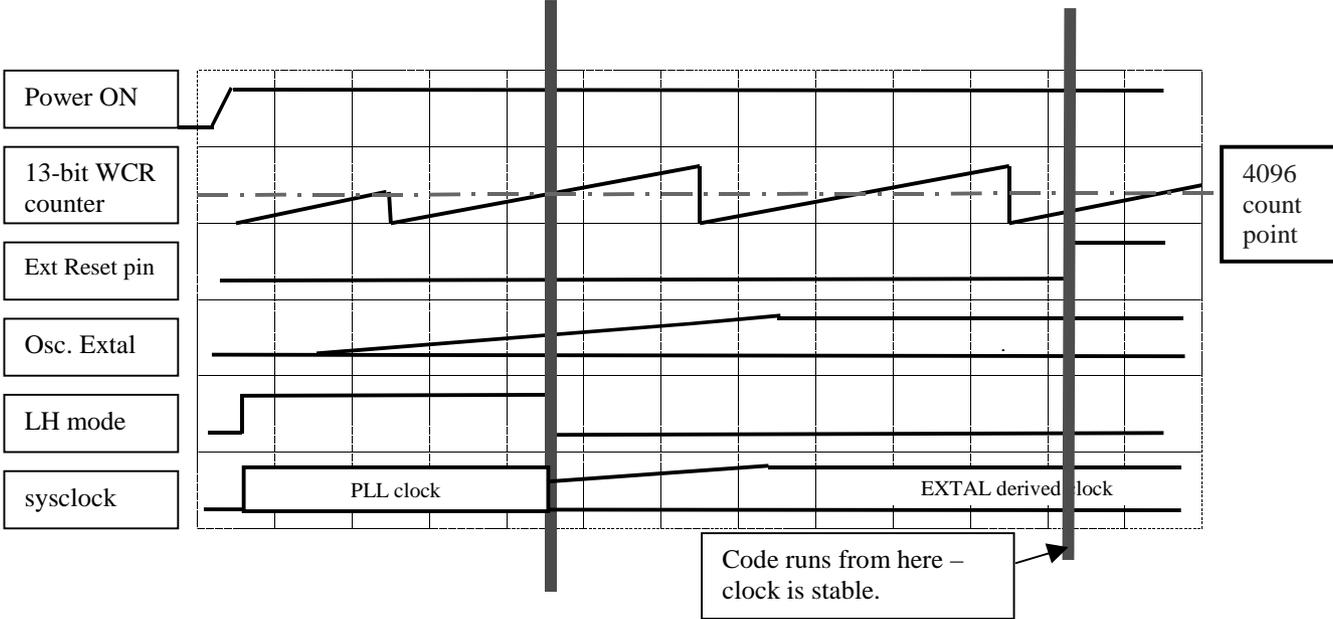
Figure 3. Representation of preferred means of overcoming issue with Figure 2

The Reset condition can be overcome by allowing the crystal oscillator circuit to stabilize before releasing the external RESET line (see fig. 3). Operation is similar to that shown in fig 2.

To determine if crystal is 'stable' at the release of reset can be difficult and the time can vary some from board to board. If the customer has special high impedance probes, it is possible to monitor the amplitude of the voltage from XTAL to ground (<2 pF scope probes are recommended). Please note that any loading on the circuit can affect its operation. (Any resistance to ground or Vdd on the EXTAL pin can greatly attenuate the amplifier gain and cause erroneous operation.)
