Mask Set Errata 4

M68HC912D60 Microcontroller Unit

68HC912D60MSE4

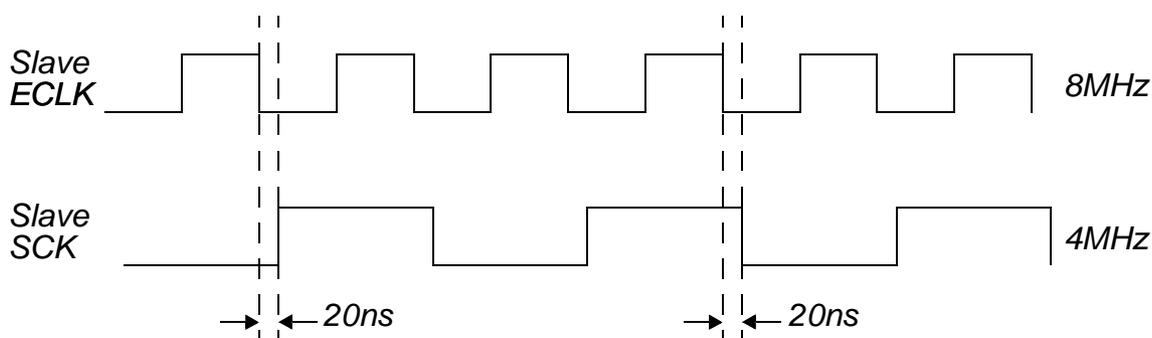
If the SPI on the HC912D60 is operated in slave mode, the SPIF flag is occasionally not set when valid data is received. The failing condition only occurs if the slave node's ECLK signals falling edge leads the SPI's incoming SCK signal by a specific phase difference.

NOTE: *The failure is very rare and has only been witnessed when the slaves ECLK falling edge leads the SCK by (20nS \pm 4nS). The failure never occurs if the SPI is operated as the master. The diagram below shows an example of the timing relationship when the failure occurs.*

1. Only use the SPI in slave mode if there is a fixed clock phase relationship between the master and slave clocks, avoiding the above scenario.

2. Implement a software timeout to gate reception of data. May require use of additional I/O for handshaking.

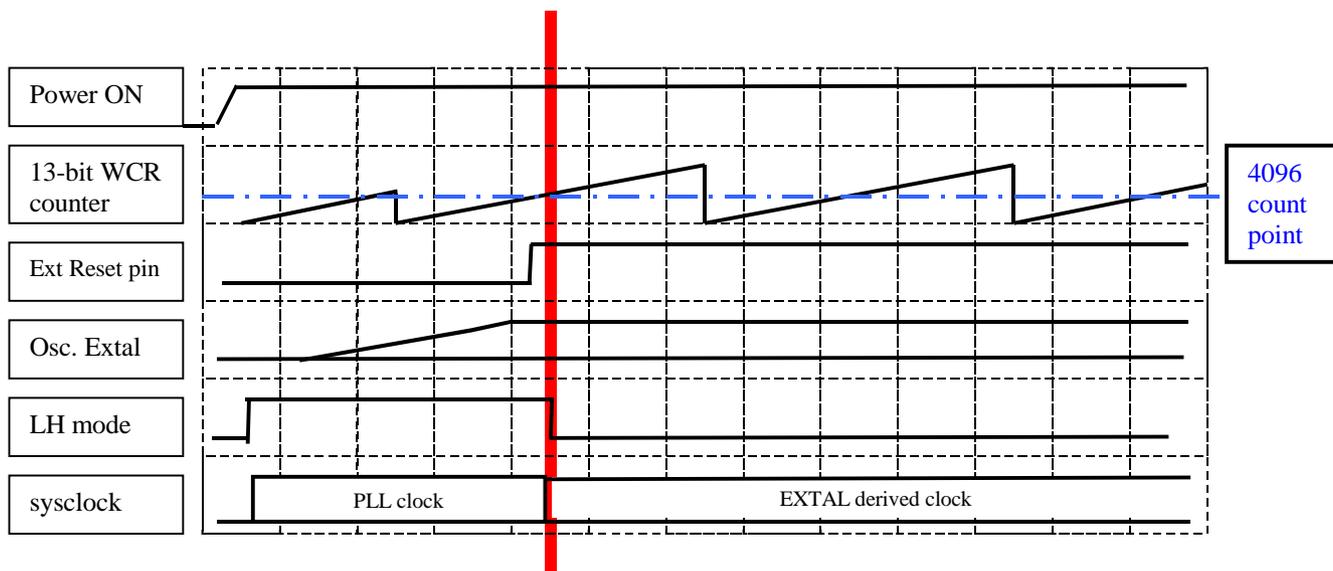
Figure 1. Representation of Normal start-up condition

Common practice for the start up mode of operation of HC12 microcontrollers is for the external RESET line to be held active until such time as the crystal has stabilized at its operating frequency. On release of the external RESET line and when the WCR (counter register) reaches a count of 4096 cycles, normal operating mode is entered with the CPU clocked from the crystal frequency (see fig. 1).

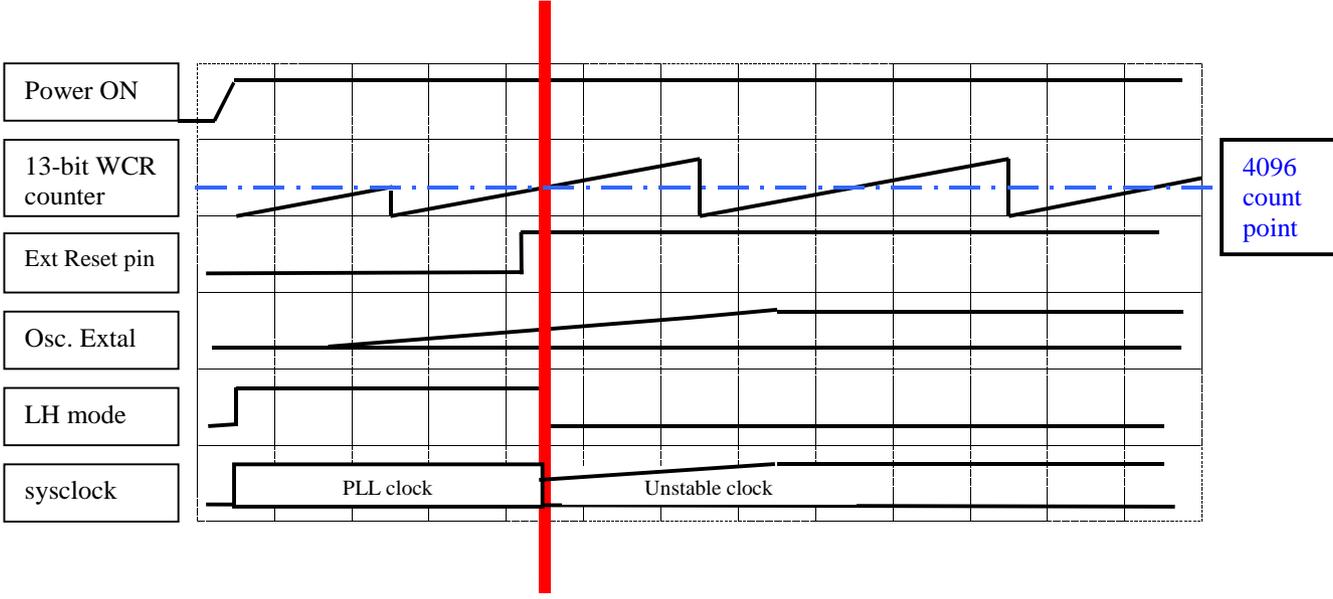
Figure 2. Representation of unreliable start-up mode with slow crystal

The HC12 mode of operation known as Limp-Home Mode (LHM) is enabled when the VDDPLL pin is at VDD and is entered if for any reason the external crystal ceases to oscillate. During this mode the CPU will be clocked from the free-running VCO clock of the PLL (at a nominal frequency of 1MHz). If LHM is enabled during the start-up phase (i.e. VDDPLL=5V, NOLHM bit=0) and the external RESET line is not held active until after the crystal frequency is stable then the device starts up

in LHM since no crystal oscillations will be detected. This situation can arise with short reset periods and/or crystals that exhibit slow start-up characteristics.

For the first 4096 cycles i.e. during the internal reset period, Limp Home mode will be de-asserted if oscillator activity is detected by the clock monitor circuit -due to the asserted Reset signal there can be no CPU activity during the Reset phase. Following release of the external or internal POR RESET in LHM (which ever is later) the crystal oscillator is sampled by the clock monitor circuit after another 4096 VCO clock cycles and at intervals of 8192 clock cycles thereafter until the crystal is deemed to be operating. If the crystal oscillator is showing activity at the time it is checked then it will be deemed to be good, even though it may not have fully stabilized, and LHM will be de-asserted. This can cause the device to switch from LH mode to normal mode with the CPU clocked from an unstable signal from the crystal oscillator (see fig. 2) resulting in unpredictable function of the CPU.
