Chip Errata
DSP56156 Digital Signal Processor
 Mask: D13N

ERRATA

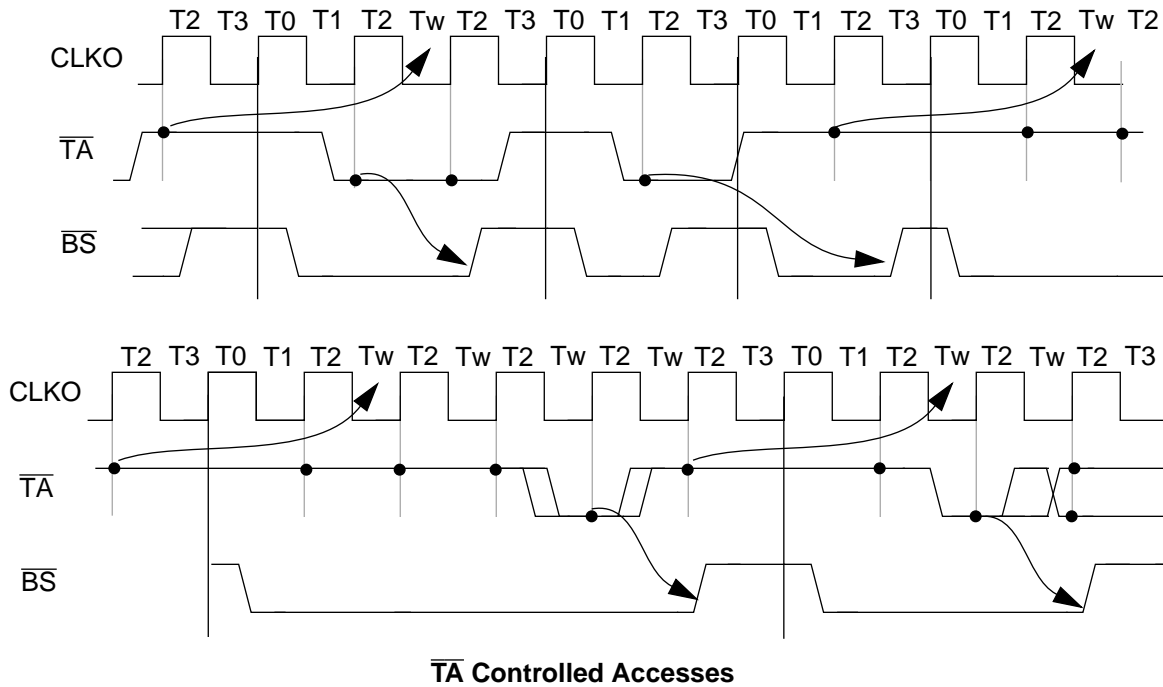
- The \overline{TA} pin behavior of this mask set (as well as all previous mask sets) does not match the \overline{TA} definition described in the DSP56156 data sheet (2/1/92). The \overline{TA} behavior is described below; it will be changed to the behavior described in the data sheet in a later revision of the silicon:

\overline{TA} (Transfer Acknowledge) - active low input. If there is no external bus activity, the \overline{TA} input is ignored by the DSP. When there is external bus cycle activity, \overline{TA} can be used to insert wait states in the external bus cycle. \overline{TA} is sampled on the leading edge of T2. Any number of wait states from 1 to infinity may be inserted by using \overline{TA} . If \overline{TA} is sampled high one clock period before the beginning of a bus cycle, at least one wait states will be inserted in the bus cycle. The bus cycle will end 4T after the \overline{TA} has been sampled low on a leading edge of the clock, if the Bus Control Register (BCR) value does not program more wait states. The number of wait states is determined by the \overline{TA} input or by the BCR, whichever is longer. \overline{TA} is still sampled during the leading edge of the clock when wait states are controlled by the BCR value. In that case, \overline{TA} will have to be sampled low during the leading edge of the last wait state programmed by the BCR (4T before the end of the bus cycle programmed by the BCR) in order not to add any wait states. If \overline{TA} is sampled low (asserted) at the leading edge of T2 preceding the bus cycle, and if no wait states are specified in the BCR register, zero wait states will be inserted in the external bus cycle.
