## ES\_LPC11U6x Errata sheet LPC11U6x

Rev. 1.5 — 19 January 2024

Errata

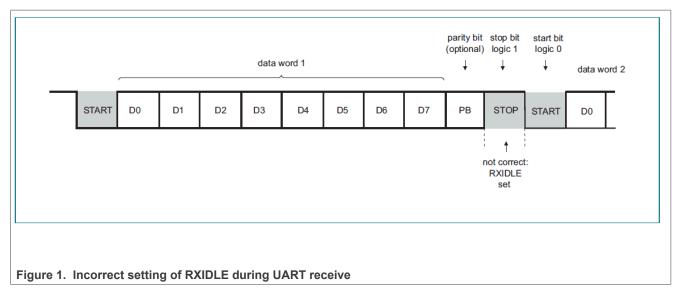
The RXIDLE bit is incorrectly set for a fraction of the clock cycle between the reception of the last data bit and the reception of the start bit of the next word, that is while the stop bit is received. RXIDLE is cleared at the beginning of the start bit.

When writing code that checks for the setting of any of the status bits RXIDLE, TXIDLE, TXDISSTAT, check the value of the status bit in the STAT register:

- If status bit = 1, add a delay of one UART bit time (if STOPLEN = 0, one stop bit) or two bit times (if STOPLEN
  - = 1, two stop bits) and check the value of the status bit again:
  - If status bit = 1, the receiver is idle.
  - If status bit = 0, the receiver is receiving data.
- If the status bit = 0, the receiver is receiving data.

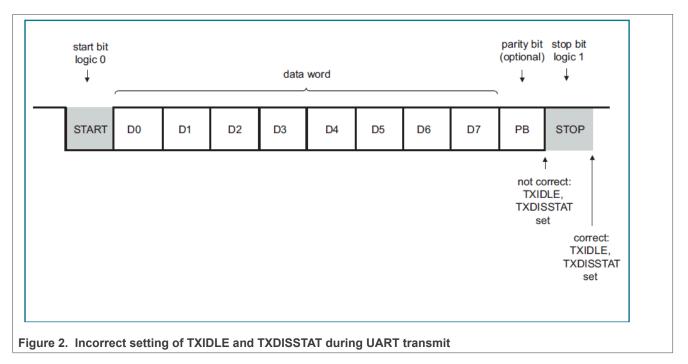
Both, TXIDLE and TXDISSTAT are set incorrectly between the last data bit and the stop bit while the transfer is still ongoing.
