ES_LPC15xx Errata sheet LPC15xx Rev. 2.4 — 7 March 2018

Info	Content
Keywords	LPC1549JBD100; LPC1549JBD64; LPC1549JBD48; LPC1548JBD100; LPC1548JBD64; LPC1547JBD64; LPC1547JBD48; LPC1519JBD100; LPC1519JBD64; LPC1518JBD100; LPC1518JBD64; LPC1517JBD64; LPC1517JBD48
Abstract	LPC15xx errata

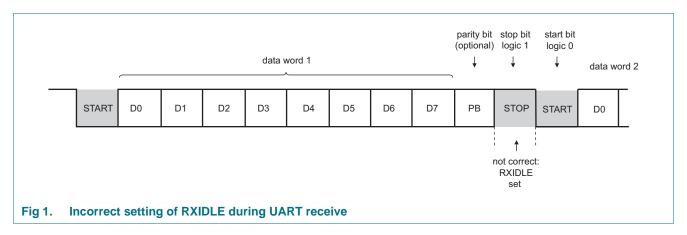
The RXIDLE bit is incorrectly set for a fraction of the clock cycle between the reception of the last data bit and the reception of the start bit of the next word, that is while the stop bit is received. RXIDLE is cleared at the beginning of the start bit.

When writing code that checks for the setting of any of the status bits RXIDLE, TXIDLE, TXDISSTAT, check the value of the status bit in the STAT register:

- If status bit = 1, add a delay of one UART bit time (if STOPLEN = 0, one stop bit) or two bit times (if STOPLEN = 1, two stop bits) and check the value of the status bit again:
 - If status bit = 1, the receiver is idle.
 - If status bit = 0, the receiver is receiving data.
 - If the status bit = 0, the receiver is receiving data.

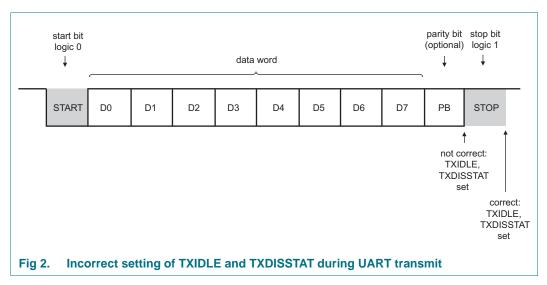
Both, TXIDLE and TXDISSTAT are set incorrectly between the last data bit and the stop bit while the transfer is still ongoing.
