ES_LPC185x/3x/2x/1x Flash

Errata sheet LPC185x, LPC183x, LPC182x, LPC181x
flash-based devices

Rev. 6.7 — 7 March 2018

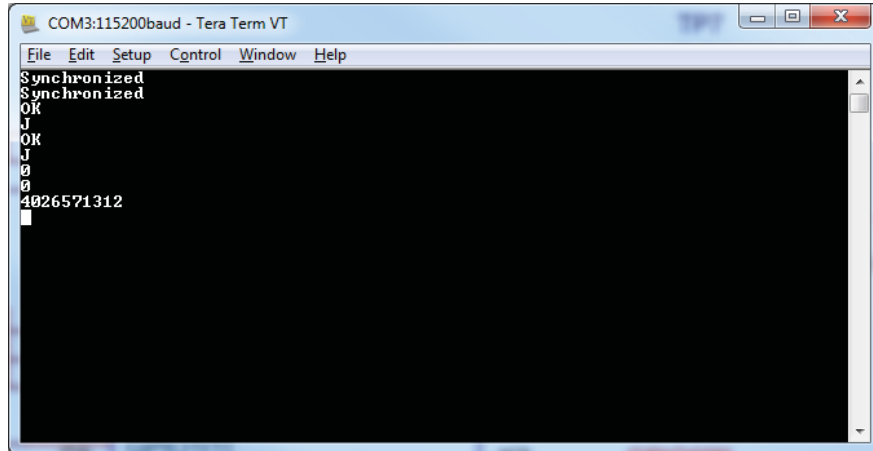
Incorrect example:

The 'J' command in ISP mode should return an error code, followed by an ASCII string representation of the part ID, followed by a 0. However what is actually returned is the error code, followed by a 0, followed by an ASCII string representation of the part ID. The problem is the last two items returned are swapped.

There is no work-around for this problem.

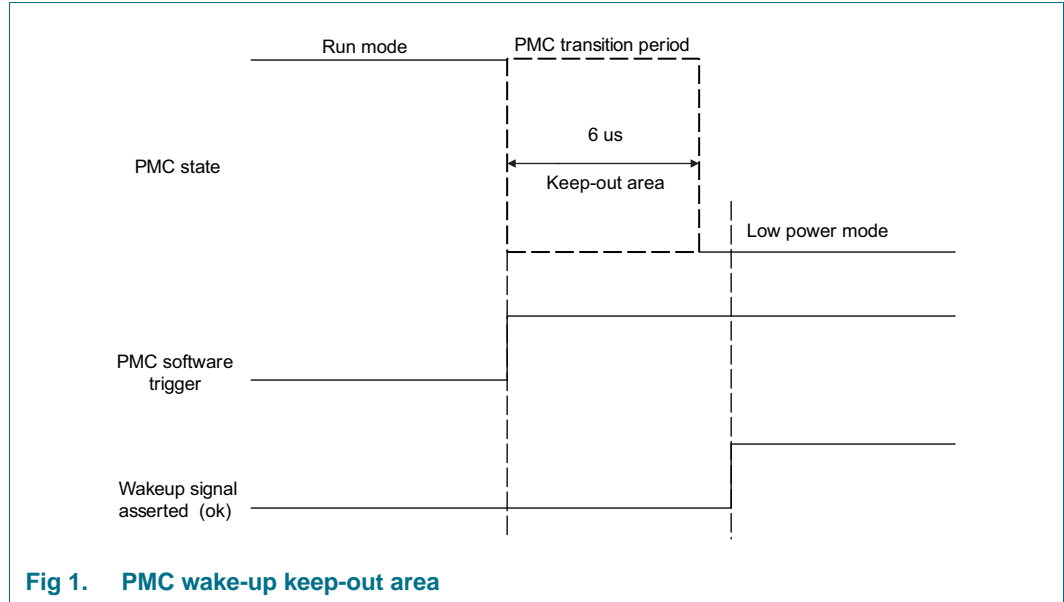
When the chip is in a transition from active to Deep Sleep, Power Down, or Deep Power Down, wake-up events are not captured and they will block further wake-up events from propagating. The time window for this transition is 6 μ s and is not affected by the chip clock speed. After a wake-up event is received during the PMC transition, the chip can only recover by using an external hardware reset or by cycling power.

Make sure that a wake-up signal is not received during the Deep Sleep, Power Down, or Deep Power Down transition period. An example circuit to work around this could include an external 6 μ s one shot which could be triggered via software using a GPIO line when entering Deep Sleep, Power Down, or Deep Power Down mode. The one-shot's output could be used to gate the wake-up signal(s) to prevent receiving a wake-up signal during the PMC transition period. Depending on the system design, it may also be needed to latch the wake-up signal(s) so that they will still be present after the one-shot's 6 μ s time-out.

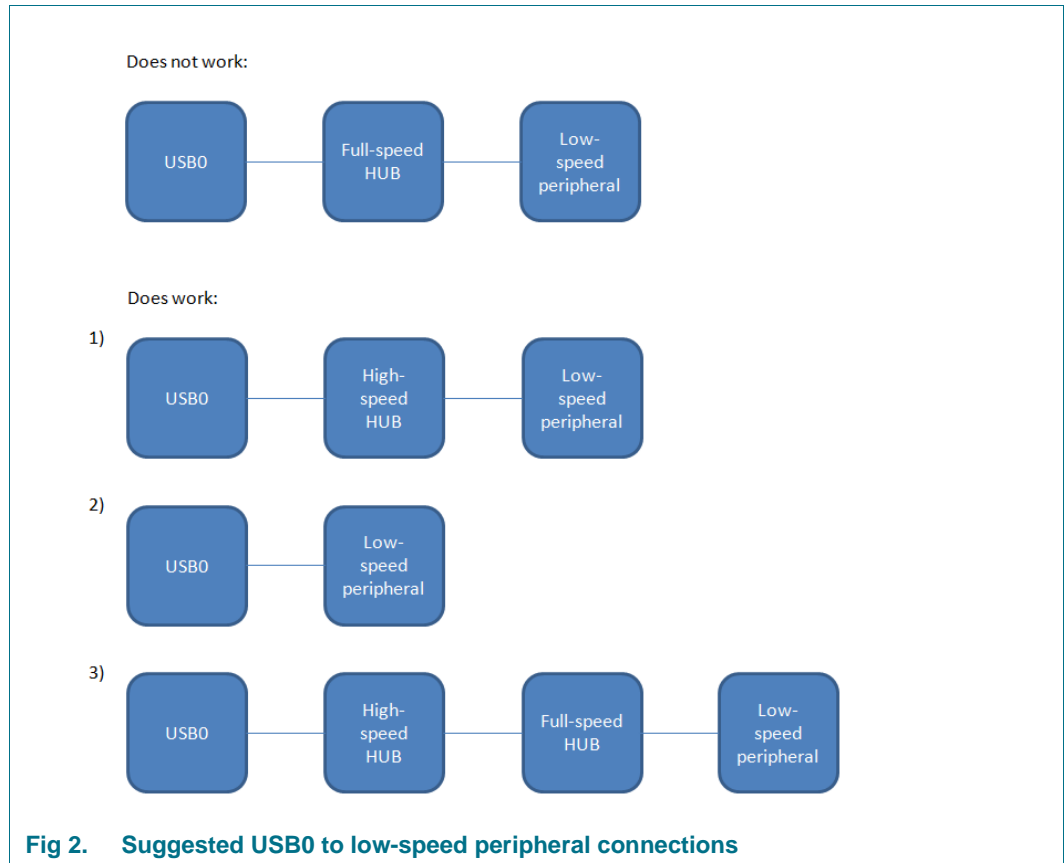
Fig 2. Suggested USB0 to low-speed peripheral connections

The USB controller called USB0 is unable to communicate with a low-speed USB peripheral in host mode when there is a full-speed hub directly connected to the USB0 port and a low-speed peripheral is connected in the tree somewhere below this full-speed hub. Only USB0 has this problem; the other USB controller, USB1 does not.

There is no work-around for this problem. It is suggested that the low-speed USB peripheral is either connected directly to USB0 or a high-speed hub is placed between that peripheral and USB0.

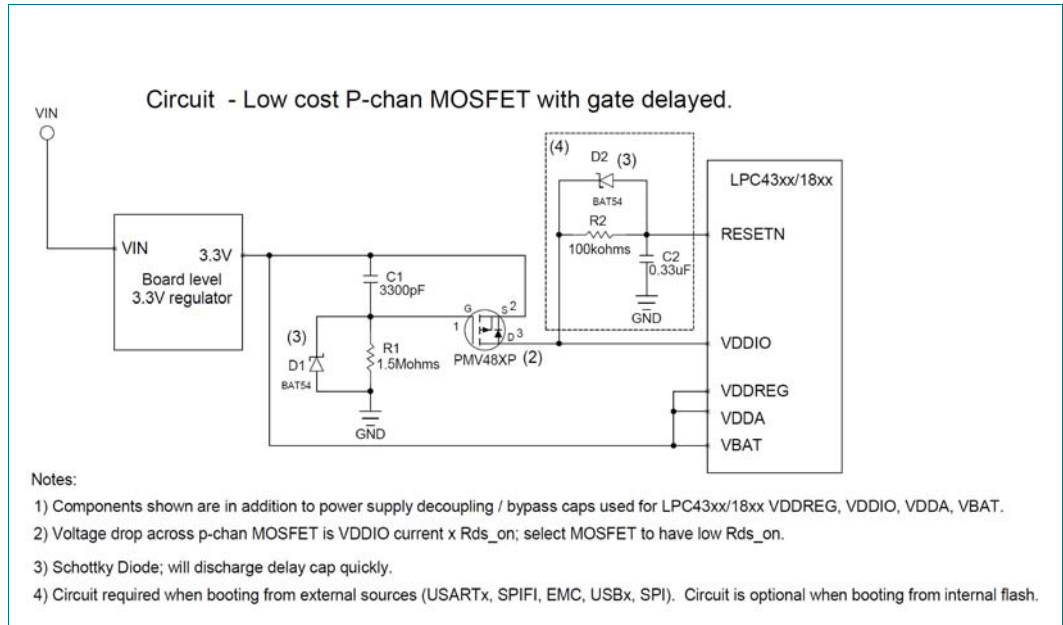
On all packages, repeated power cycling of the device may cause erroneous programming of the OTP banks. During ramp-up, the VDDREG supply voltage does not have enough time to settle and initialize the OTP controller before valid programming voltage is reached on the VPP pin. This may cause accidental programming of the OTP banks. Accidental programming of the OTP banks does not occur during Power-down of the supply voltage.

The following circuit diagram is an example that shows the P-channel MOSFET with the gate delayed and the R-C delay circuit connected to the RESETN pin.
