# ES\_LPC1850/30/20/10

Errata sheet LPC1850, LPC1830, LPC1820, LPC1810

Rev. 7.1 — 7 March 2018

Errata sheet

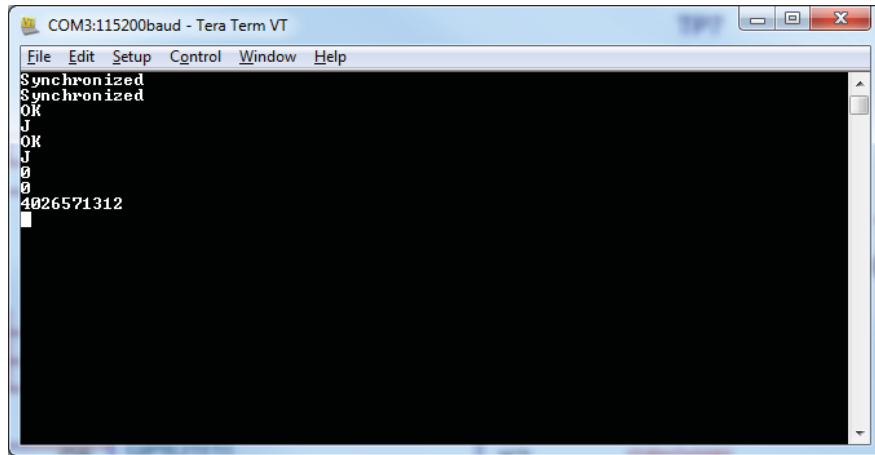
Incorrect example:

The 'J' command in ISP mode should return an error code, followed by an ASCII string representation of the part ID, followed by a 0. However what is actually returned is the error code, followed by a 0, followed by an ASCII string representation of the part ID. The problem is the last two items returned are swapped.

There is no work-around for this problem.

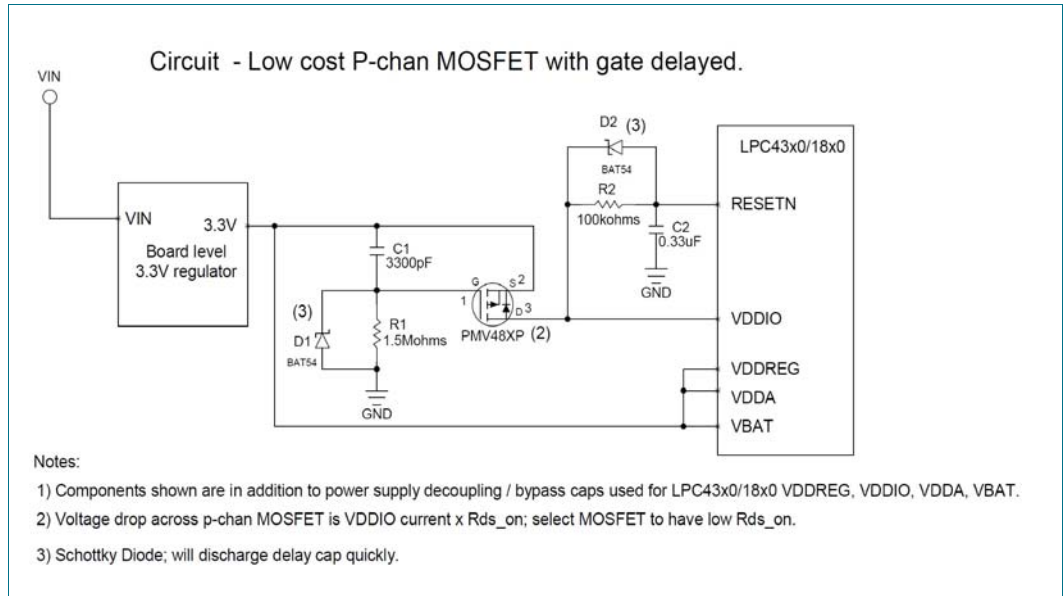
On all packages, repeated power cycling of the device may cause erroneous programming of the OTP banks. During ramp-up, the VDDREG supply voltage does not have enough time to settle and initialize the OTP controller before valid programming voltage is reached on the VPP pin. This may cause accidental programming of the OTP banks. Accidental programming of the OTP banks does not occur during Power-down of the supply voltage.

- Do not tie VDDIO to VDDREG and VDDA pins. The power supplied to the VDDIO pin should be delayed by 2 ms after the power supply on the VDDREG and VDDA pins stabilizes at the operating voltage level. The signal to the RESETN pin must also be delayed by 2 ms after the power supply on the VDDIO pin stabilizes at the operating voltage level.

The following circuit diagram is an example that shows the P-channel MOSFET with the gate delayed and the R-C delay circuit connected to the RESETN pin.

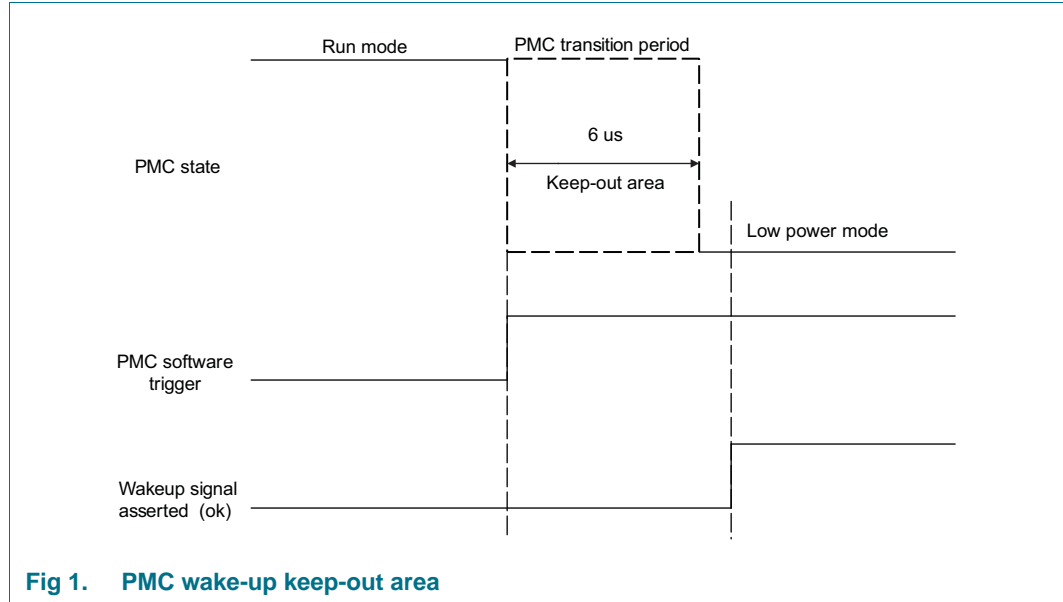
**Fig 1. PMC wake-up keep-out area**

When the chip is in a transition from active to Deep Sleep, Power Down, or Deep Power Down, wake-up events are not captured and they will block further wake-up events from propagating. The time window for this transition is 6  $\mu$ S and is not affected by the chip clock speed. After a wake-up event is received during the PMC transition, the chip can only recover by using an external hardware reset or by cycling power.

Make sure that a wake-up signal is not received during the Deep Sleep, Power Down, or Deep Power Down transition period. An example circuit to work around this could include an external 6  $\mu$ S one shot which could be triggered via software using a GPIO line when entering Deep Sleep, Power Down, or Deep Power Down mode. The one-shot's output could be used to gate the wake-up signal(s) to prevent receiving a wake-up signal during the PMC transition period. Depending on the system design, it may also be needed to latch the wake-up signal(s) so that they will still be present after the one-shot's 6  $\mu$ S time-out.

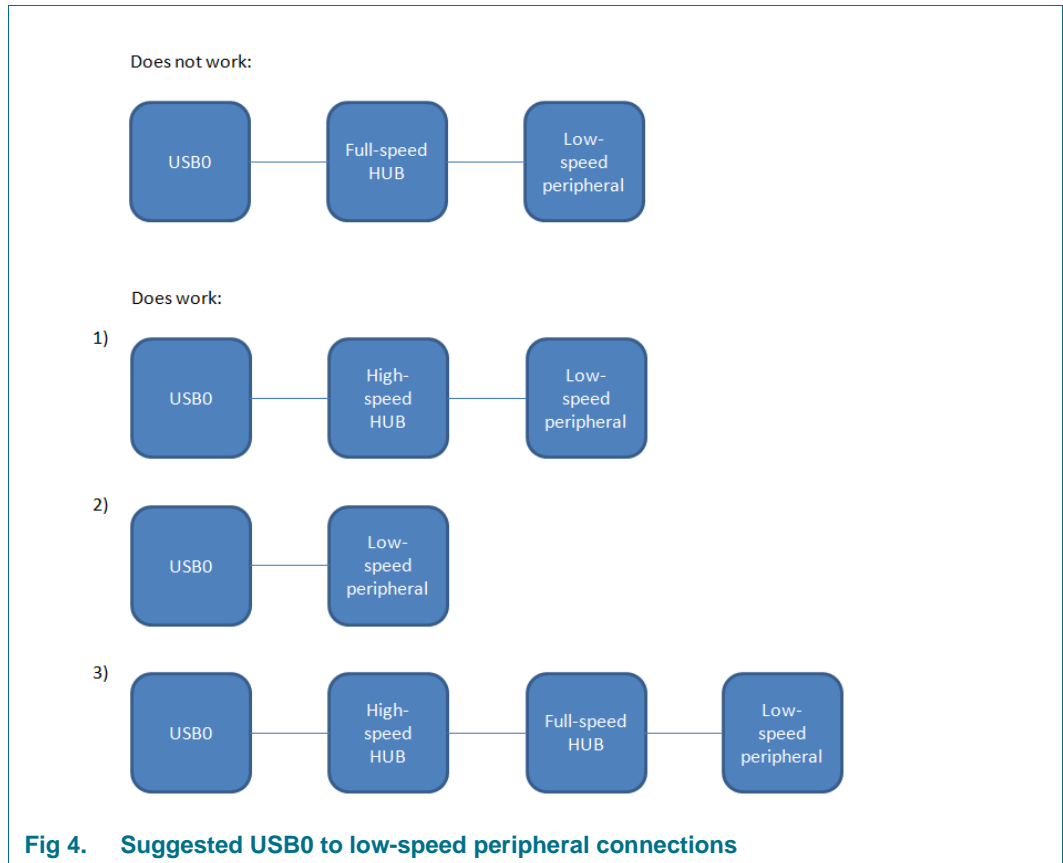
Fig 4. Suggested USB0 to low-speed peripheral connections

The USB controller called USB0 is unable to communicate with a low-speed USB peripheral in host mode when there is a full-speed hub directly connected to the USB0 port and a low-speed peripheral is connected in the tree somewhere below this full-speed hub. Only USB0 has this problem; the other USB controller, USB1 does not.

There is no work-around for this problem. It is suggested that the low-speed USB peripheral is either connected directly to USB0 or a high-speed hub is placed between that peripheral and USB0.

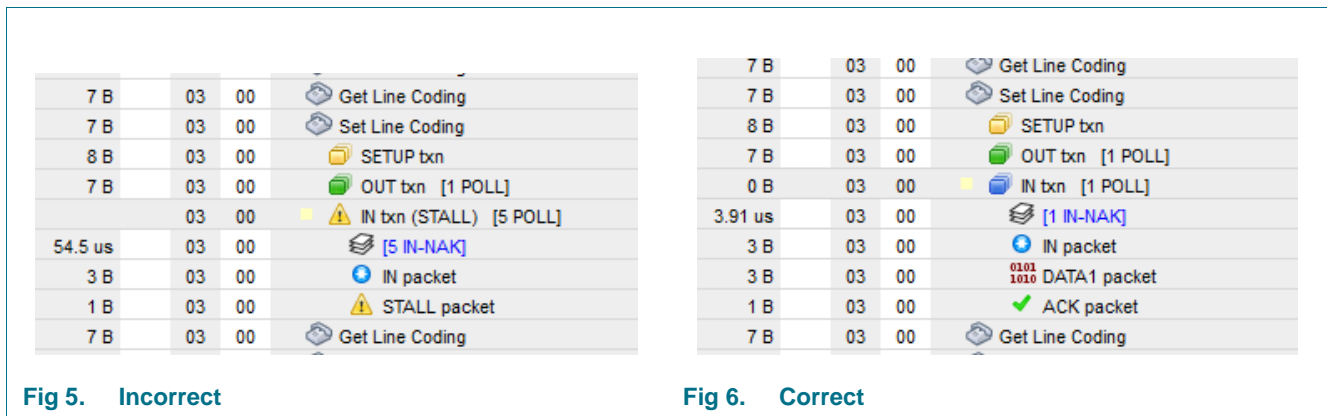
The CDC class USB ROM drivers return a STALL condition after the DATA stage of a Set Line Coding CONTROL transfer from the host. The correct behavior is to return an ACK.

The way to work around this bug is to override the default CDC class specific endpoint 0 handler and handle the processing of OUT packets in your application. Use the following source code in red to accomplish this.
