ES_LPC3230

Errata sheet LPC3230

Rev. 9 — 1 June 2011

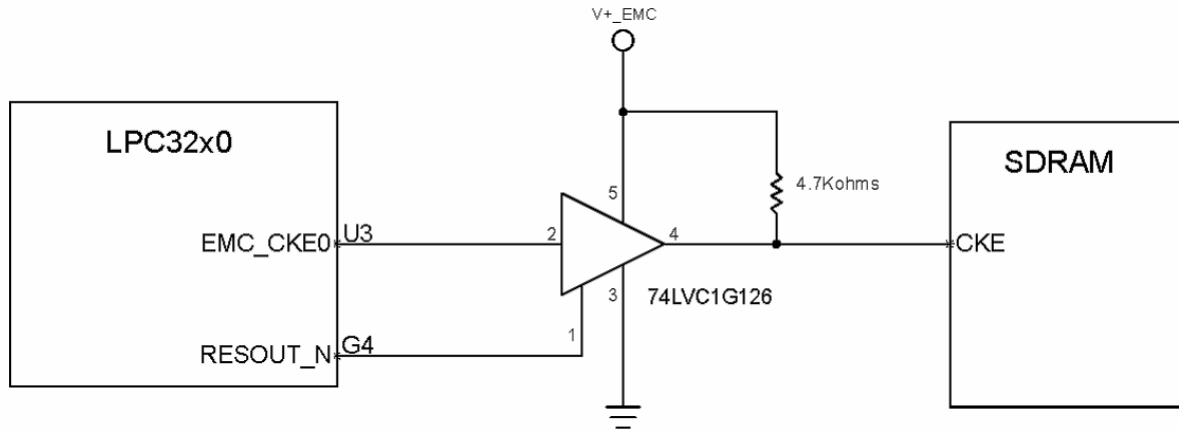
Fig 3. 128 MB DDR SDRAM example

If the LPC3230 is reset during an SDRAM access, the SDRAM clock and clock enable will be immediately de-asserted. If the de-assertion occurs during the period of time the SDRAM is driving the data bus, the SDRAM will hold that state until the next clock occurs at the SDRAM clock input when the clock enable is active. However, the LPC3230 won't deliver the clock and clock enables until software actually sets up the EMC state to do this, so the SDRAM will remain in the data assertion state on the data bus while the LPC3230 tries to boot.

When the chip attempts to load boot code from NOR FLASH after reset, the correct signals are asserted to the NOR FLASH device and the NOR FLASH device places its data on the data bus. But if the SDRAM is still driving the bus, the NOR FLASH device and SDRAM device are in contention and the data will not be read correctly into the LPC3230. In this situation, the LPC3230 will fail to boot.

If booting from NOR FLASH is a requirement, the simple circuit shown in [Figure 3](#) can be used to clear the SDRAM state at system reset. This will not change the normal functioning of the LPC3230 EMC or SDRAM operations. If SDRAM devices are also present on the 2nd SDRAM chip select, a similar circuit will be needed for those devices using EMC_CKE1.

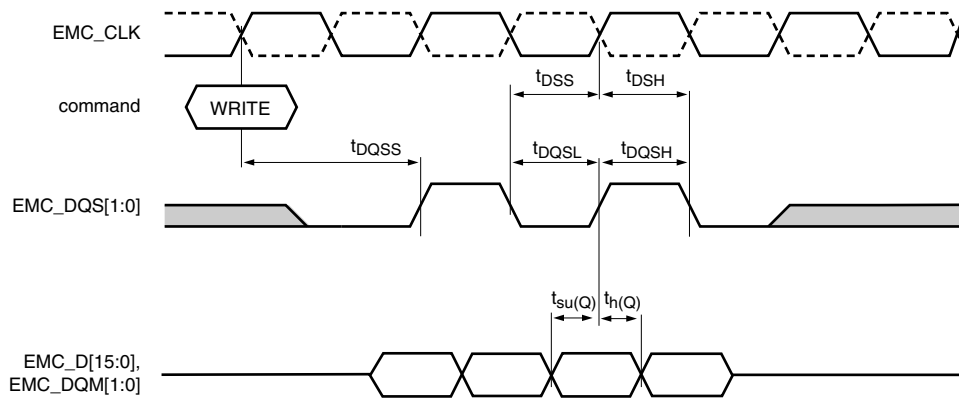
Fig 4. Basic DDR write timing

For DDR writes the LPC3230 drives the EMC_DQS[1:0] earlier in the data valid window than center aligned. With the EMC_CLK at 133 MHz this produces a minimum set-up time between the EMC_D[15:0] and EMC_DQS[1:0] of 600 ps across silicon process, voltage and temperature. Test conditions are with the EMC buffers set to fast slew rate driving

2 inches of 50 Ω transmission line and 10 pF load capacitance. DDR memories specify EMC_D[15:0] to EMC_DQS[1:0] set-up time minimum as 400 ps. This leaves 200 ps set-up time margin due to customer specific load and PCB layout implementation. See the LPC3220_30_40_50 data sheet for the complete range of DDR data output set-up time, $t_{su(Q)}$, and data output hold time $t_{h(Q)}$ times.
