ES_LPC43S50/S30/S20

Errata sheet LPC43S50, LPC43S30, LPC43S20

Rev. 1.7 — 7 March 2018

Errata sheet

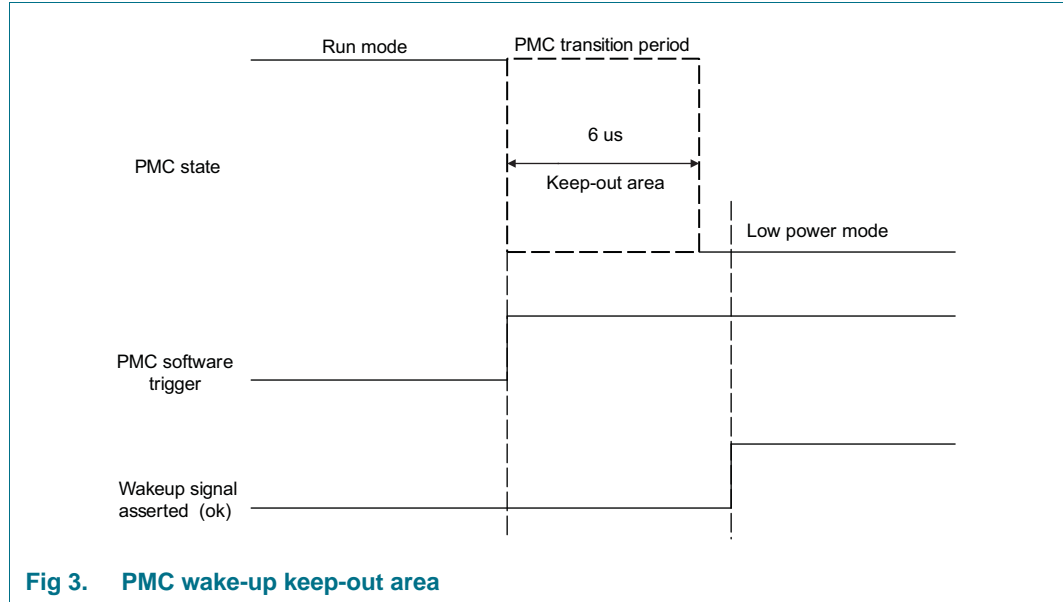
Fig 3. PMC wake-up keep-out area

When the chip is in a transition from active to Deep Sleep, Power Down, or Deep Power Down, wake-up events are not captured and they will block further wake-up events from propagating. The time window for this transition is 6 μ s and is not affected by the chip clock speed. After a wake-up event is received during the PMC transition, the chip can only recover by using an external hardware reset or by cycling power.

Make sure that a wake-up signal is not received during the Deep Sleep, Power Down, or Deep Power Down transition period. An example circuit to work around this could include an external 6 μ s one shot which could be triggered via software using a GPIO line when entering Deep Sleep, Power Down, or Deep Power Down mode. The one-shot's output could be used to gate the wake-up signal(s) to prevent receiving a wake-up signal during the PMC transition period. Depending on the system design, it may also be needed to latch the wake-up signal(s) so that they will still be present after the one-shot's 6 μ s time-out.

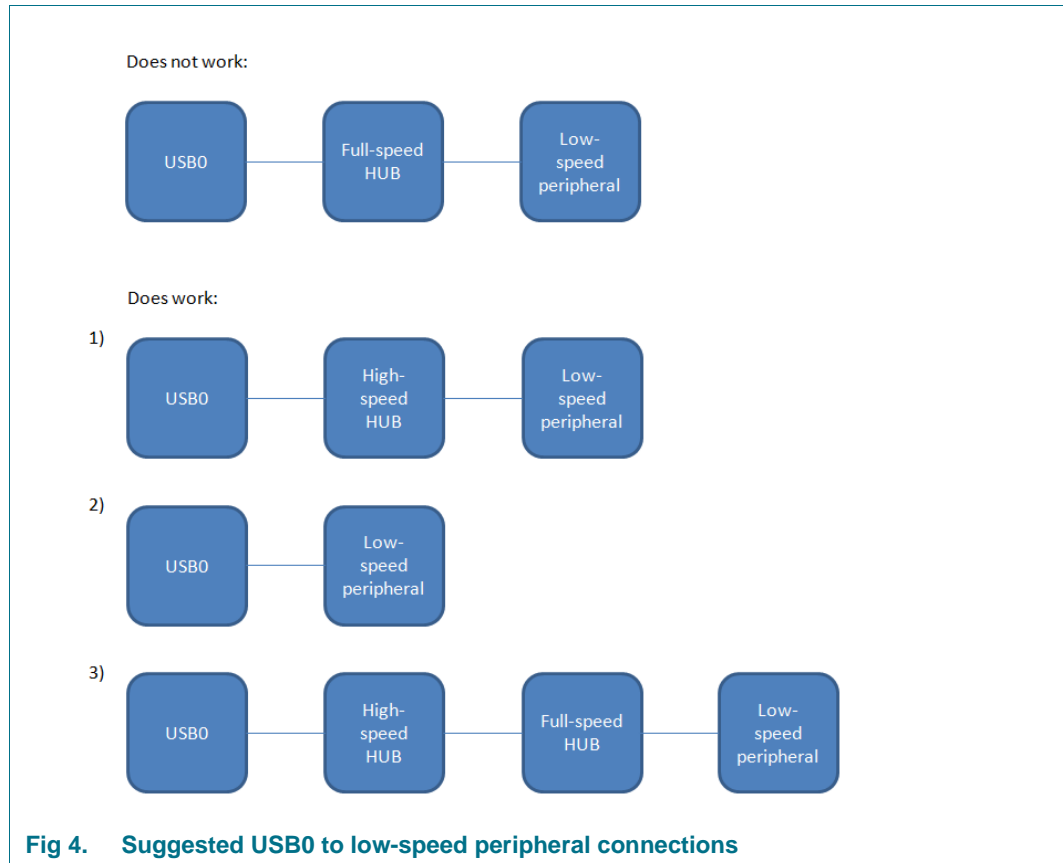
Fig 4. Suggested USB0 to low-speed peripheral connections

The USB controller called USB0 is unable to communicate with a low-speed USB peripheral in host mode when there is a full-speed hub directly connected to the USB0 port and a low-speed peripheral is connected in the tree somewhere below this full-speed hub. Only USB0 has this problem; the other USB controller, USB1 does not.

There is no work-around for this problem. It is suggested that the low-speed USB peripheral is either connected directly to USB0 or a high-speed hub is placed between that peripheral and USB0.
