ES_LPC4370/50/30/20/10

Errata sheet LPC4370, LPC4350, LPC4330, LPC4320, LPC4310

Rev. 7.1 — 7 March 2018

Errata sheet

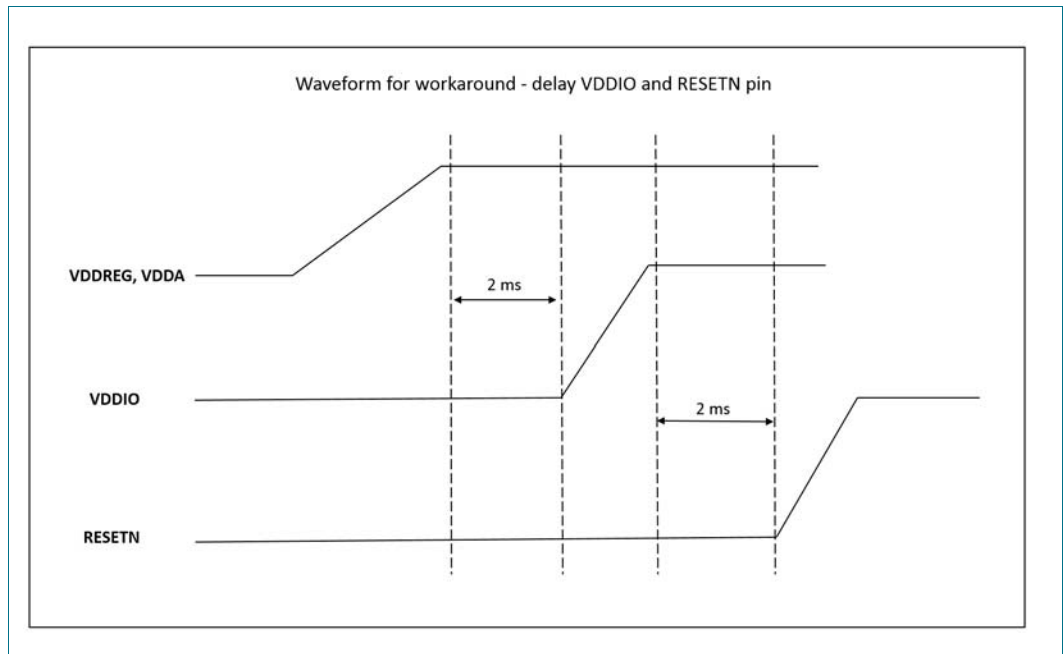
On all packages, repeated power cycling of the device may cause erroneous programming of the OTP banks. During ramp-up, the VDDREG supply voltage does not have enough time to settle and initialize the OTP controller before valid programming voltage is reached on the VPP pin. This may cause accidental programming of the OTP banks. Accidental programming of the OTP banks does not occur during Power-down of the supply voltage.

The following diagram shows the waveform for the work-around.

- Do not tie VDDIO to VDDREG and VDDA pins. The power supplied to the VDDIO pin should be delayed by 2 ms after the power supply on the VDDREG and VDDA pins stabilizes at the operating voltage level. The signal to the RESETN pin must also be delayed by 2 ms after the power supply on the VDDIO pin stabilizes at the operating voltage level.

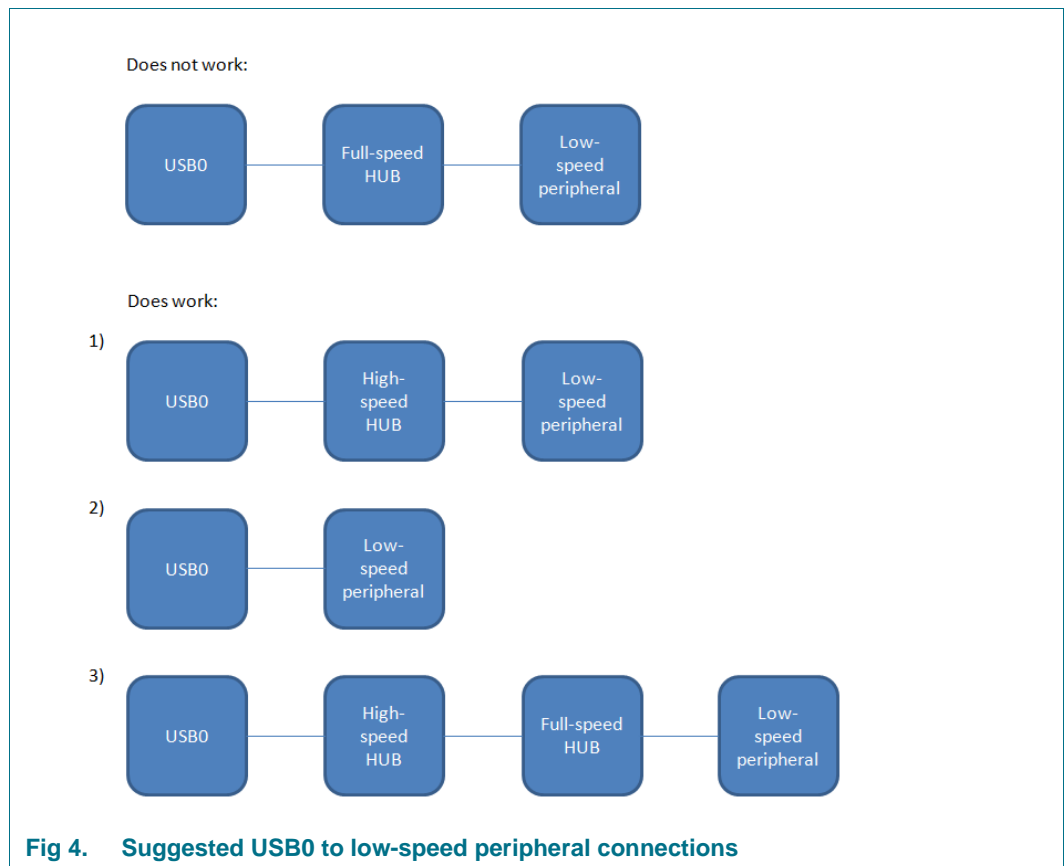
Fig 4. Suggested USB0 to low-speed peripheral connections

The USB controller called USB0 is unable to communicate with a low-speed USB peripheral in host mode when there is a full-speed hub directly connected to the USB0 port and a low-speed peripheral is connected in the tree somewhere below this full-speed hub. Only USB0 has this problem; the other USB controller, USB1 does not.

There is no work-around for this problem. It is suggested that the low-speed USB peripheral is either connected directly to USB0 or a high-speed hub is placed between that peripheral and USB0.
