ES_P89LPC901

Errata sheet P89LPC901

Rev. 02 — 4 May 2010

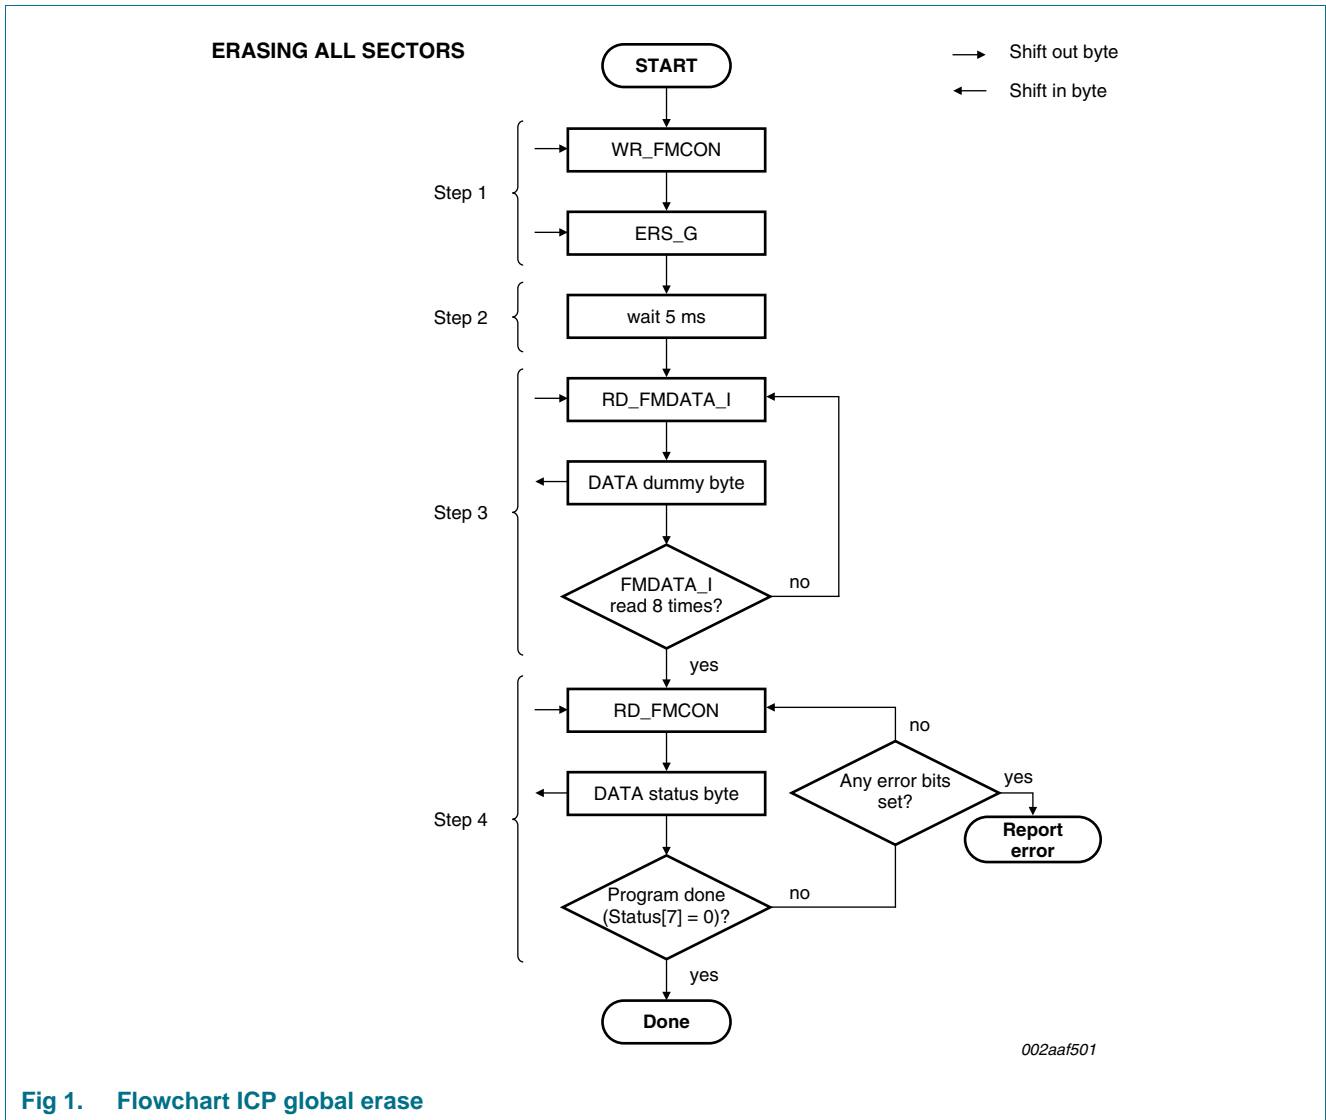
Fig 1. Flowchart ICP global erase

When giving the Erase Global command through the ICP interface the P89LPC901 will not clear the busy flag and stay busy forever.

The workaround can be done in four steps:

Step 1: Shift out the WR_FMCON command followed by the Erase Global opcode.

Step 2: Wait 5 ms.

Step 3: Do 8 dummy reads with the RD_FMDATA_I command.

Step 4: Read FMCON until the busy flag gets cleared.
