ERRATA SHEET

Date: 2008 Mar 10
Document Release: Version 1.3
Device Affected: P89LPC908

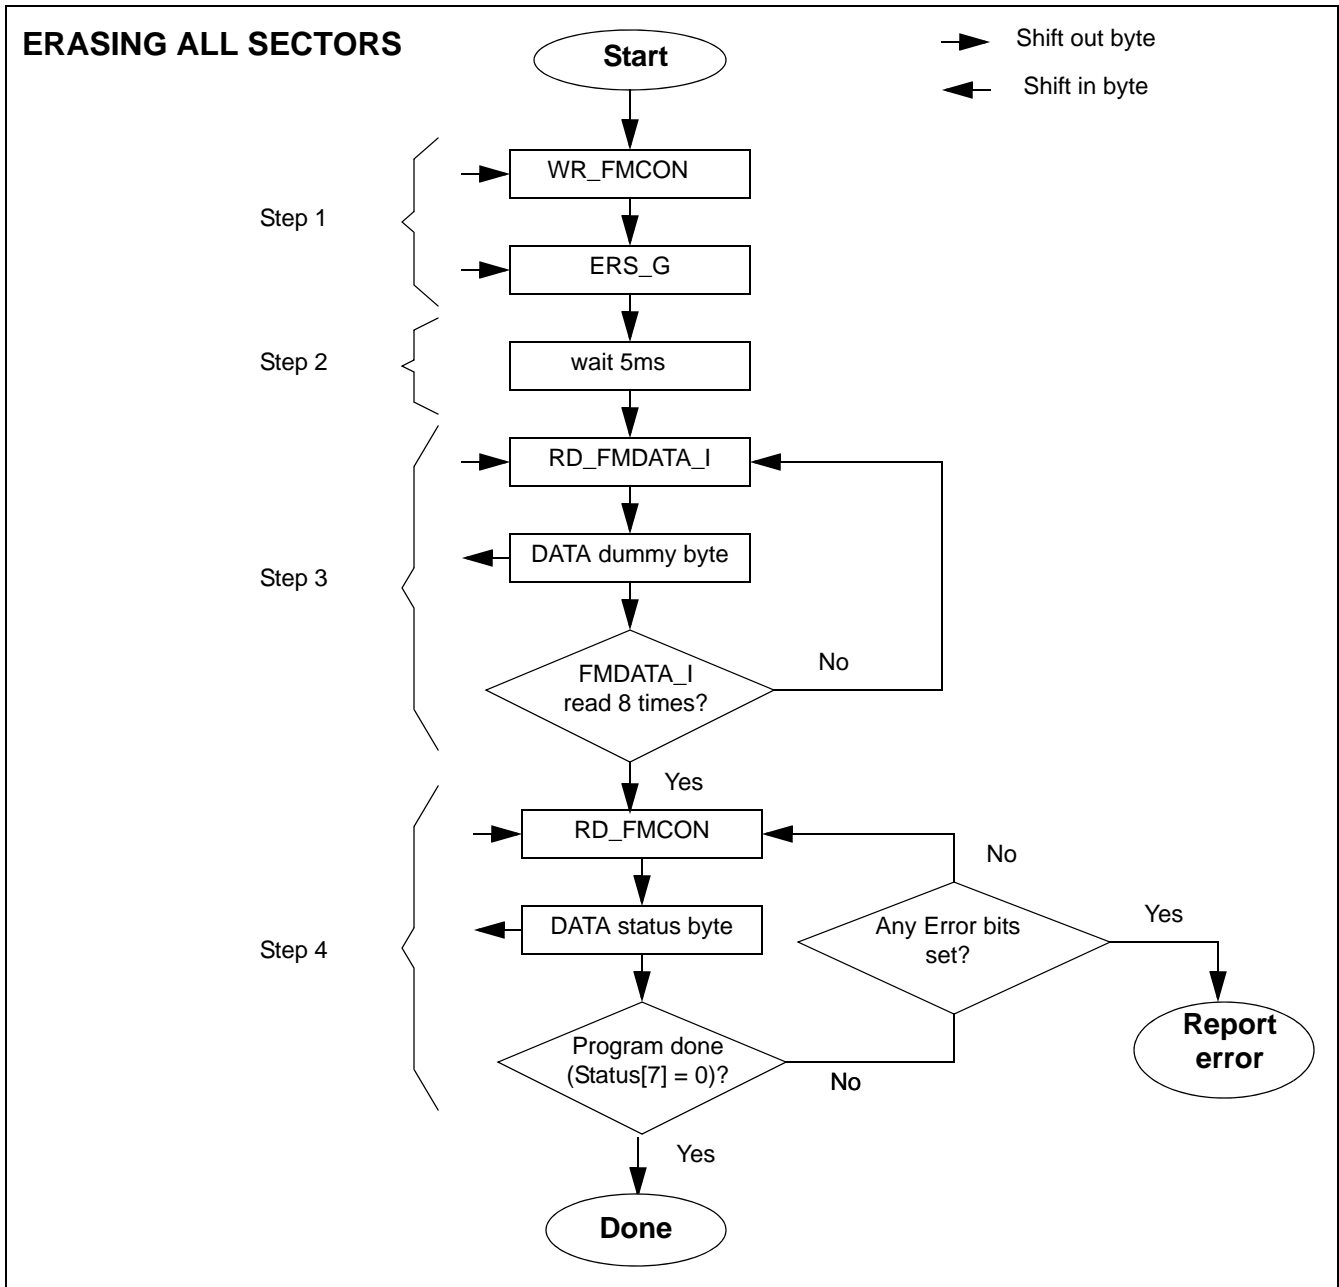
Figure 1: Flowchart ICP Global Erase

Problem: When giving the Erase Global command through the ICP interface the LPC908 will not clear the busy flag and stay busy forever.

Workaround: The workaround can be done in 4 steps:

Step 1: Shift out the WR_FMCON command followed by the Erase Global opcode.

Step 2: Wait 5ms.

Step 3: Do 8 dummy reads with the RD_FMDATA_I command.

Step 4: Read FMCON until the busy flag gets cleared.
