# ES\_P89LPC914

Errata sheet P89LPC914

Rev. 02 — 23 February 2010

Info	Content
<b>Keywords</b>	P89LPC914 errata
<b>Abstract</b>	<p>This errata sheet describes both the known functional problems and any deviations from the electrical specifications known at the release date of this document.</p> <p>Each deviation is assigned a number and its history is tracked in a table at the end of the document.</p>

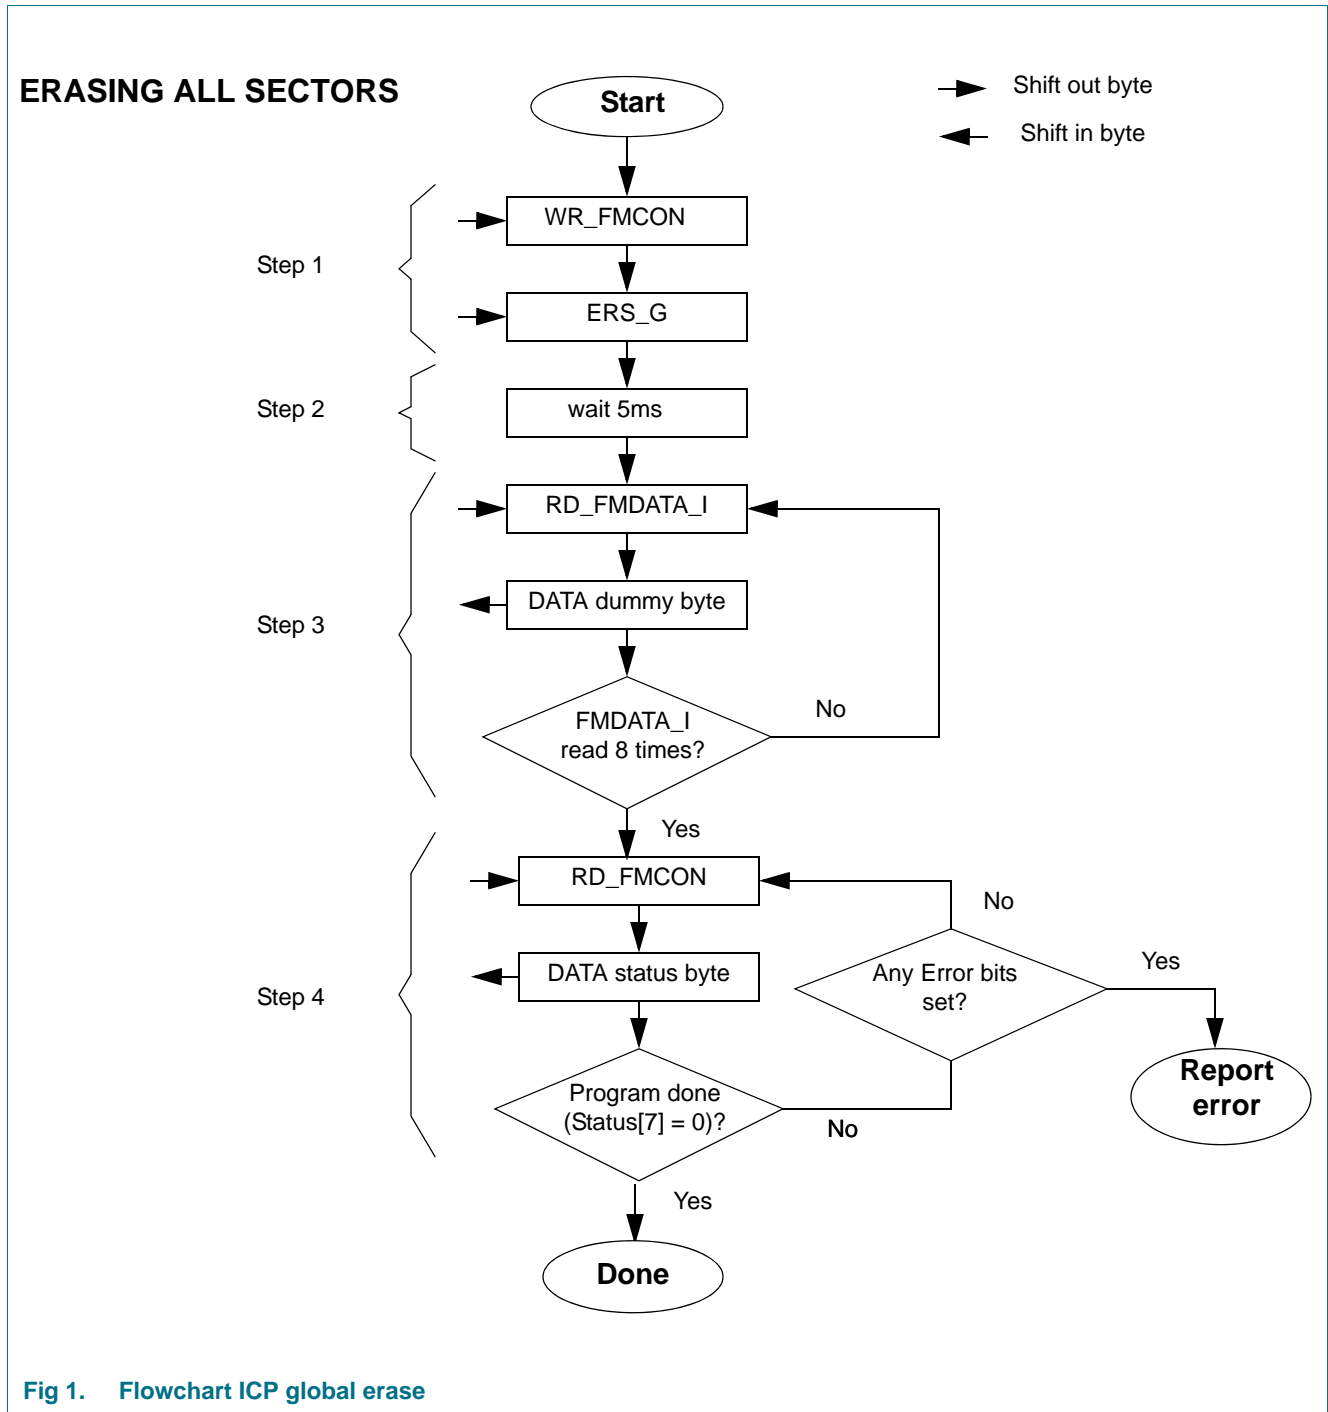
Fig 1. Flowchart ICP global erase

When giving the Erase Global command through the ICP interface the P89LPC914 will not clear the busy flag and stay busy forever.

The workaround can be done in 4 steps:

Step 1: Shift out the WR\_FMCON command followed by the Erase Global opcode.

Step 2: Wait 5ms.

Step 3: Do 8 dummy reads with the RD\_FMDATA\_I command.

Step 4: Read FMCON until the busy flag gets cleared.

Please also see [Figure 1](#).
