ERRATA SHEET

Date: 2008 Nov 07
Document Release: Version 1.2
Device Affected: P89LPC920

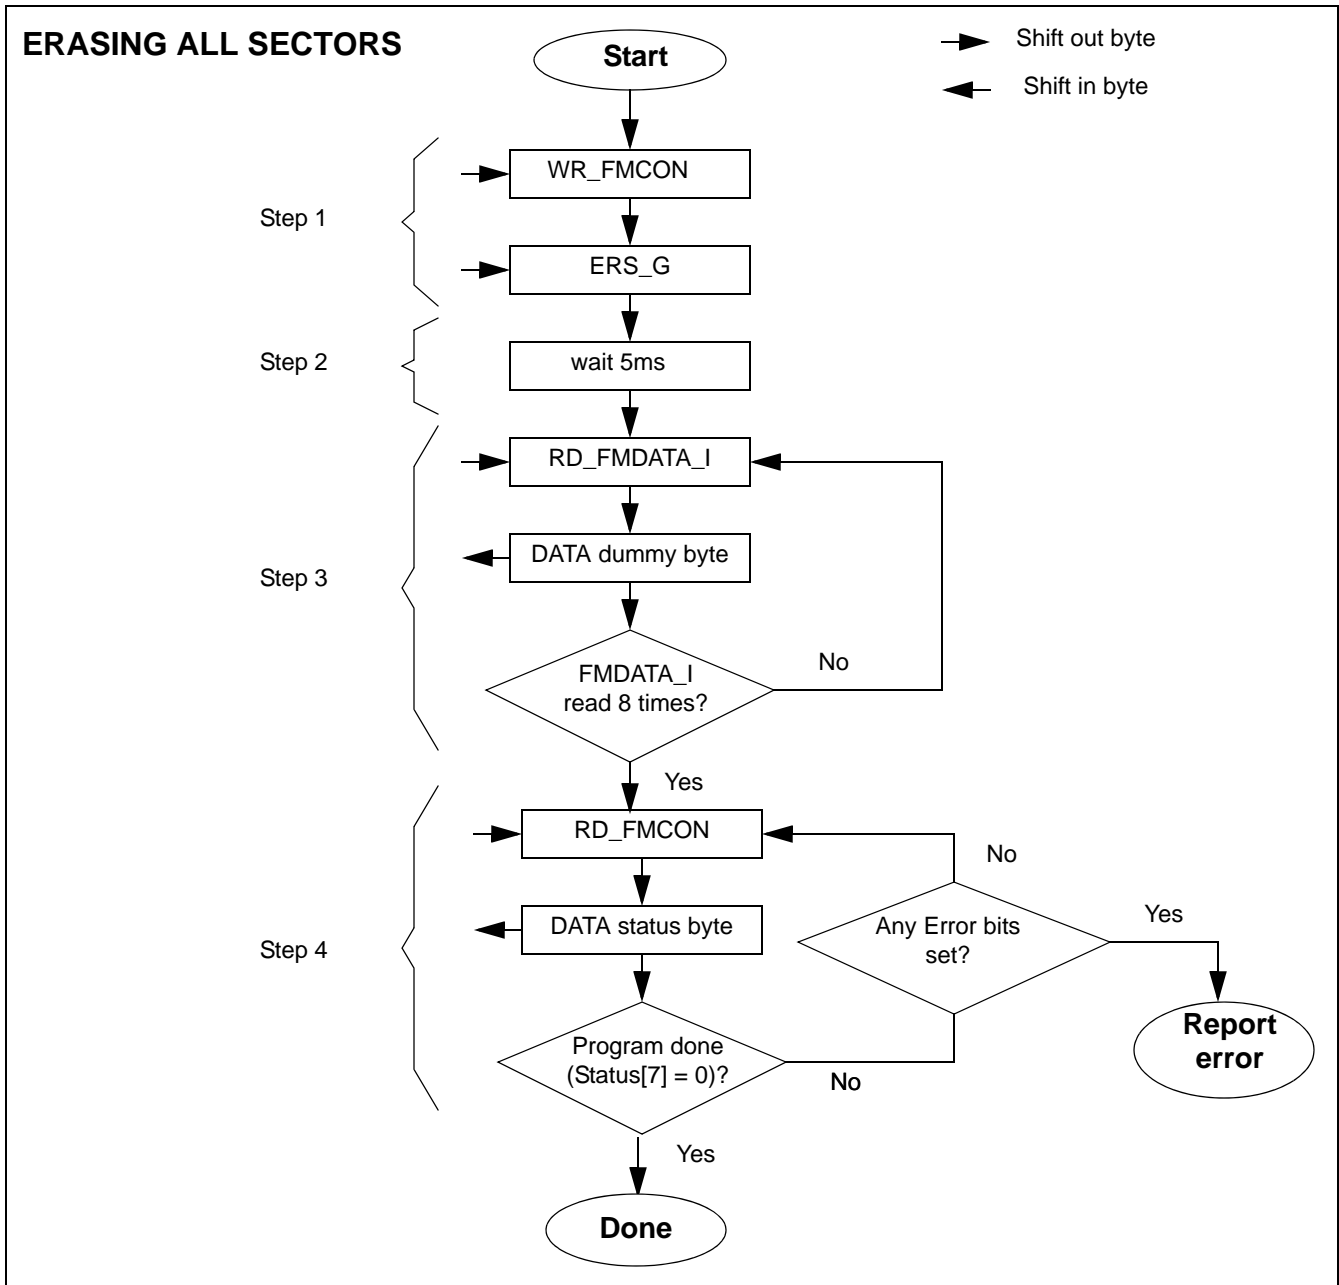
Figure 1: Flowchart ICP Global Erase

ICP.1: ICP Global Erase

Problem: When giving the Erase Global command through the ICP interface the LPC920 will not clear the busy flag and stay busy forever.

Workaround: The workaround can be done in 4 steps:

Step 1: Shift out the WR_FMCON command followed by the Erase Global opcode.

Step 2: Wait 5ms.

Step 3: Do 8 dummy reads with the RD_FMDATA_I command.

Step 4: Read FMCON until the busy flag gets cleared.

Please also see figure 1 on the following page.
