ERRATA SHEET

Date:	2008 Nov 07
Document Release:	Version 1.2
Device Affected:	P89LPC921

NXP Semiconductors

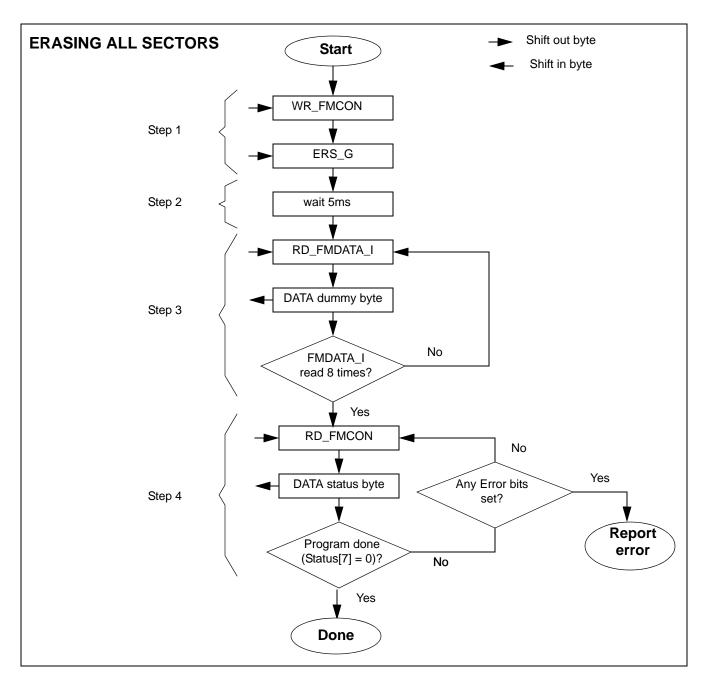
Figure 1: Flowchart ICP Global Erase

ICP.1: ICP Global Erase

- Introduction: The LPC921 can be programmed using ICP (In Circuit Programming). One of the ICP functions is the Erase Global command, which will erase the entire chip including the security bytes and configuration information.
- Problem: When giving the Erase Global command through the ICP interface the LPC921 will not clear the busy flag and stay busy forever.
- Workaround: The workaround can be done in 4 steps:

Step 1: Shift out the WR_FMCON command followed by the Erase Global opcode.

- Step 2: Wait 5ms.
- Step 3: Do 8 dummy reads with the RD_FMDATA_I command.
- Step 4: Read FMCON until the busy flag gets cleared.
