ES_P89LPC935

Errata sheet P89LPC935

Rev. 02 — 10 May 2010

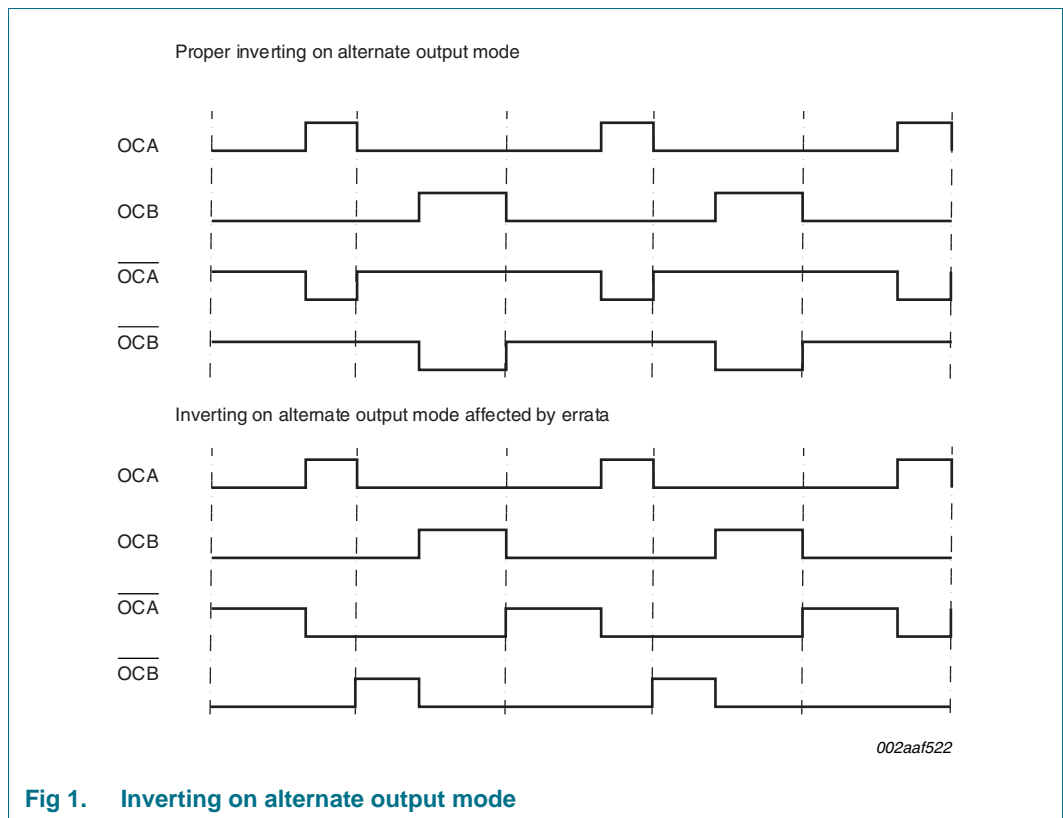
Problem:

In the inactive state of the alternate output mode the inverted PWM signal is always low.

No known work-around.

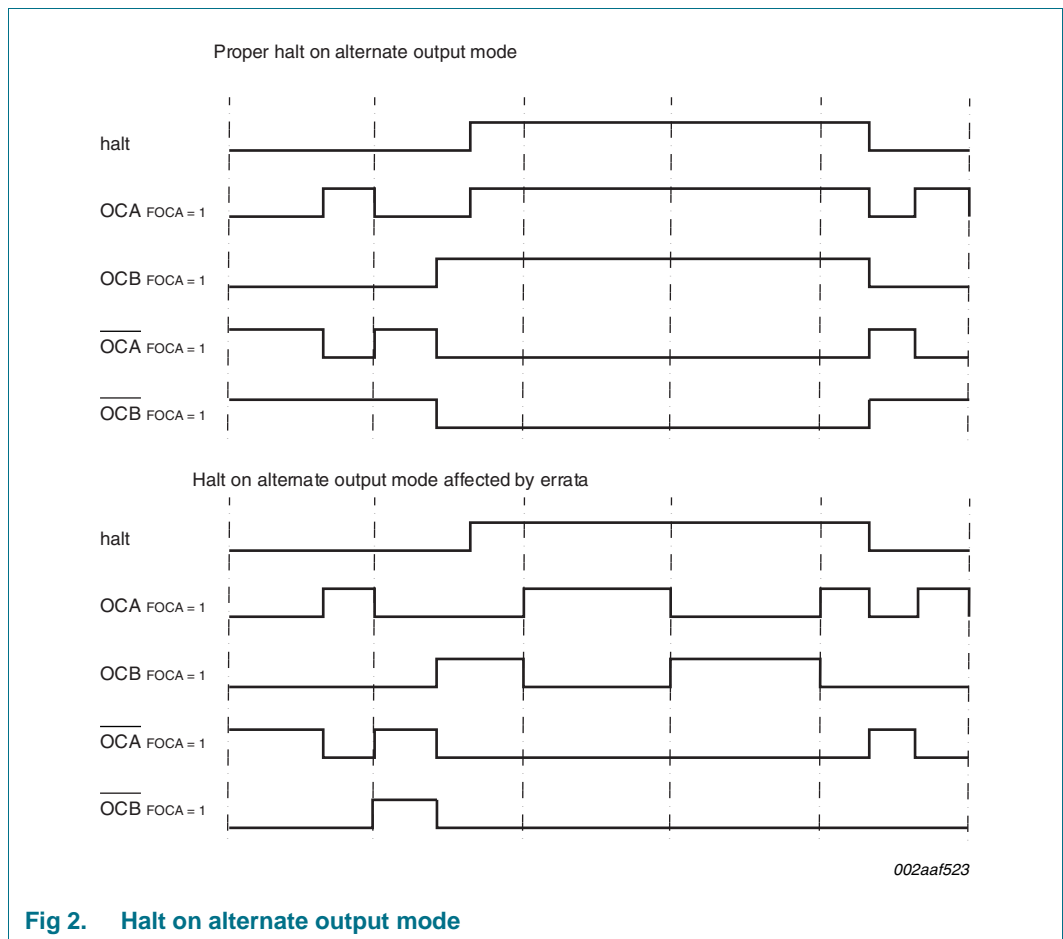
Fig 2. Halt on alternate output mode

Problem:

In the inactive state of the alternate output mode the inverted PWM signal is always low, even during a halt condition.

No known work-around.
