# ES\_PF8100\_PF8200\_2

Errata sheet for PF8100, PF8200

Rev. 2 — 11 August 2020

#### 3.1 ER101: Output overshoot/undershoot when enabling another regulator

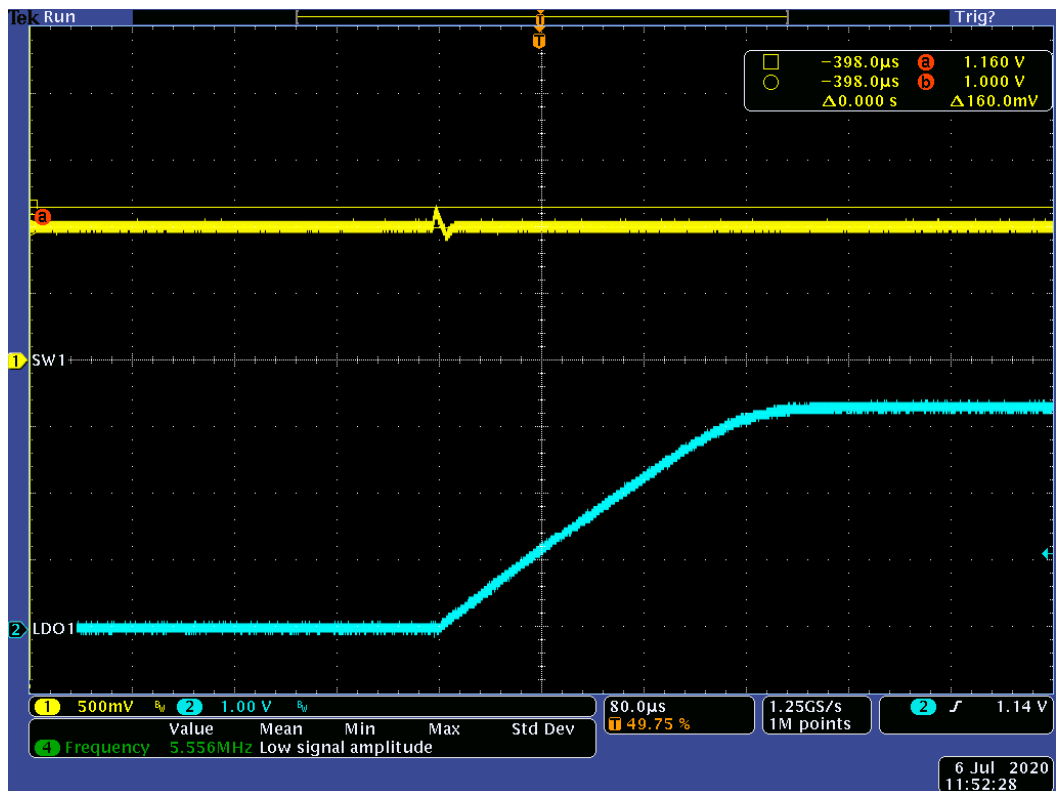
Overshoot observed on SW1, SW5 and SW7 when a specific regulator is enabled after the respective switching regulator.

When the affected regulator is using the default output capacitance ( $2 \times 44 \mu\text{F}$ ), the overshoot / undershoot can be as high as  $\pm 200 \text{ mV}$ . The overshoot / undershoot occurs only when the OV/UV monitor of the aggressor is enabled, therefore it can occur during the power-up sequence when the aggressor is turned On at a slot greater than the affected regulator, or during normal operation if the OV/UV monitor of the aggressor is enabled while the affected regulator is already On.

The PF8x00 uses a centralized bias generation block from which bias signals are routed to the respective blocks. Because of the high-density routing on PF8x00 device, some of the bias traces are too close to each other, causing induced noise to the nearby neighbors.

When the regulator is enabled, the OV/UV monitor is enabled as well, causing the inductive kick on the bias trace of the affected regulator, therefore creating the glitch at the output.

2. Ensure that the aggressor is turned On before or in the same slot as the affected regulator.
  - If all LDOs are not used, avoid using LDO3 if it cannot meet this condition.
  - If all LDOs are not used, avoid using LDO1 if it cannot meet this condition.
3. Do not toggle the aggressor Off and On during normal operation.

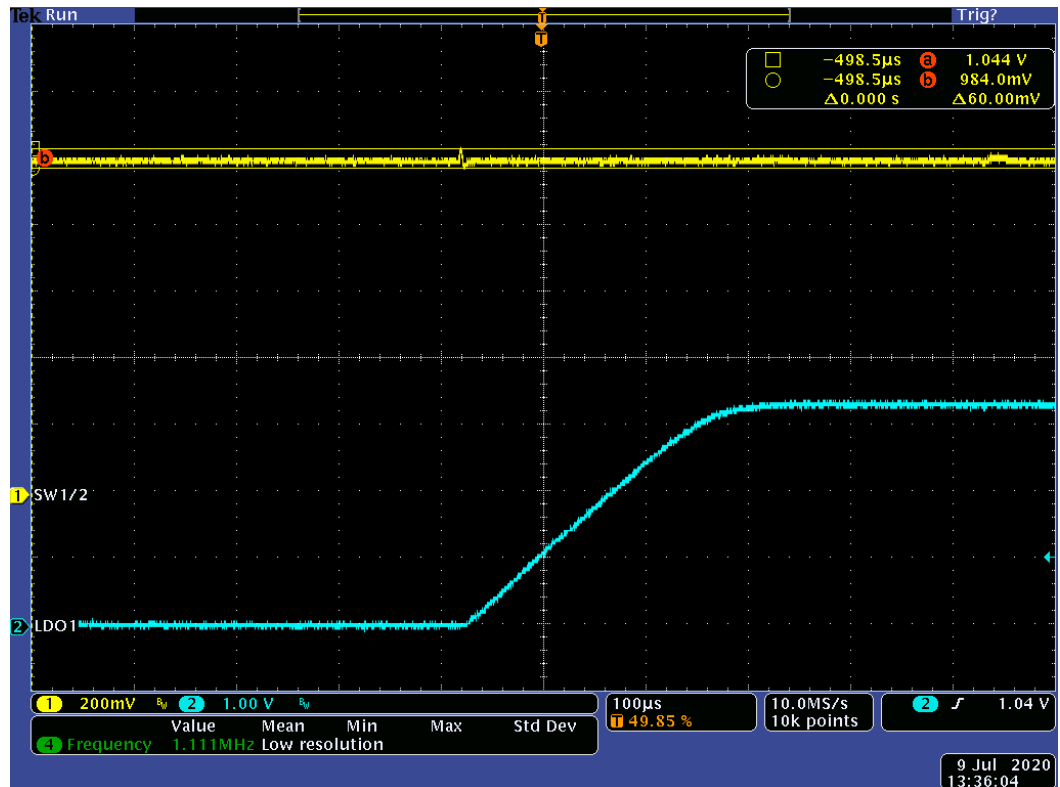
When the affected regulator is configured in dual phase, turning On the aggressor creates a glitch at the output of the affected phase, however, the second phase helps to mitigate the impact causing only around 52 mV (peak to peak) glitch on the regulator output when using the nominal capacitance 4 x 22  $\mu$ F.

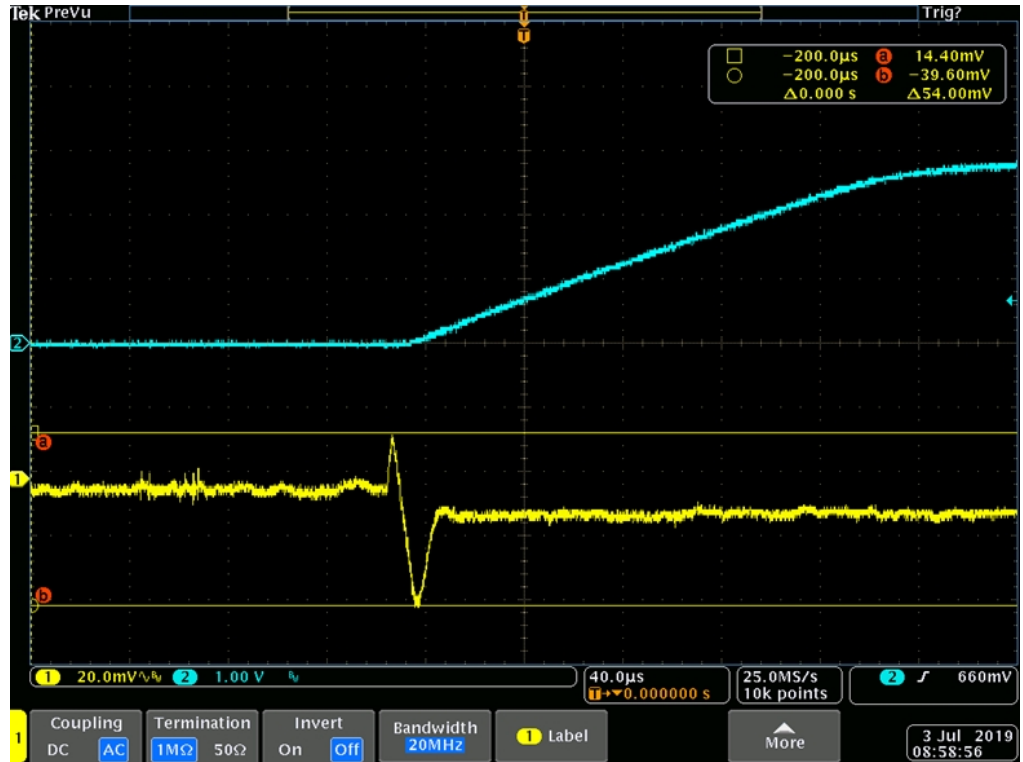
1. The overshoot / undershoot is reduced with a higher output capacitance. The systems using PF8x00 PMIC to power the i.MX8 MCUs are already loading the switching regulators from 150  $\mu$ F to 200  $\mu$ F. Based on the characterization test, the overshoot / undershoot, gets reduced to a total  $\sim$ 55 mV (peak to peak) with an output capacitance of 150  $\mu$ F.
