LS1088A RDB Errata

LS1088A RDB

Errata

Version 15

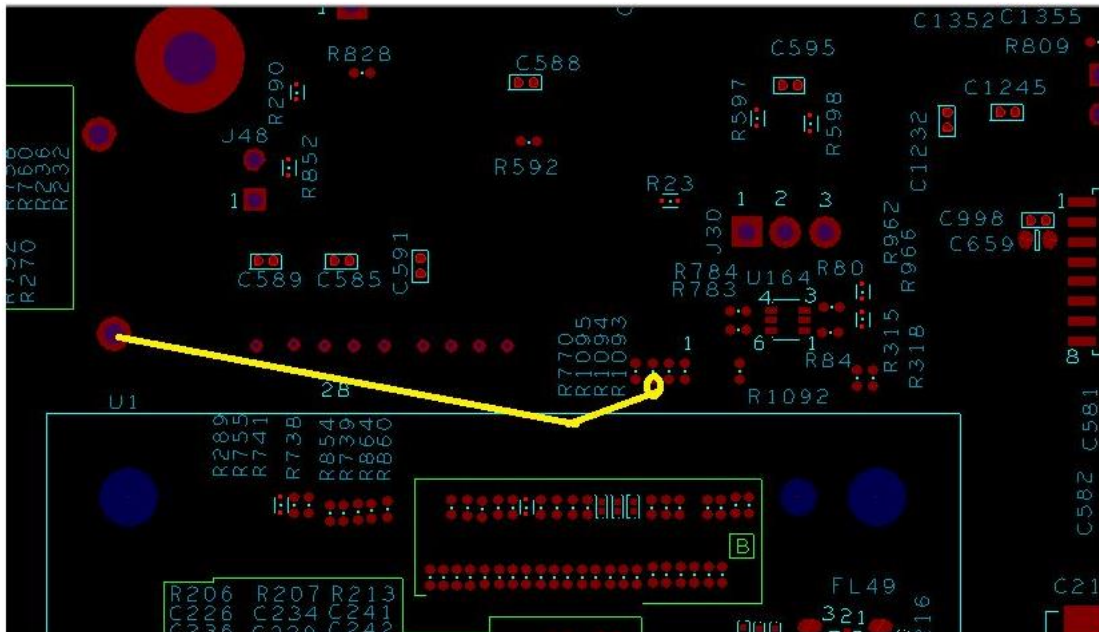
E-00001: DDR4 Selection for Interposer (LS1043A)

Description: LS1043A requires “cfg_dram_type=0” to select DDR4, the opposite that of the LS1088.

Impact: DDR will not work.

Workaround: Convert R1095 from a pullup to a pulldown.

1. Remove R1095, reinstall with pin 1 on the bottom pad and pin 2 free.
2. Connect R1095 pin 2 to ground at location shown.

Fix: All Rev A boards have had the above rework instructions applied. A permanent fix will be done on PCB Rev. B where the CPLD will drive the correct value based on the device type used (LS1043 or LS1088).

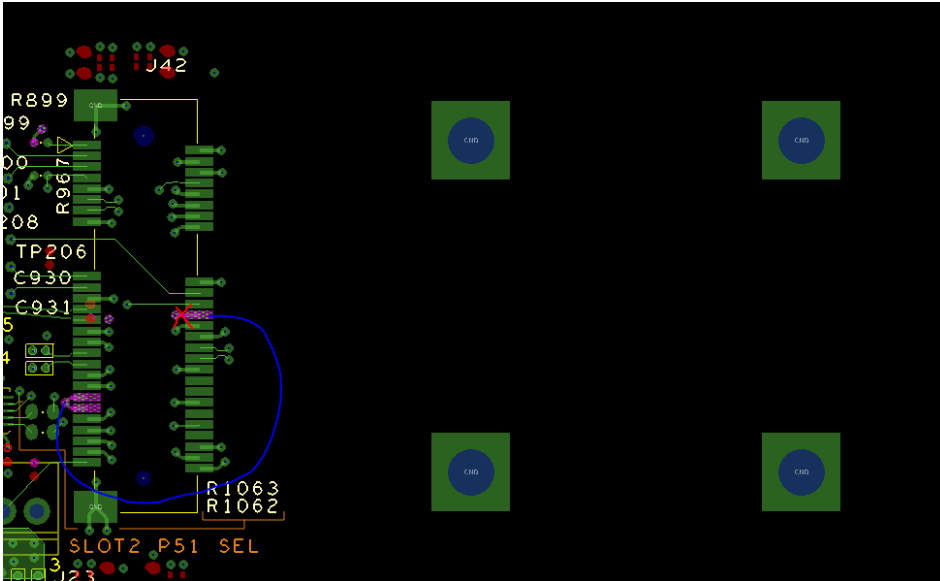
E-00002: WiFi Cards May Short Power Rails.

Description: Certain WiFi cards connect 3V3SB and 3V3.

Impact: Installing such cards causes the system to incorrectly power-on.

1. Cut trace between pad and via at J42 pin 24 (BEFORE ASSEMBLY) –or– Lift J42 pin 24 and isolate from pad with Kapton tape (AFTER ASSEMBLY).
2. Wire from J42 pin 24 to J42 pin 39/41 (shown in blue).

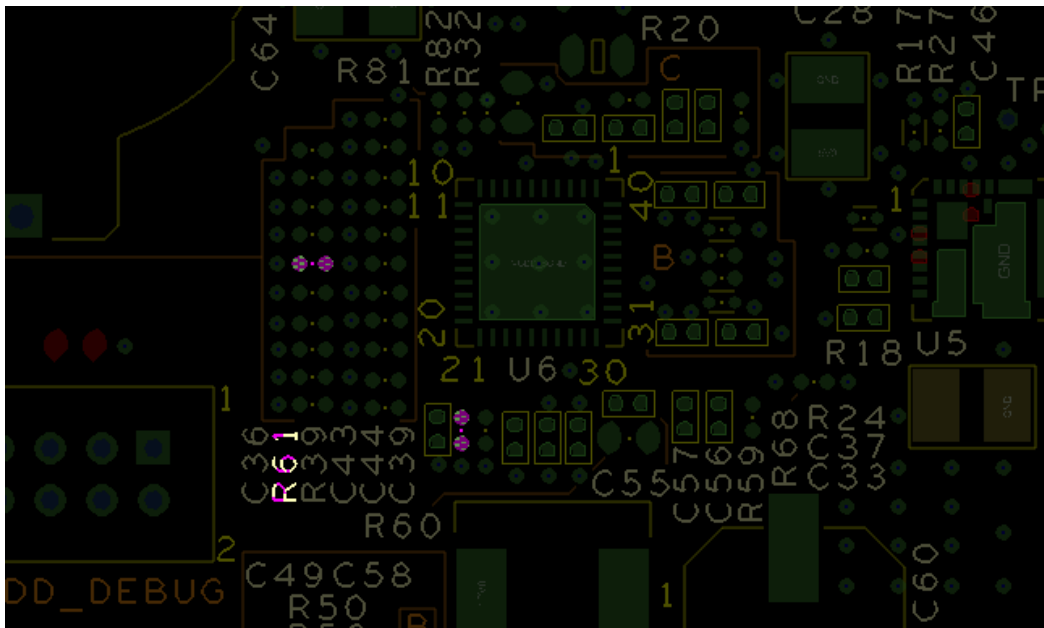
E-00003: LTC3882 at incorrect I2C address.

Description: The LTC3882 I2C (PMBus) address should be 0x63. It is currently at 0x66 and cannot be accessed due to the CPLD I2C address (0x66).

Impact: Processor cannot access LTC3882 for PMBus VDD setup, or monitoring.

Workaround: 1. Change R69 to 4.32K
2. Change R61 to 10K.

Fix: All Rev A boards have had the above rework instructions applied.
Will be fixed on schematic Rev A1 and PCB Rev. B.

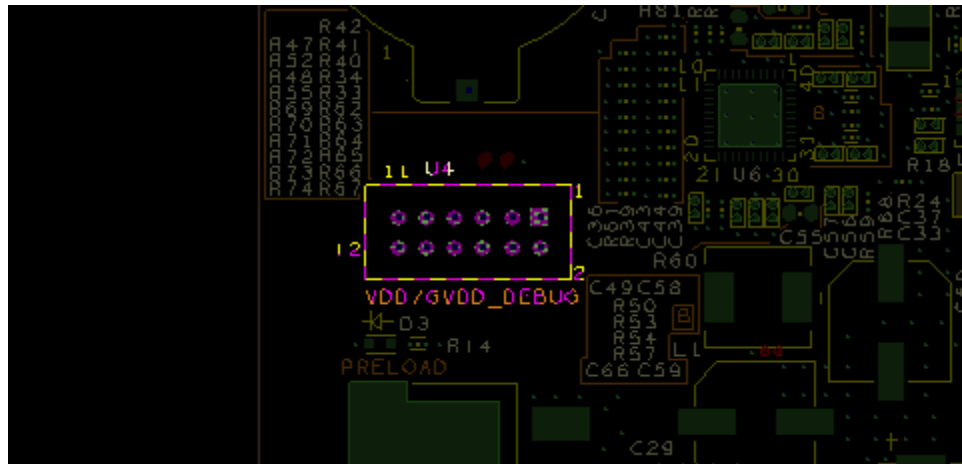
E-00005: LTC3882 Programming Header Missing

Description: U4 is required.

Impact: U4 is required for assembly and test.

Workaround: Install U4 (FCI #98414-G08-12ULF, Agile P/N 210-80051).

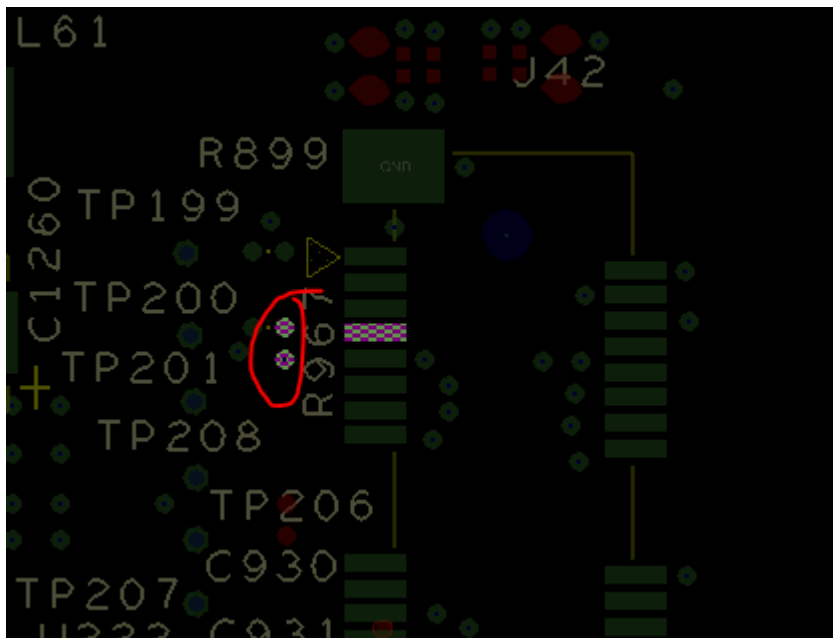
Description: Using some miniPCIe-to-PCIe adapters may not work as CLKREQ# is not asserted.

Impact: PCIe cards in an adapter are not usable.

1. Remove R967.

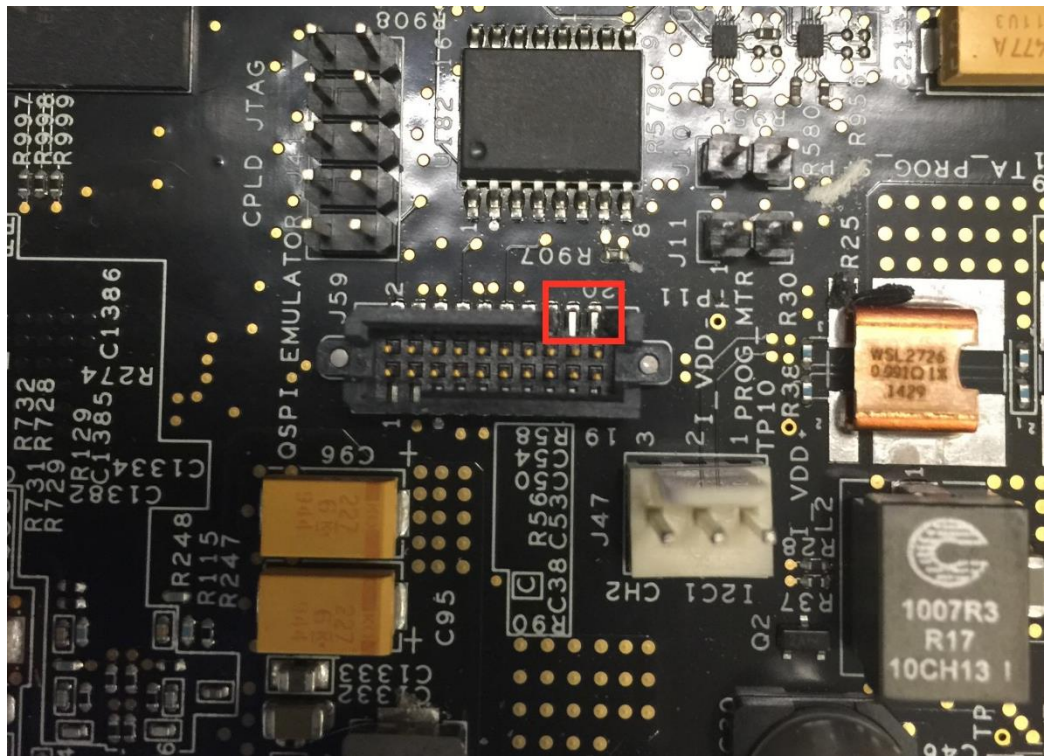
E-00007: QSPI Emulator Header is Incorrect

Description: The pinout of J59 does not match the DediProj QSPI emulator

Impact: Emulator is not usable.

Workaround: Pin 1 should be diagonally opposite the alignment key. There are two possible workarounds:

1. Remove J59 and reinstall rotated 180 degrees. If possible, rotate prior to board assembly.
2. Use cutters to remove part of the sidewall of J59. The width should be two pins worth:

Fix: Install the part such that the mechanical key is opposite pin 1.
Note: schematics and boards are all correct, this is an assembly issue.

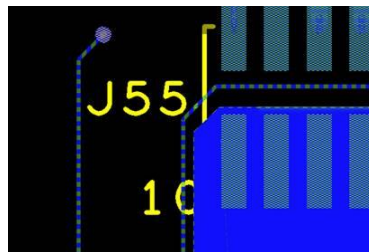
E-00010: JTAG Header Shorted

Description: A schematic net is misplaced, causing all even JTAG header pins to be shorted.

Impact: JTAG is unusable; processor will not exit reset.

3f. Connect J55 pin 10 (JTAG_RST_B) to nearby via (above letter J in J55):

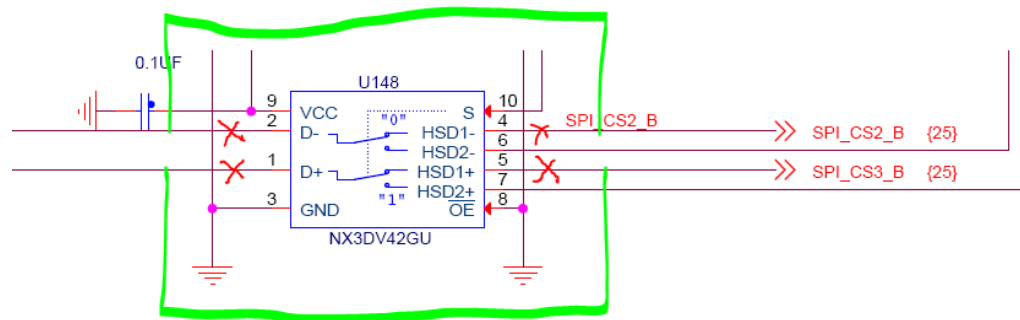
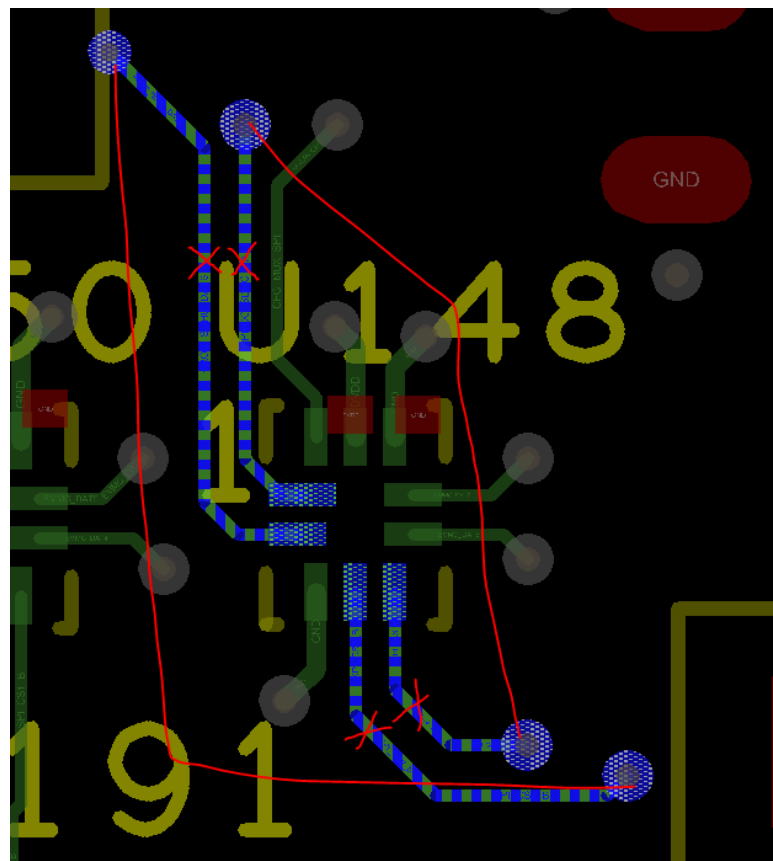
E-00013: TDM Slot Not Working

Description: The two SPI chip selects used for TDM (SPI_CS2_B and SPI_CS3_B) pass through a mux with sufficient series resistance to cause issues in the weak-drive voltage translation devices (NTB0104BQ). The CS signals oscillate, or remain in the previous drive level.

Impact: The TDM Riser card will not work.

The workaround requires wiring across the CS pins that were muxed in U148:

Fix: Since TDM only works on systems which must be opened (and the PCIe riser adapter removed), the optimal solution is to use two 1x3 “berg” headers for zero resistance.

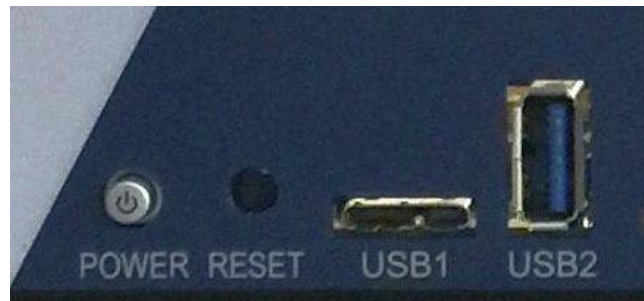
Incorrect:

Description: The front panel labels on the chassis describe the vertical USB Type A connector as USB1, and the horizontal USB 3.0 connector as USB2. These are reversed.

Impact: Connected devices will appear on a different USB controller than may be expected. Since linux automounts most devices this may not be easily noticeable except under test conditions.
