Silicon revision mask N58A, N13J, N65K, MC24XS4 and MC36XSD errata

Document Number: MC24XS4ER

Rev. 3.0

8/2016

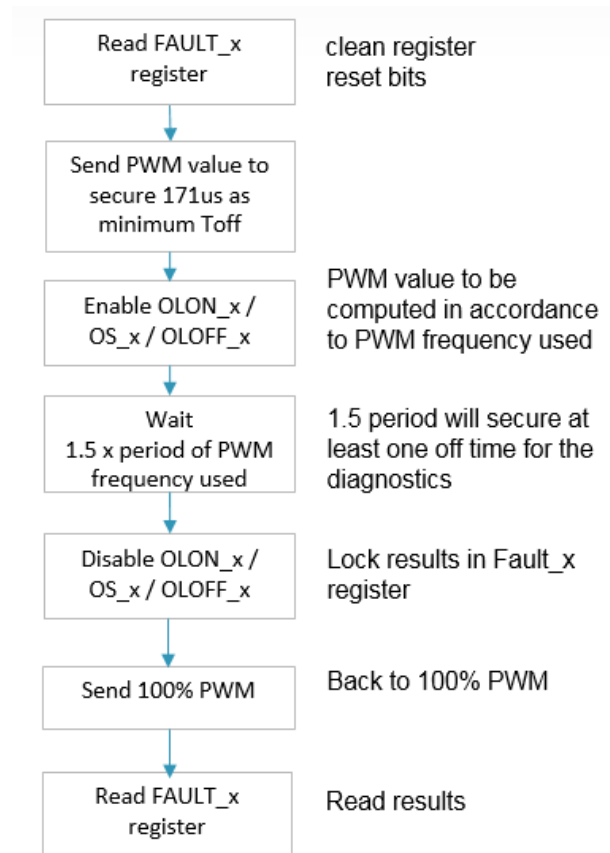
Figure 1. Proposed off time sequence

ER06 – Open load detection in low current mode 100% duty cycle

When running the device in 100% PWM mode, the open load detection can be corrupted in Low-current mode (CSNS_ratio_s=1).

The device returns a short to battery instead of open load.

A 171 μ s minimum OFF time is recommended to be sent by the ECU for robust open load detection. A proposed sequence is shown in [Figure 1](#).

Under evaluation.
