# MC33816 chip errata

This errata document applies to the [MC33816](#) SMARTMOS product family.

Document Number: MC33816ER

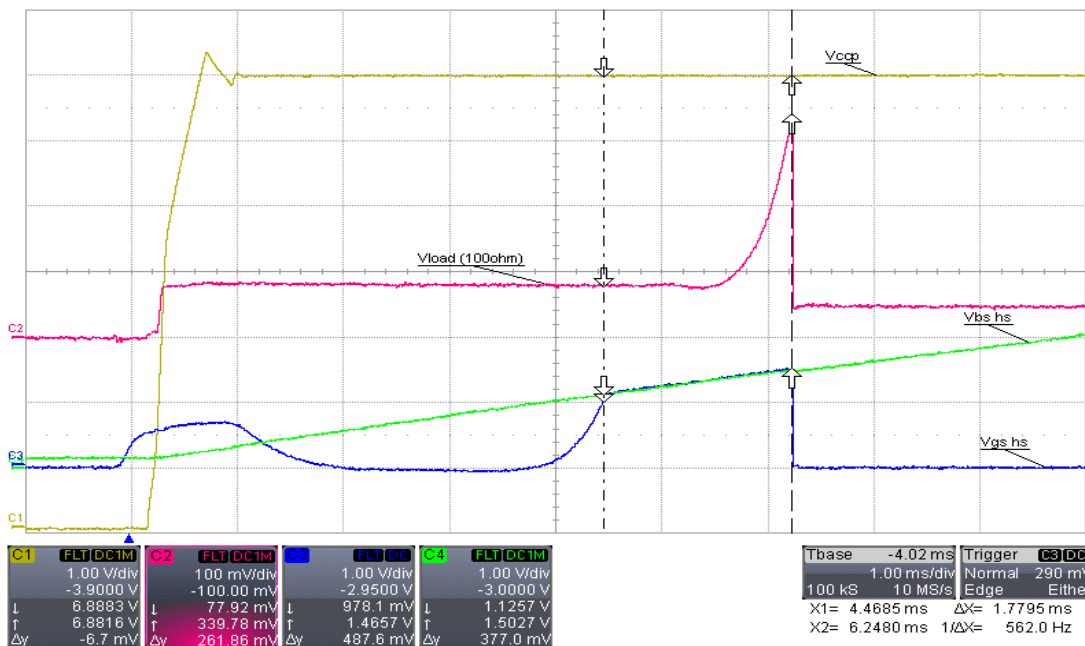
**Figure 1. Measurement of glitch on G\_HSx during V<sub>BS</sub> Ramp-up at 25 °C**

An analog design flaw in the HS pre-driver control circuitry causes several issues:

- The PMOS transistor in the HS pre-driver switches on briefly during device startup. This happens as the HS pre-driver's VBS supply voltage is ramping up to about 1.1 V to 1.5 V. The glitch does not occur at G\_HSx during ramp down of the VBS voltage.
- The HS pre-driver can not switch on as long as B\_HSx voltage is below 2.0 V with respect to PGND (refer to [Table 3](#)).
- The HS pre-driver G\_HSx switches on briefly when recovering from a -8.0 V glitch at S\_HSx.

[Figure 1](#) shows measurement results for the glitch at G\_HSx during VBS ramp up. The duration of the glitch in these measurements is about 1.8 ms. The maximum voltage at G\_HSx is about 1.5 V.

No workaround available, needs to be taken in account during ECU design

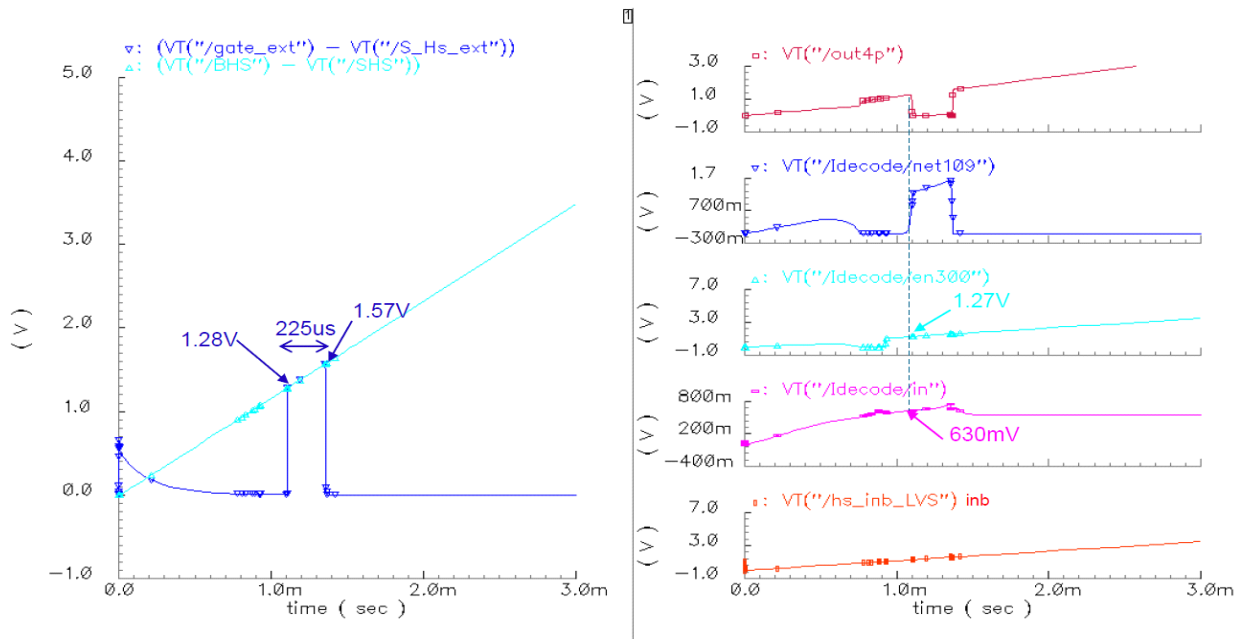
Figure 2. Simulation of glitch on G\_HSx during V<sub>BS</sub> ramp-up

[Figure 2](#) shows simulation results for the same issue with similar results.

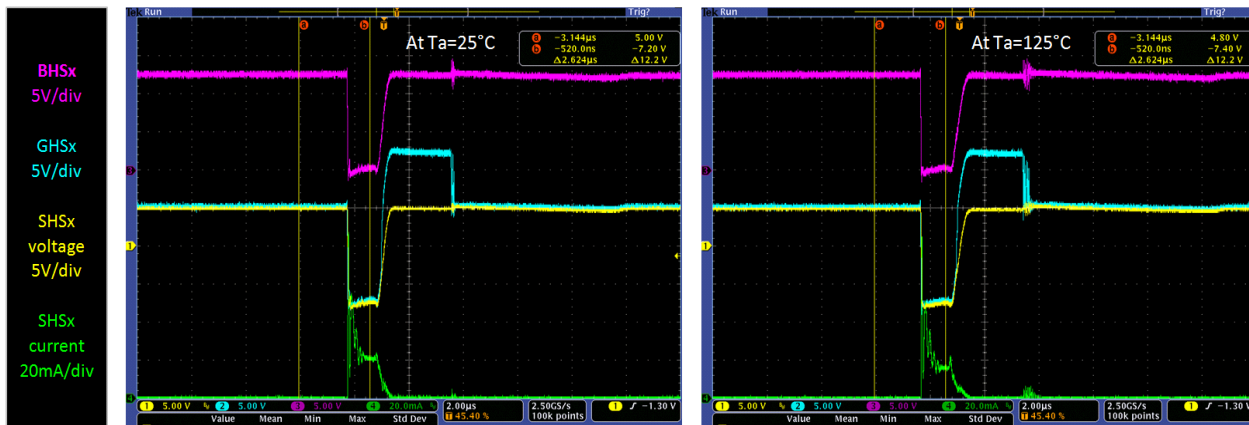
Figure 3. Measurement of glitch on G\_HSx when -8.0 V transient is removed

Figure 3 shows an active G\_HSx signal after recovery from a -8.0 V transient at S\_HSx. The G\_HSx is switched on for about 2.5 μs. Figure 4 shows that the glitch is no longer present when the negative transient is limited to -7.0 V.

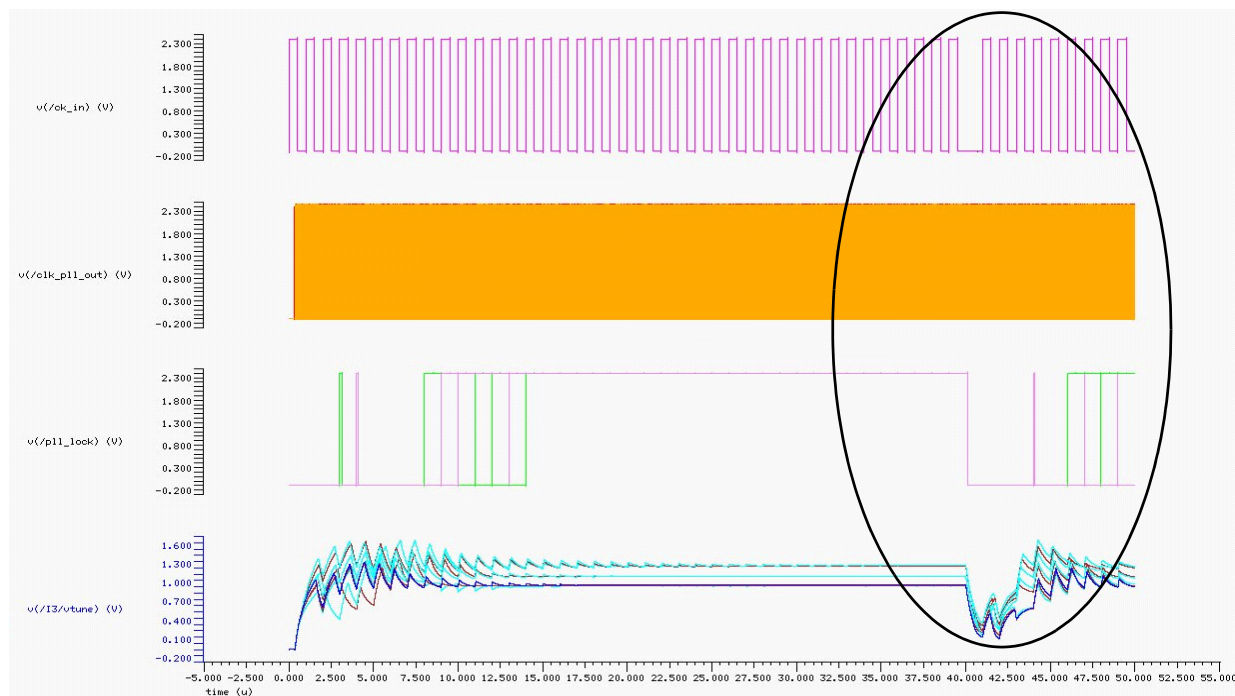
**Figure 5. Simulation CLK on edge missing**

Simulations of the MC33816 cksys frequency indicate that, under certain circumstances, cksys exceeds 24 MHz while it is still propagated to the digital core.

The specified maximum clock frequency for the digital core and memory is 25.725 MHz (nominal 24 MHz). Clock frequencies beyond 24 MHz may cause the digital core to malfunction.

All measurements indicate that the PLL reacts very quickly to a disturbance in the CLK clock reference. In the process it may occasionally generate a cksys output frequency beyond the 24 MHz limit. The clock monitor doesn't always switch the PLL input to the backup clock when the cksys frequency overshoot occurs. But in some cases it does, which can result in the generation of additional cksys frequencies beyond the 24 MHz limit.

[Figure 5](#) shows the effect of one missing clock edge.

To avoid a malfunction of the digital core and the power stage when ext. CLK fails, do the following:

- Configure ASIC to assert IrqB when a loss of clock is detected
- Set IrqB to be detected by  $\mu$ C
- Read ASIC status via SPI (e.g. backup\_clock\_status register)
- Trigger SW reset of ECU if a loss of clock is detected

Simulations have demonstrated that, with this configuration, the IrqB pin function and the SPI interface and registers are reliable up to a PLL output frequency of 83.3 MHz (41.65 MHz on cksys.)

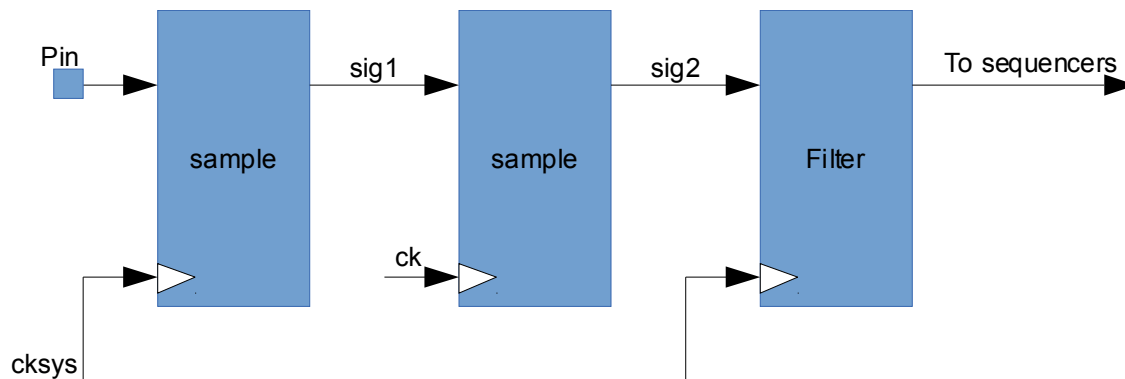
Figure 6. Anti-glitch filters current implementation

All the digital input pins (flag/start) have an anti-glitch filter whose time constant is 3 clock cycles (125 ns@24 MHz). The anti-glitch filters are preceded by a sampling stage using the ck clock, whose period can be longer than filter time constant. When this occurs, the filters are useless.

In the current implementation (Figure 6):

- Sig1 maximum bandwidth is the cksys frequency (24 MHz). Because this is a sampling stage, a glitch can bypass the first stage, as long as the pin value changes during the cksys clock edge.

- Sig2 maximum bandwidth is the ck frequency (12 MHz or lower). Because this is also a sampling stage, a glitch can bypass the second stage, as long as the pin value changes during ck clock edge. Because ck is slower than cksys, a glitch that bypasses the first stage could be caught in the second sampling stage. However, the glitch might also bypass both stages.

- The filter cutoff frequency is 8 MHz, while its input has a bandwidth of 12 MHz or lower. If the "ck frequency"/bandwidth is 6.0 MHz (very common in applications), the filter is useless (filtering an 6.0 MHz signal with an 8.0 MHz period). Under these circumstances, any filter that bypass the second sampling stage will also bypass the filters.

If ck frequency is lower than 8.0 MHz, no anti-glitch filter function is available on flag/start pins.

No workaround is possible: if ck frequency is lower than 8.0 MHz, no anti-glitch filter function is available on flag/start pins.

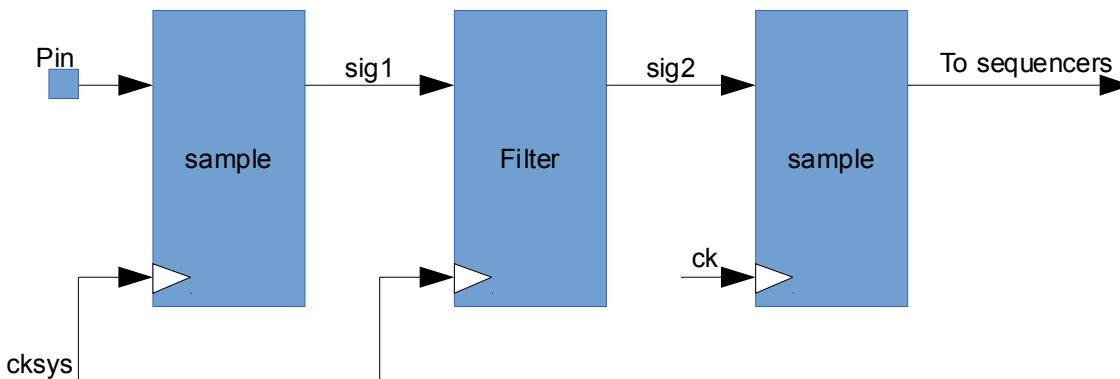
Figure 7. Anti-glitch filters correct implementation

In a correct implementation, the filter would have been placed before the ck sampling stage so that its input would always have a 24 MHz bandwidth.
