MC56F81xxx_0N91Z

Mask Set Errata

Mask Set Errata for Mask 0N91Z

This report applies to mask 0N91Z for these products:

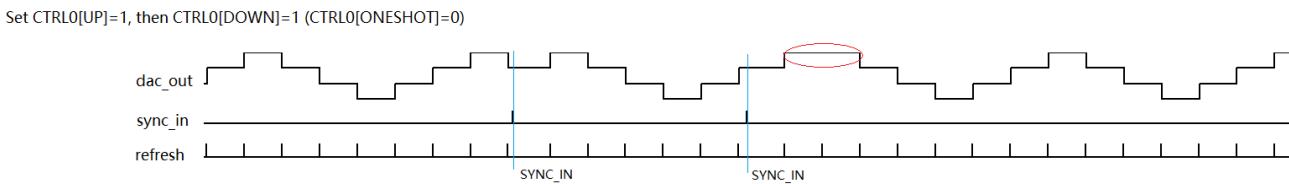
**Figure 1. "UP is set and then DOWN is set"**

ERR051706: The DAC output jumps to MAXVAL or MINVAL value and lasts two REFRESH clock cycles (instead of one) in the first waveform period after an active SYNC_IN signal occurs with CTRL0[ONESHOT]=0 and CTRL0[AUTO]=1 in triangle waveform mode

1. When CTRL0[UP] is set first, then CTRL0[DOWN] is set in the initialization: DAC output goes down first and then goes up. If an active SYNC_IN signal occurs when DAC output is ramping up, DAC output by design is set to the updated MAXVAL value and a new periodic triangle waveform is generated. In this situation, at the beginning of the first waveform period after SYNC_IN signal occurs, DAC output stays at updated MAXVAL for two REFRESH clock cycles instead of one. There's no such issue if an active SYNC_IN signal occurs when DAC output is ramping down in this case. See the illustration below.

No workaround.

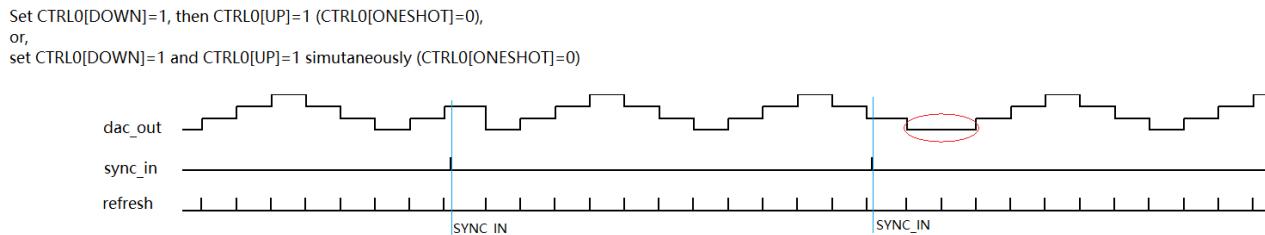
**Figure 2. "DOWN is set and then UP is set"**

2. When CTRL0[DOWN] is set first, then CTRL0[UP] is set (or DOWN and UP are set simultaneously) in the initialization: DAC output goes up first and then goes down. If an active SYNC_IN signal occurs when DAC output is ramping down, DAC output by design is set to the updated MINVAL value and a new periodic triangle waveform is generated. In this situation, at the beginning of the first waveform period after SYNC_IN signal occurs, DAC output stays at updated MINVAL for two REFRESH clock cycles instead of one. There's no such issue if an active SYNC_IN signal occurs when DAC output is ramping up in this case. See the illustration below.
