MC68302 Errata Revision C.1 (Masks 0F26E, 1F26E)

ERRATA

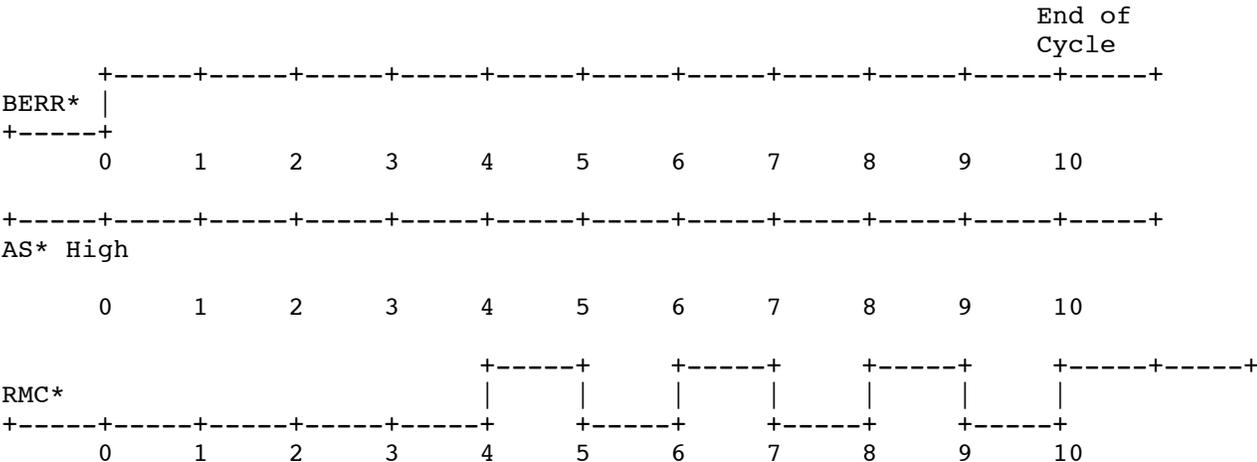
When BERR* is either internally or externally generated during a Read-Modify-Write Cycle, the end of the cycle is extended by 10 clocks from BERR* going high, and RMC* oscillates 3 times before being negated at the end of the cycle. The MC68302 waits for RMC* to go High and stay High before it starts handling the bus error. Before the end of the cycle, BERR*, AS*, and RMC* look like the following:

This problem is not going to be fixed. If a product has to wait on RMC* to go High and stay High, then the following circuit will work and will only cause a 1 clock delay after the 10 clocks of the extended TAS cycle. CLKO is the Clock output of the 68302.
