High Performance Computing Platform II (HPC II) V2 Evaluation Board Errata

Document Number: MCEVALHPC2ERR

Rev. 2.1

06/2008

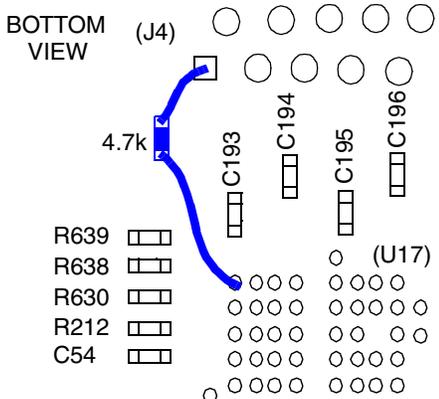
#	Problem/ Respin Resolution	Errata Correction/ Work Around
1	<p>MDIO net requires pull-up resistor. Ethernet PHYs may not function correctly without it.</p> <p>Connect 4.7 kΩ resistor from U17 pin M1 (corner via on bottom of board) to J4 pin 1.</p>	<p>Connect 4.7 kΩ resistor from U17 pin M1 (corner via on bottom of board) to J4 pin 1, as shown below:</p>

<p style="text-align: center;">BOTTOM VIEW</p> <p>Note that on some early boards, a 4.7 kΩ resistor is connected from U11 pin M1 to J22 pin 1. This is also acceptable because the MDIO signal is shared by the PHYs and may be pulled up at either location.</p>
2	<p>U47 VCC not connected to VCC_HOT_5, preventing power switch operation.</p> <p>Correct typo in component property in schematic to “VCC_3.3=VCC_HOT_5.”</p>	<p>Connect U47 pin 5 to U66 pin 5.</p>
3	<p>R10 populated on initial build.</p> <p>None; assembly error.</p>	<p>Remove R10 (top right quadrant of board, between DIMM socket 2 and L2).</p>

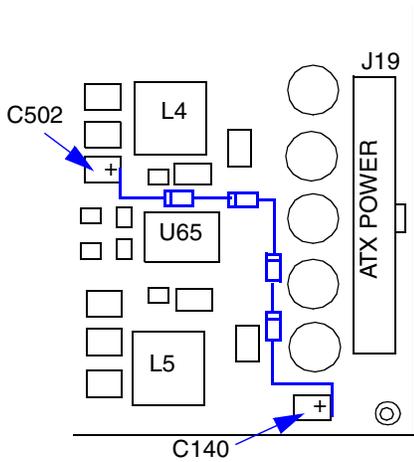
9	<p>U65 PWM #1, which supplies VCC_2.5, not switching when preliminary work around for Erratum 6 (three-diode stack) is implemented. If the diode drops are lower than expected, the VCC_2.5 supply can be above 2.5 V, in which case the switcher does not supply or regulate the voltage. As a result, the VCC_2.5 supply may be powered entirely by VCC_3.3 supply via the diode stack.</p> <p>None. (See Erratum 6.)</p>	<p>As a work around to address Erratum 6, three 1N5817 diodes in series were added between VCC_3.3 (at C140) and VCC_2.5 (at C502). Three diodes has been found to be insufficient, and four are now recommended:</p>

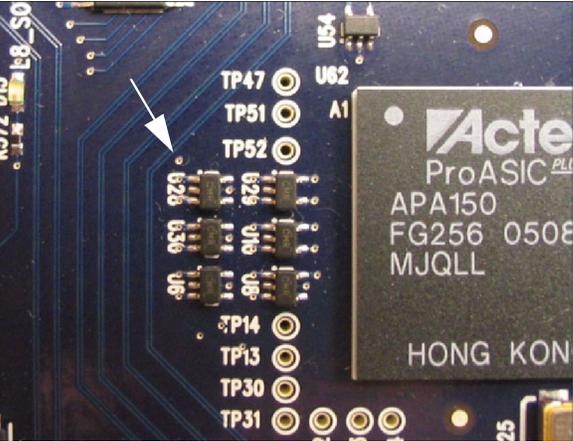
#	Problem/ Respin Resolution	Errata Correction/ Work Around
11	<p>Glitching on PCIRST* signal by FPGA at POR causes erratic SATA behavior.</p> <p>Under review.</p>	<p>Disconnect PCIRST* signal from FPGA by drilling out via near U28, as shown in the figure below. Caution: this via is surrounded by traces on internal layers, in addition to the SATA channel signals on the top layers. Great care must be taken to not damage these traces. A #78 drill bit is recommended.</p>
