MCF5235 Chip Errata

Silicon Revision: All

This document identifies implementation differences between the MCF523x processors and the description contained in the *MCF5235 ColdFire® Reference Manual*. Refer to <http://www.freescale.com/coldfire> for the latest updates.

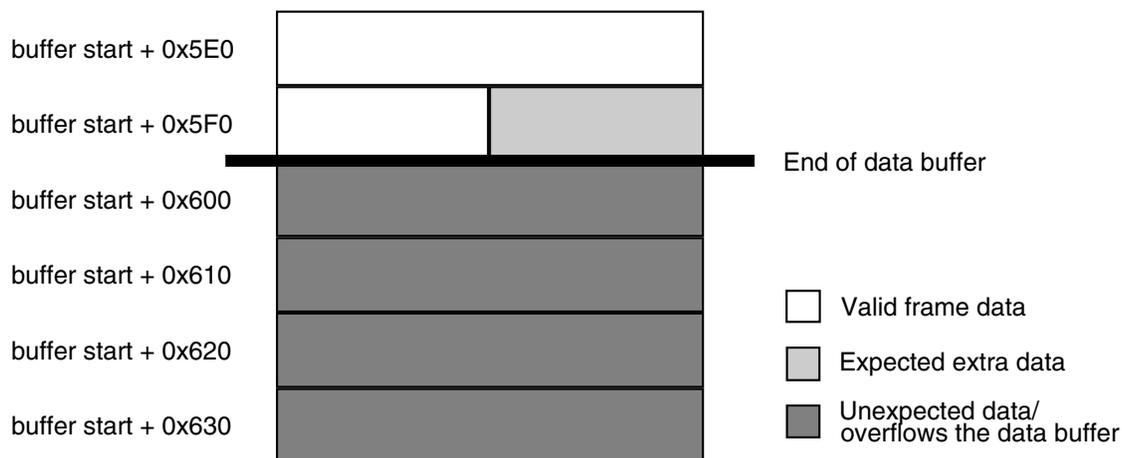
Figure 1. Buffer Overrun Example

Description: When the FEC is connected to a 10BaseT network, if length of the data stored in a descriptor is not evenly divisible by 16 (not line-aligned), the FEC writes extra lines at the end of the buffer. The entire line that contains the last valid data is written and at least one extra line, but up to four lines after the end of the valid data can also be written. In most cases, this is not a problem because the extra lines of data continue falling within the limits of the buffer. However, if the valid data ends near the end of the buffer, the extra lines written by the FEC might be outside of the data buffer. This leads to corruption of the next buffer, descriptor, data, or code stored in the adjacent memory.

For example, as shown in the figure below, if the max buffer size is programmed to 0x600 and a frame that is 0x5F8 bytes long is received, a line is written starting at buffer start + 0x5F0. The first half of the line at buffer start + 0x5F0 is valid frame data that should be processed by the FEC driver; the second half of the line is additional data that is written because the FEC only writes complete lines. This data should be ignored by the FEC driver. So far, this is correct FEC behavior as originally specified. However, the FEC repeats the last line of valid data a number of times. The line at buffer start + 0x600 is written, and as many as three additional lines beyond the end of the data buffer could be written.

Workaround: Only use 100BaseT.

Workaround: Allocate extra lines for the receive data buffers. The actual allocated memory for each buffer should be equal to the receive buffer size programmed in the FEC's EMRBR register plus four lines (16 byte-sized lines).

Workaround: Program the data buffer size one line larger than the max packet size (data buffer size = EMRBR + 0x40).
