MCF5271 Chip Errata

Silicon Revision: All

This document identifies implementation differences between the MCF5270 and MCF5271 processors and the description contained in the *MCF5271 ColdFire® Reference Manual*. Refer to <http://www.freescale.com/coldfire> for the latest updates.

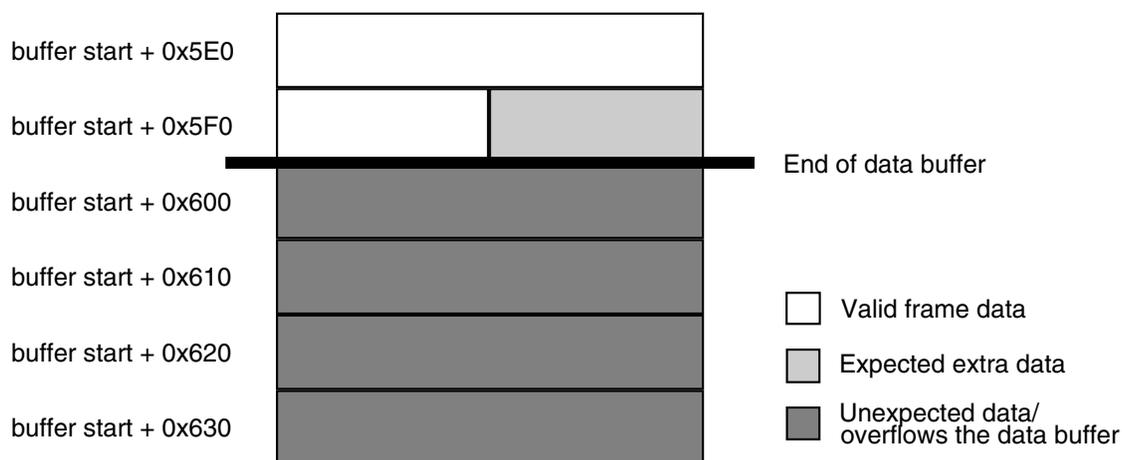
Figure 1. Buffer Overrun Example

SECF009: FEC Receive Buffer Overrun in 10BaseT Mode

Description: When the FEC is connected to a 10BaseT network, if length of the data stored in a descriptor is not evenly divisible by 16 (not line-aligned), the FEC writes extra lines at the end of the buffer. The entire line that contains the last valid data is written and at least one extra line, but up to four lines after the end of the valid data can also be written. In most cases, this is not a problem because the extra lines of data continue falling within the limits of the buffer. However, if the valid data ends near the end of the buffer, the extra lines written by the FEC might be outside of the data buffer. This leads to corruption of the next buffer, descriptor, data, or code stored in the adjacent memory.

For example, as shown in the figure below, if the max buffer size is programmed to 0x600 and a frame that is 0x5F8 bytes long is received, a line is written starting at buffer start + 0x5F0. The first half of the line at buffer start + 0x5F0 is valid frame data that should be processed by the FEC driver; the second half of the line is additional data that is written because the FEC only writes complete lines. This data should be ignored by the FEC driver. So far, this is correct FEC behavior as originally specified. However, the FEC repeats the last line of valid data a number of times. The line at buffer start + 0x600 is written, and as many as three additional lines beyond the end of the data buffer could be written.

Workaround: Only use 100BaseT.

Workaround: Allocate extra lines for the receive data buffers. The actual allocated memory for each buffer should be equal to the receive buffer size programmed in the FEC's EMRBR register plus four lines (16 byte-sized lines).

Workaround: Program the data buffer size one line larger than the max packet size (data buffer size = EMRBR + 0x40).
