## MCF5282 Chip Errata

### Silicon Revision: All

This document identifies implementation differences between the MCF5281/82 processors and the description contained in the *MCF5282 ColdFire® Reference Manual*. Refer to <http://www.freescale.com/coldfire> for the latest updates.

Document Number: MCF5282DE  
Rev. 8, 02/2015

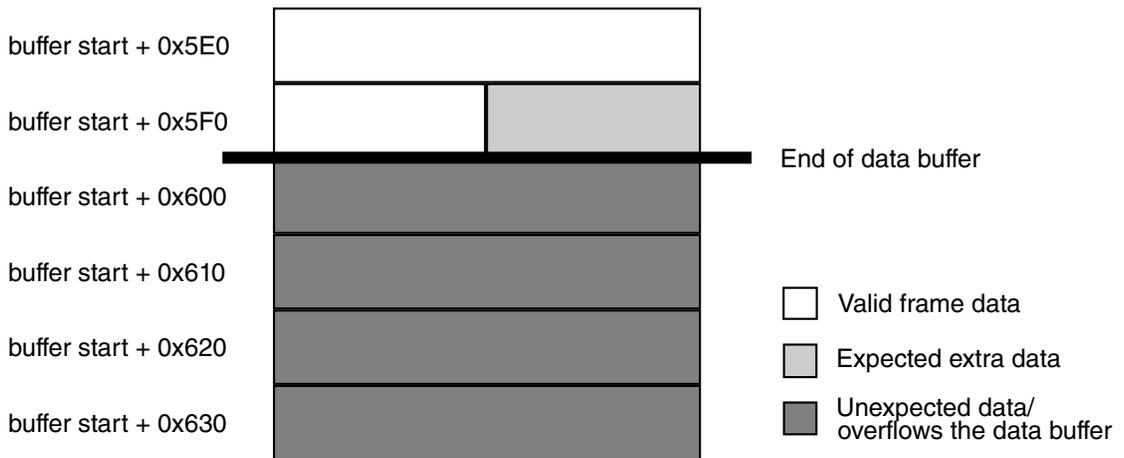
**Figure 1. Buffer Overrun Example**

**Description:** When the FEC is connected to a 10BaseT network, if length of the data stored in a descriptor is not evenly divisible by 16 (not line-aligned), the FEC writes extra lines at the end of the buffer. The entire line that contains the last valid data is written and at least one extra line, but

up to four lines after the end of the valid data can also be written. In most cases, this is not a problem because the extra lines of data continue falling within the limits of the buffer. However, if the valid data ends near the end of the buffer, the extra lines written by the FEC might be outside of the data buffer. This leads to corruption of the next buffer, descriptor, data, or code stored in the adjacent memory.

For example, as shown in the figure below, if the max buffer size is programmed to 0x600 and a frame that is 0x5F8 bytes long is received, a line is written starting at buffer start + 0x5F0. The first half of the line at buffer start + 0x5F0 is valid frame data that should be processed by the FEC driver; the second half of the line is additional data that is written because the FEC only writes complete lines. This data should be ignored by the FEC driver. So far, this is correct FEC behavior as originally specified. However, the FEC repeats the last line of valid data a number of times. The line at buffer start + 0x600 is written, and as many as three additional lines beyond the end of the data buffer could be written.

**Workaround:** Only use 100BaseT.

**Workaround:** Allocate extra lines for the receive data buffers. The actual allocated memory for each buffer should be equal to the receive buffer size programmed in the FEC's EMRBR register plus four lines (16 byte-sized lines).

**Workaround:** Program the data buffer size one line larger than the max packet size (data buffer size = EMRBR + 0x40).
