MCF5329 Chip Errata

Silicon Revision: All

This document identifies implementation differences between the MCF532x processors and the description contained in the *MCF5329ColdFire® Reference Manual*. Refer to <http://www.freescale.com/coldfire> for the latest updates.

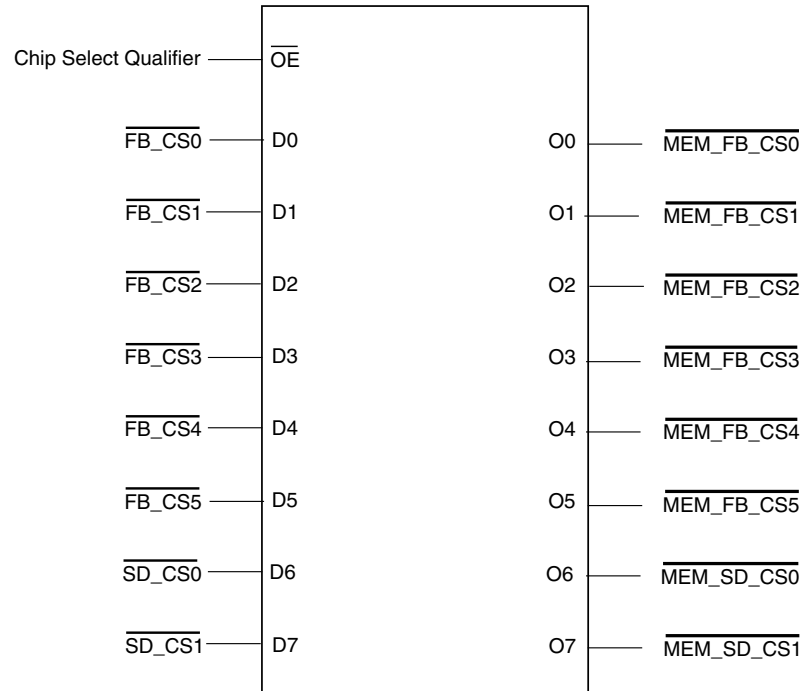
Figure 5. Qualifying multiple chip selects using a buffer

Description: Some power ramp and clock startup sequences can cause FlexBus, SDRAMC, and BDM pins to drive undefined values for a period of time during the reset sequence.

Initially the pins are tri-stated while IVDD and EVDD/SDVDD are not fully powered. As the voltage rails ramp to the operating levels, the processor releases the pins from tri-state and the pin states are determined by digital control logic. However, the digital logic needs several clock cycles to initialize, so between tri-state release and clock startup the pins can be driven by uninitialized logic.

Depending on how the processor signals are used in the rest of the system, an undefined pin state could cause unexpected behavior for an external memory device. Since the undefined pin states are temporary (pins will enter a defined state well before the processor exits reset) in many cases the undefined pin states won't cause a functional issue for the system.

The second step of the workaround is to use the qualifier signal generated to qualify or mask chip select signals to external devices as needed.

In the diagram above “MEM_” is used to differentiate the chip select signals from the processor and the qualified versions that would be connected to external memories. Each of the “MEM_” signals should include a pullup resistor to force the signal high while the buffer is disabled.

Fix plan: This issue has been fixed starting with the 6M29B mask set. The fix that has been implemented ensures that $\overline{SD_CS}[1:0]$ and $\overline{FB_CS}[2:0]$ will either drive high or float during reset. These pins will never driver low during the reset sequence. The operation of $\overline{FB_CS}[5:3]$ is unchanged. The state of $\overline{FB_CS}[5:3]$ can still be undefined during the reset sequence.
