MCF5373 Chip Errata

Silicon Revision: All

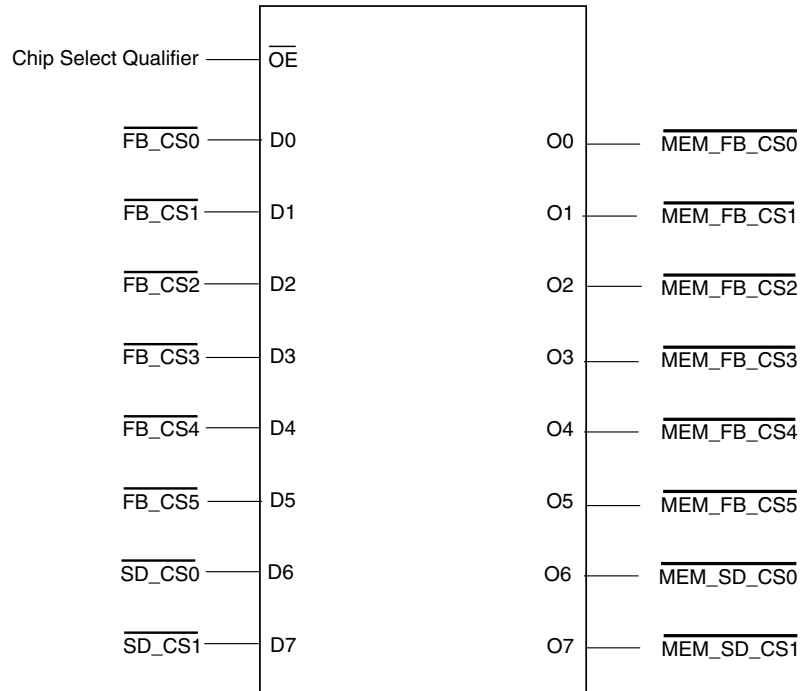
Figure 5. Qualifying multiple chip selects using a buffer

In the diagram above “MEM_” is used to differentiate the chip select signals from the processor and the qualified versions that would be connected to external memories. Each of the “MEM_” signals should include a pullup resistor to force the signal high while the buffer is disabled.

The second step of the workaround is to use the qualifier signal generated to qualify or mask chip select signals to external devices as needed.
