MCF5407DE/D
Rev. 2.2, 1/2004

MCF5407 Device Errata

This document identifies implementation differences between the MCF5407 processor and the description contained in the *MCF5407 User's Manual*. Refer to <http://www.motorola.com/ColdFire> for the latest updates. The errata items listed in this document (summarized in Table 1) describe differences from the following documents:

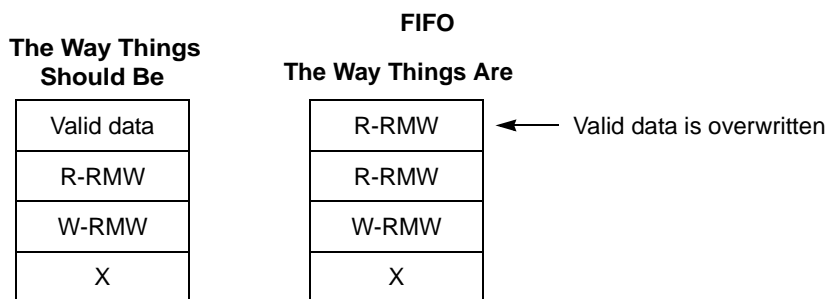
Figure 3. Read Data from Read-Modify-Write Operation Erroneously Overwrites Valid Data

If both read and write data captures are enabled, i.e., CSR[12-11] = 11, the execution of single-cycle read-modify-write instructions result in two data operands being captured: first the read data and then the write data. In the current design, the generation of the pipeline stall signal does not correctly account for this condition. Depending on the amount and sequencing of previous captures, one FIFO location can be overwritten. Therefore, one incorrect data word is output from the core. The valid data that should have been output will be overwritten in the FIFO by the RMW instruction. This data will be followed by the RMW data. The read-modify-write instruction captures will be output correctly as will all subsequent instructions and data captures.

This “one incorrect PSTDDATA output” scenario can occur anytime a read-modify-write instruction occurs with only one entry in the PSTDDATA FIFO being available.

Do not enable both read and write captures; that is, don't set CSR[12-11] = 11. Enabling read or write data captures separate functions correctly.

Another possible workaround would be to guarantee no single-cycle RMW instructions reference addresses mapped into cache or on-chip memories.

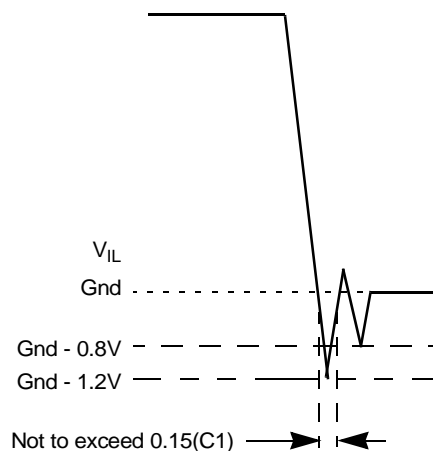
Figure 4. Undershoot Voltage

Figure 4 shows the allowable undershoot voltage on the MCF5407. Note that a 1.2V undershoot is only allowable if it is present 1% or less of the total processor operating time.
