## MCF5475 Chip Errata

**Silicon Revision: All**

**Supports: MCF5470, MCF5471, MCF5472, MCF5473, MCF5474, and MCF5475**

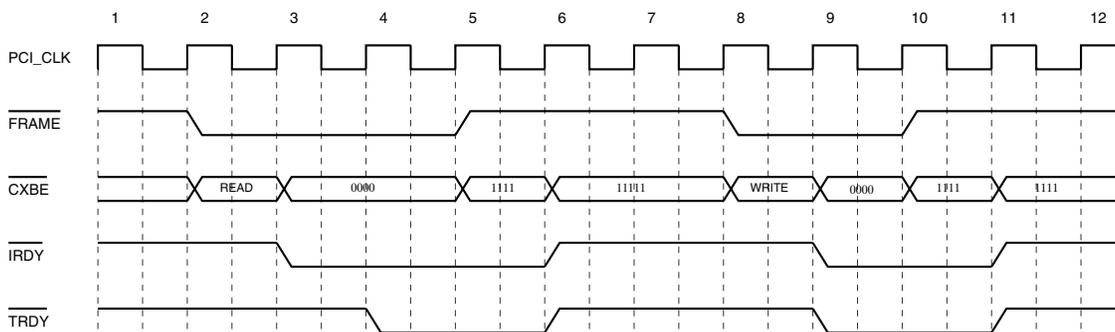
**Figure 1. PCI bus 2-beat transfer**

**Description:** As shown below, an unexpected 2-beat transfer is issued on the PCI bus when a Type 1 configuration PCI cycle is performed using the Configuration Mechanism and more than 3 bytes are being transferred. The byte enables are correctly driven, but a second false data transfer is issued.

For writes, there is no harm done other than one or more (if a disconnect occurs) wasted PCI cycles for the false data transfer. During reads, two beats of data, the good data and the false data, are pushed into an internal read data FIFO and only one is popped off the FIFO. The first 32-bit read completes as expected. Any read following this read, causes the transaction on the PCI bus as expected. However, internally the data returned for this next read is not new data but what remained in the FIFO from the first two-beat read, the second false data transfer. The addition of the false data in the read FIFO causes subsequent reads to be out-of-sync with the data in the FIFO.

**Workaround:** Only issue byte or 2-byte type 1 configuration reads. Addresses at byte offsets retrieve the correct bytes. This avoids the two-beat read transactions.

**Workaround:** Use the SPCPI RX interface to issue 32-byte type 1 configuration reads to PCI.

**Workaround:** After issuing a 32-bit type 1 configuration read via the configuration mechanism (using PCICAR), clear the read data FIFO of the false data by immediately issuing an XLB transaction that results in a master abort. For instance, after a type 1 configuration read (to bridge), change the bus number in the PCICAR to an unused bus and issue another type 1 configuration transaction (read or write). A read returns all 1s. The master abort status bits flag, PCISCR[MA] and PCIISR[IA]. If subsequent configuration reads across the bridge are needed, reprogram the bus number to the valid value and continue interleaving the master abort transaction between each.
