Mask Set Errata 1

MMC2107 32-Bit Microcontroller Unit

- K61K

MMC2107MSE1

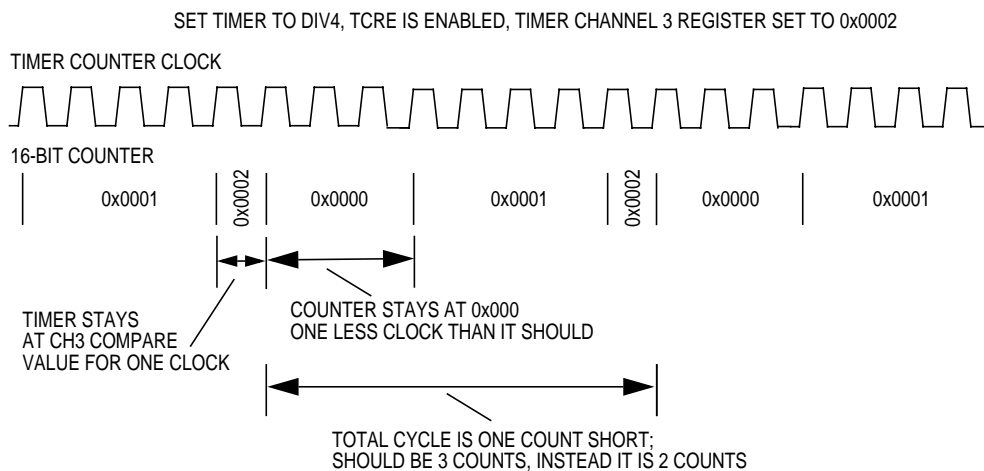
Figure 1. Timer

When the TCRE (timer counter reset enable) bit is set, the counter only stays at the channel 3 compare value for one timer clock cycle and then it resets to 0x0000. The 0x0000 count is then one timer counter clock cycle short. (for example, three clocks for div 4). The picture shows what happens for div 4, TCRE enabled and the timer channel 3 register set to 0x0002. See **Figure 1**.

The net result is that you lose a count in the whole repeating loop. The repeating loop is only two timer counter counts long instead of three.

Make the channel 3 compare value one larger to account for the missing count.
