This document details all known silicon errata for the MPC107 and its derivatives. Table 1 provides a revision history for this chip errata document.

Error No. 1: ROM three-state wait functionality not working correctly for EDO/FPM systems

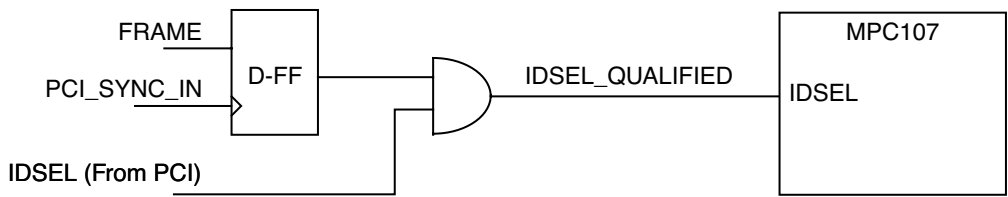
Figure 1. External Logic Work Around for Agent Mode

Error No. 12: MPC107 may misinterpret IDSEL during a PCI transaction that does not involve MPC107

When a PCI master is performing a transaction to some other PCI device, the MPC107 may interpret the transaction as a configuration cycle to the MPC107.

This is a problem when the MPC107 is operating in peripheral (agent) mode and is a potential problem in host mode if the IDSEL pin of the MPC107 is not pulled down to a logic 0.

Motorola recommends, in host mode, to pull down the IDSEL input on the MPC107. In general, this is an acceptable solution for host mode operation as PCI configuration cycles are normally issued by the host controller.

In agent mode, external logic needs to be added to qualify the IDSEL input to the MPC107 in such a way where the IDSEL input will not be asserted after the address phase of any PCI transaction. This may introduce a timing problem as $\overline{\text{FRAME}}$ and IDSEL are involved in order to generate the qualified IDSEL signal to the MPC107 during the cycle when $\overline{\text{FRAME}}$ transitions from logic 1 to logic 0. (Refer to Figure 1 and Figure 2.)

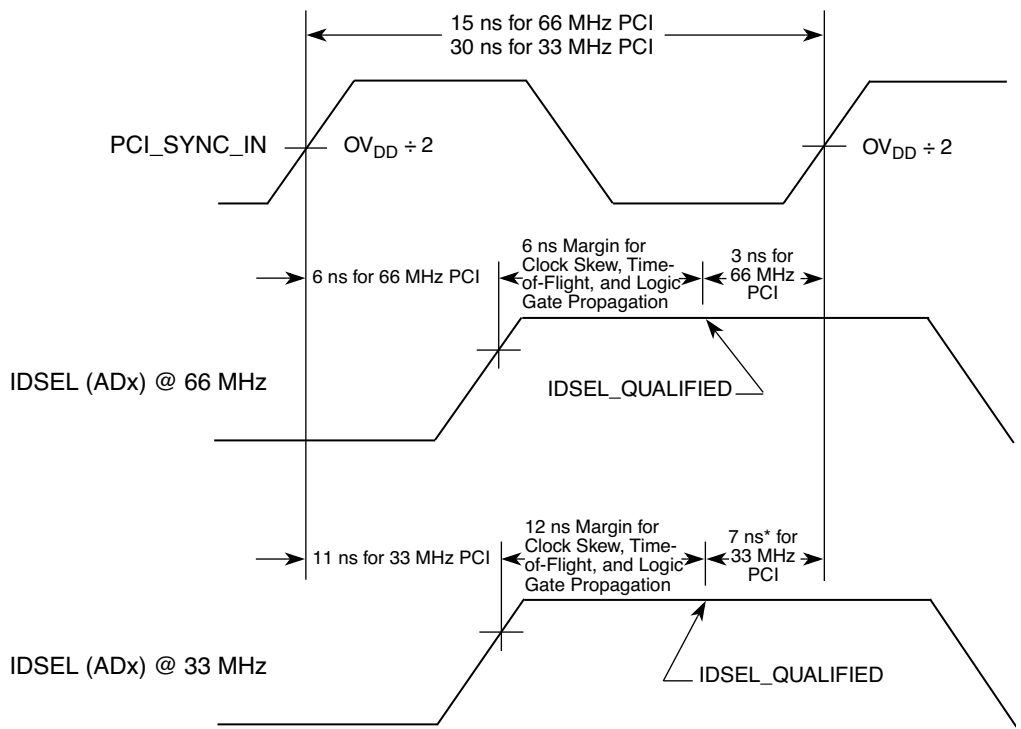
Figure 2. Timing Diagram for External Logic

*MPC107 specifies 3 ns for PCI input setup; therefore, there are 4 ns of additional margin for logic gate propagation time.
