MPC5200 (L25R) Errata

by: Microcontroller Division

This document identifies implementation differences between the MPC5200, L25R (Rev. 1.2), and the processor's description contained in the *MPC5200 Microcontroller User's Manual* and the *MPC5200 Microcontroller Data Sheet*. Refer to <http://www.freescale.com> for the latest updates.

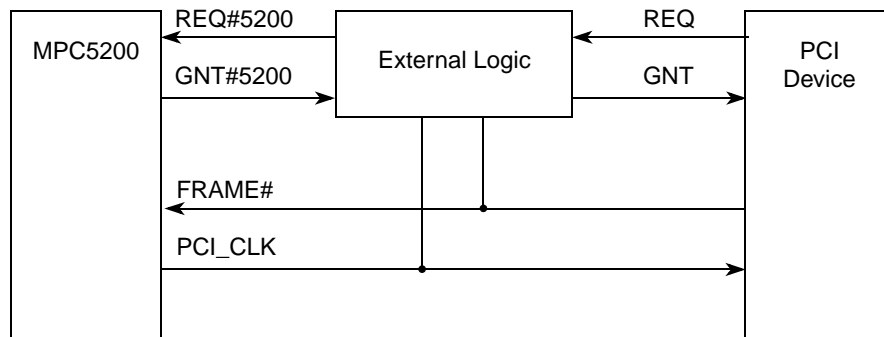
10.7 PCI arbiter can grant external and internal PCI master at the same time

The internal PCI arbiter should grant bus ownership only to one master at a time.

This rule of operation is violated under certain conditions. An external PCI Initiator requests (REQ#) and gets the bus (GNT#). If exactly at this time, in a window of one IP bus clock cycle, an internal PCI Initiator asserts a request for the bus too, the internal PCI arbiter grants the internal requestor, in addition to the external one. As a result of two granted initiators there is contention on the PCI bus.

External logic is required to delay the GNT# by at least two PCI clock cycles and to deassert the REQ# when FRAME# becomes active and to reassert REQ# again.

The following diagrams illustrate the workaround:
