MPC8245/MPC8241 Integrated Processor Device Errata

This document details all known silicon errata for the MPC8245/MPC8241 and its derivatives. The MPC8245 and MPC8241 are PowerPC™ integrated microprocessors. [Table 1](#) provides a revision history for this chip errata document.

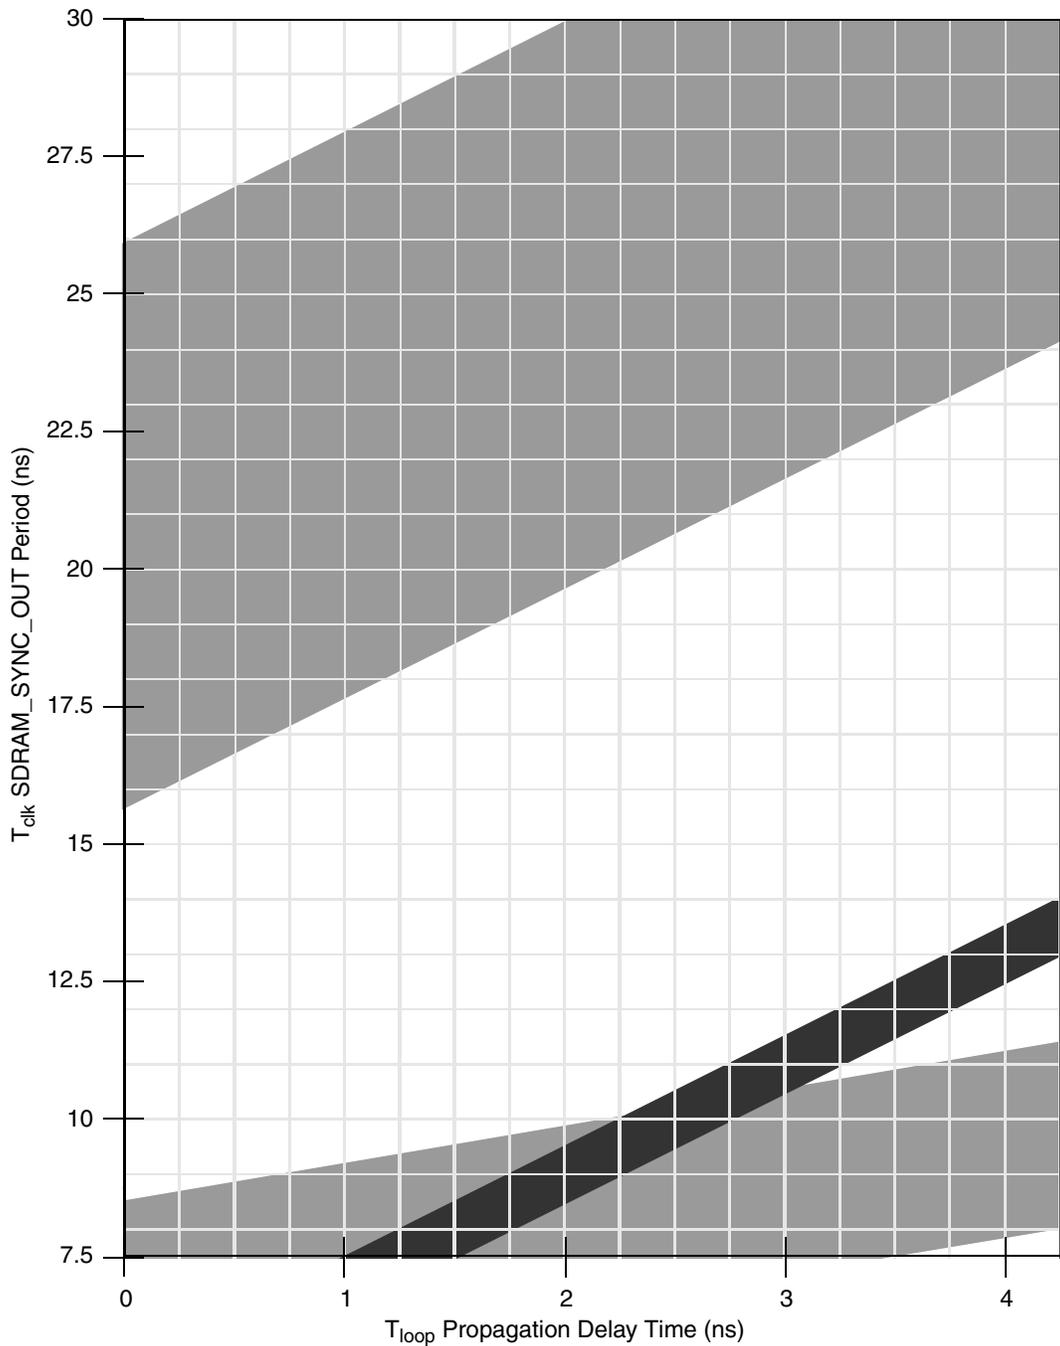
**Figure 1. Work Around Chart 1: (DLL_Extend = 1 and Normal Tap Delay)
(DLL Locking Range versus Frequency of Operation)**

The memory interface DLL is sensitive to operating variables that consist of voltage, frequency, temperature, and processing. For a given frequency, an associated feedback loop length range does not function reliably because the DLL intermittently loses lock.

Board designs must avoid certain SDRAM_SYNC_OUT to SDRAM_SYNC_IN feedback loop lengths to prevent intermittent loss of DLL lock.

Using the charts shown in [Figure 1](#) through [Figure 4](#), find the clock speed of the memory interface for the design in question by finding the associated clock period in nanoseconds (ns) on the Y axis. Then use the black band associated with that frequency to index delay times in ns (X axis) that must be avoided when designing the feedback loop for the design. The grey bands indicate valid operating points for different DLL mode settings and represent where the DLL locks. (Do not use white spaces: the DLL does not lock in any non-grey areas.) The black band represents regions; if the DLL is locked in these regions it will be unstable. The width of the black and grey bands take into account temperature, voltage, and processing variations. For any given part, the actual failure region is more narrow than what is shown in [Figure 1](#) through [Figure 4](#). Consult the *MPC8245 Integrated Processor Hardware Specifications* or the *MPC8241 Integrated Processor Hardware Specifications* for more information on DLL locking and the settings. In addition, see Application Note AN2164, *MPC8245/MPC8241 Memory Clock Design Guidelines*.
