Chip Errata for the MPC8260 PowerQUICC II Family

This document describes all known silicon errata for the MPC8260 PowerQUICC II family of integrated communications processors. See [Table 2](#) for a list of devices.

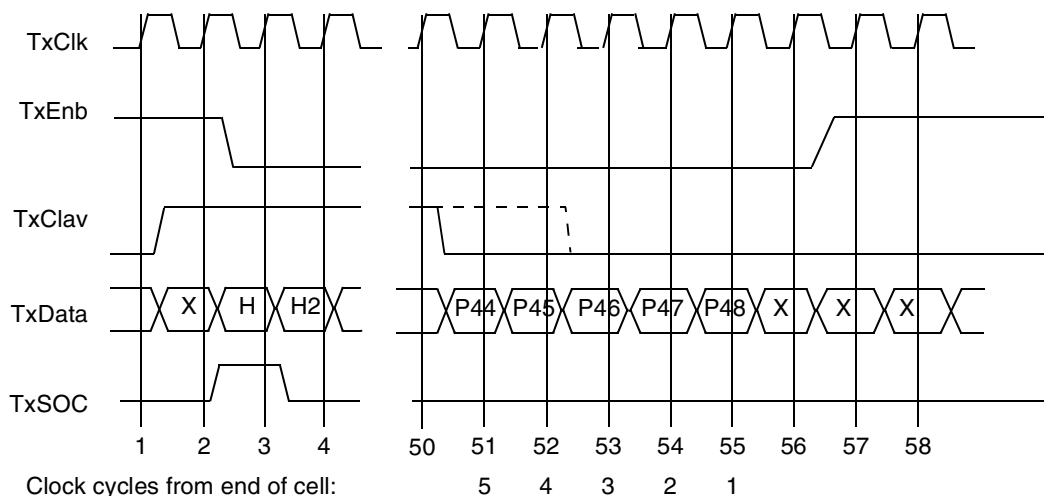
Figure 1. Transmit Timing for Cell-Level Handshake

FCC ATM receive UTOPIA slave mode. When the RxFIFO is full, RxClav is negated 2 cycles before the end of the cell transfer instead of 4. A master that polls RxClav or pauses 3 or 4 cycles before the end of the cell transfer may sample a false RxClav and an overrun condition may occur. The dashed line in the timing diagram below depicts the actual RxClav negation (2 cycles before the end of the cell transfer instead of 4 cycles). The signals in the timing diagram are with respect to the master, hence, Tx interface is shown.

- Master should not poll RxClav or pause cell transfer at 4 cycles before the end of cell transfer. Master should poll 2 cycles before the end of the current cell or later. This can be achieved by introducing a cell-to-cell polling (and transfer) delay, which is equal or larger than one cell transfer time. If this can be achieved, the impact on performance is minimal.
- Configuring ATM only on FCC1 and setting FPSMR[TPRI] ensures highest priority to FCC1 Rx. In addition, for CPM utilization lower than 80% (as reported by the CPM performance tool based on UTOPIA maximal bus rate) the CPM performance is enough to guarantee that the RxFIFO does not fill up.

- Multi-PHY with single Clav polling—Master should ensure that the address corresponding to an MPC826xA slave is not placed on the address bus before 5 cycles before the end of a cell transfer to that slave.
