# Chip Errata for the MPC8272 PowerQUICC II Family

This document describes all known silicon errata for the MPC8272 PowerQUICC II family of 0.13- $\mu$ m (HiP7) communications processors. See [Table 2](#) for a list of devices.

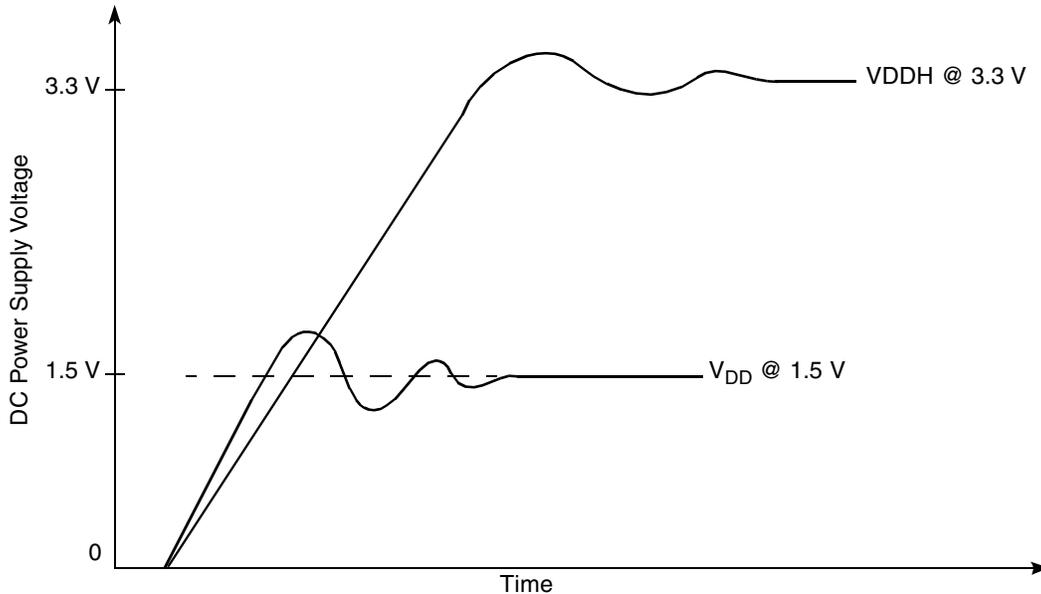
Figure 1. Power Supply Ramping

If core supply voltage (VDD) is below recommended operating conditions while I/O supply voltage (VDDH) is high during a power-on reset sequence, I/O pins (including those designated input only) might drive a value instead of being Hi-Z. This could confuse connected devices and, in turn, cause the PowerQUICC II device to behave improperly. Affected pins include such interfaces as the communication parallel I/O, reset, address and data bus pins, and JTAG pins. The value a pin may drive is random. As soon as core voltage has stabilized at its nominal level within recommended operating conditions, all pins will behave normally and the PowerQUICC II will continue to function properly.

It is recommended that VDD/VCCSYN be raised before or simultaneously with VDDH during the power-on reset sequence; that is, while  $VDDH \leq$  recommended operating condition for VDD/VCCSYN during ramp of all voltages, it should be ensured that  $VDD/VCCSYN \geq VDDH$  at all times. Refer to [Figure 1](#).

If the power supply design cannot be altered as recommended, then any logic connected to the PowerQUICC II which may react or be affected in an undesirable manner by unexpected low or high signal values during power ramp up should be appropriately secured in the design. Using

SDRAM as an example, it is usually sufficient to connect the CKE input to  $\overline{\text{PORESET}}$ . The practice of tying CKE high may not be safe and may lead to an unrecoverable system state.

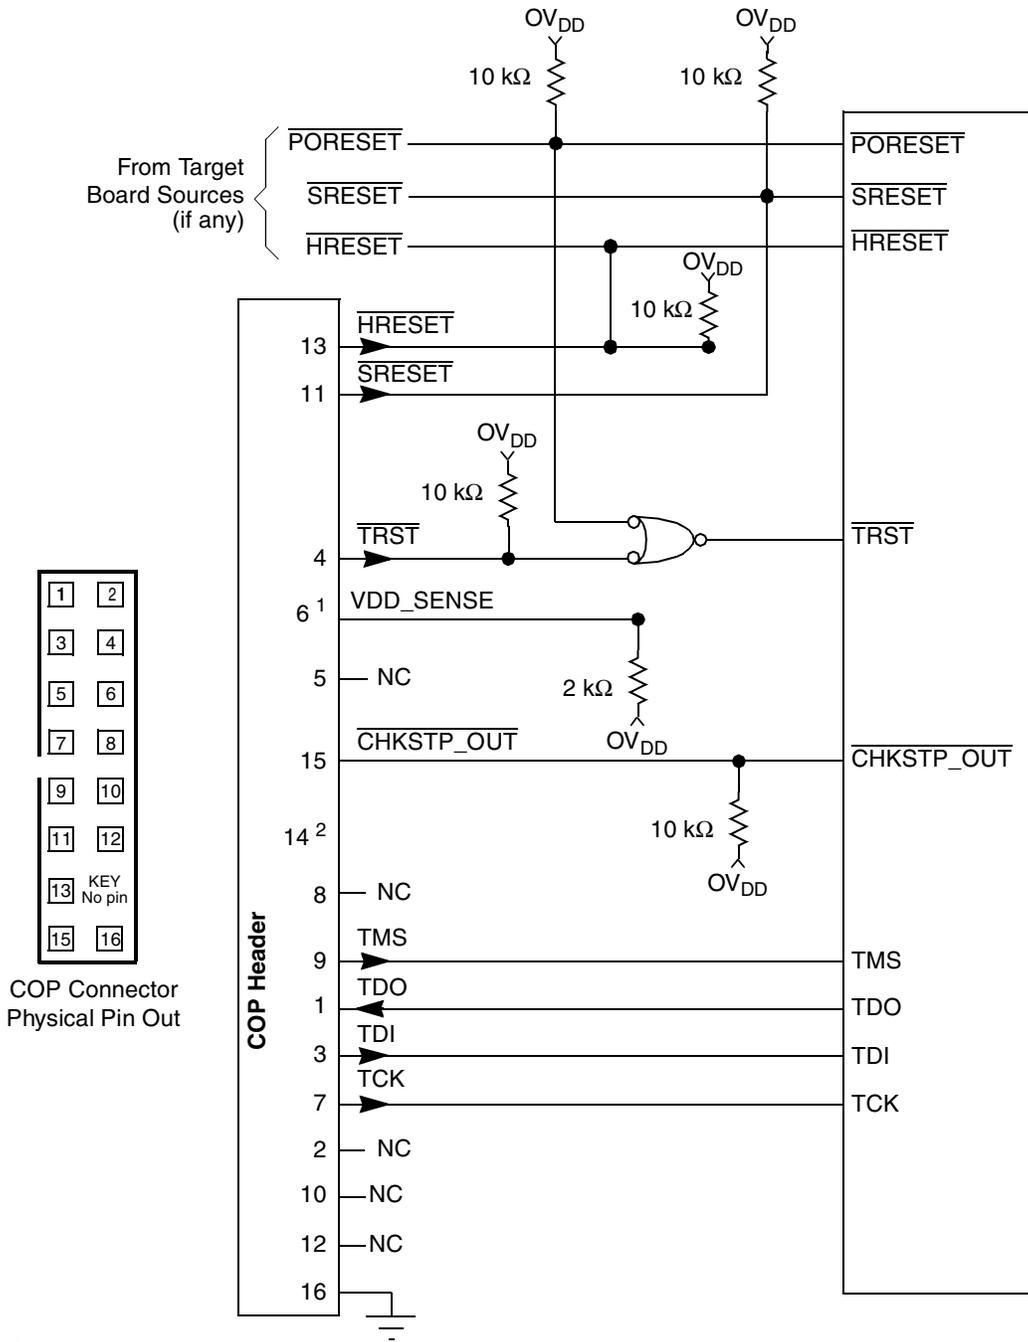
**Figure 2. COP Connections to PowerQUICC II Processors**

$\overline{\text{PORESET}}$  does not reset the CPU JTAG machine and, therefore,  $\overline{\text{TRST}}$  must be asserted during  $\overline{\text{PORESET}}$  in order for the CPU to work correctly.

For boards that require debugging capability, implement an external circuit as shown in [Figure 2](#).

1. Some systems require power to be fed from the application board into the debugger repeater card via the COP header. The resistor value for VDD\_SENSE is around 20 Ω.
2. Key location; pin 14 is not physically present on the COP header.

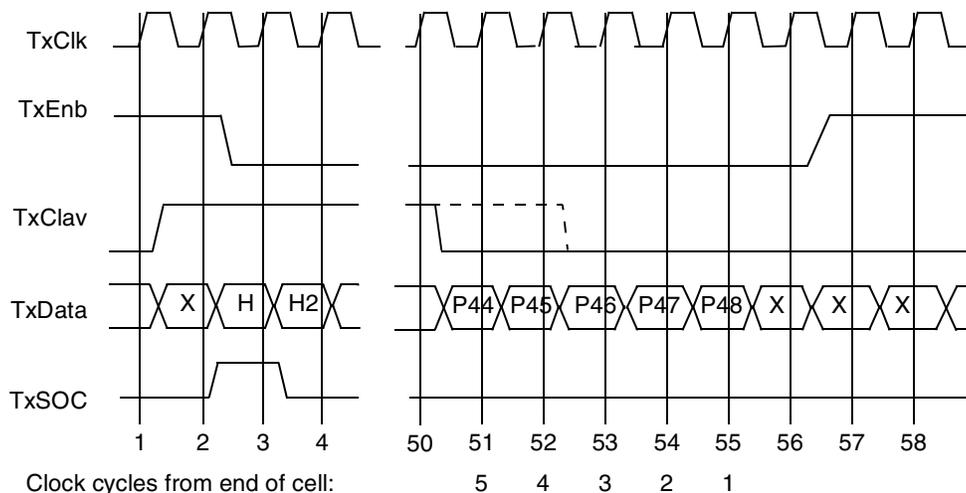
Figure 3. Transmit Timing for Cell-Level Handshake

FCC ATM receive UTOPIA slave mode. When the RxFIFO is full, RxClav is negated 2 cycles before the end of the cell transfer instead of 4. A master that polls RxClav or pauses 3 or 4 cycles before the end of the cell transfer may sample a false RxClav and an overrun condition may occur. The dashed line in the timing diagram below depicts the actual RxClav negation (2 cycles before the end of the cell transfer instead of 4 cycles). The signals in the timing diagram shown in [Figure 3](#) are with respect to the master, hence, Tx interface is shown.

- Master should not poll RxClav or pause cell transfer at 4 cycles before the end of cell transfer. Master should poll 2 cycles before the end of the current cell or later. This can be achieved by introducing a cell-to-cell polling (and transfer) delay, which is equal or larger then one cell transfer time. If this can be achieved, the impact on performance is minimal.
- Configuring ATM only on FCC1 and setting FPSMR[TPRI] ensures highest priority to FCC1 Rx. In addition, for CPM utilization lower then 80% (as reported by the CPM performance tool based on UTOPIA maximal bus rate) the CPM performance is enough to guarantee that the RxFIFO does not fill up.
