# Chip Errata for the MPC8280 PowerQUICC II Family

This document describes all known silicon errata for the MPC8280 PowerQUICC II family of integrated communications processors. See [Table 2](#) for a list of devices.

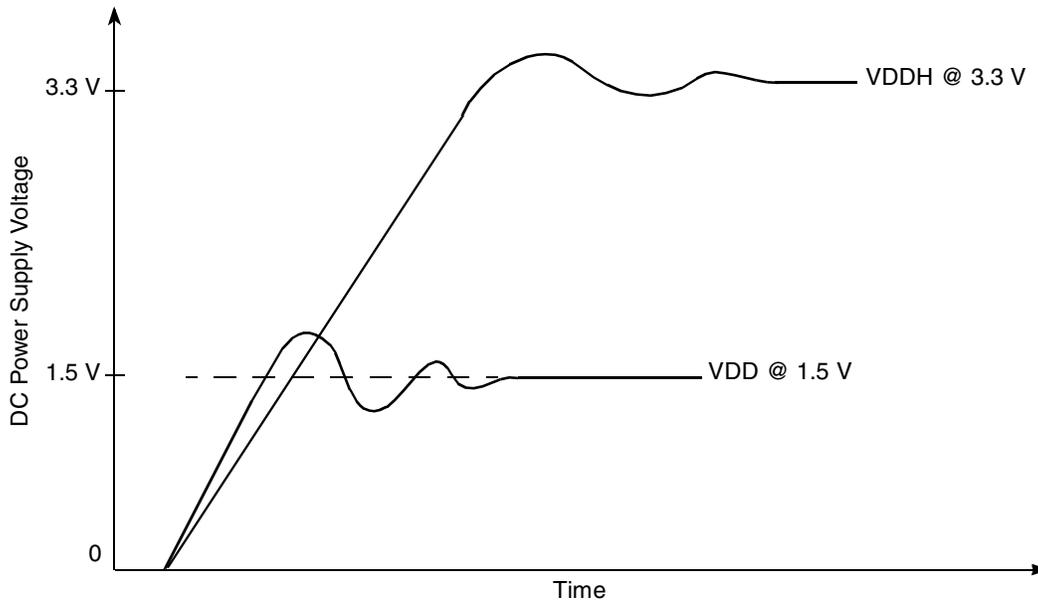
Figure 1. Power Supply Ramping

If core supply voltage (VDD) is below recommended operating conditions while I/O supply voltage (VDDH) is high during a power-on reset sequence, I/O pins (including those designated input only) might drive a value instead of being Hi-Z. This could confuse connected devices and, in turn, cause the PowerQUICC II device to behave improperly. Affected pins include such interfaces as the communication parallel I/O, reset, address and data bus pins, and JTAG pins. The value a pin may drive is random. As soon as core voltage has stabilized at its nominal level within recommended operating conditions, all pins will behave normally and the PowerQUICC II will continue to function properly.

It is recommended that VDD/VCCSYN be raised before or simultaneously with VDDH during the power-on reset sequence; that is, while  $VDDH \leq$  recommended operating condition for VDD/VCCSYN during ramp of all voltages, it should be ensured that  $VDD/VCCSYN \geq VDDH$  at all times. Refer to [Figure 1](#).

If the power supply design cannot be altered as recommended, then any logic connected to the PowerQUICC II which may react or be affected in an undesirable manner by unexpected low or high signal values during power ramp up should be appropriately secured in the design. Using

SDRAM as an example, it is usually sufficient to connect the CKE input to  $\overline{\text{PORESET}}$ . The practice of tying CKE high may not be safe and may lead to an unrecoverable system state.

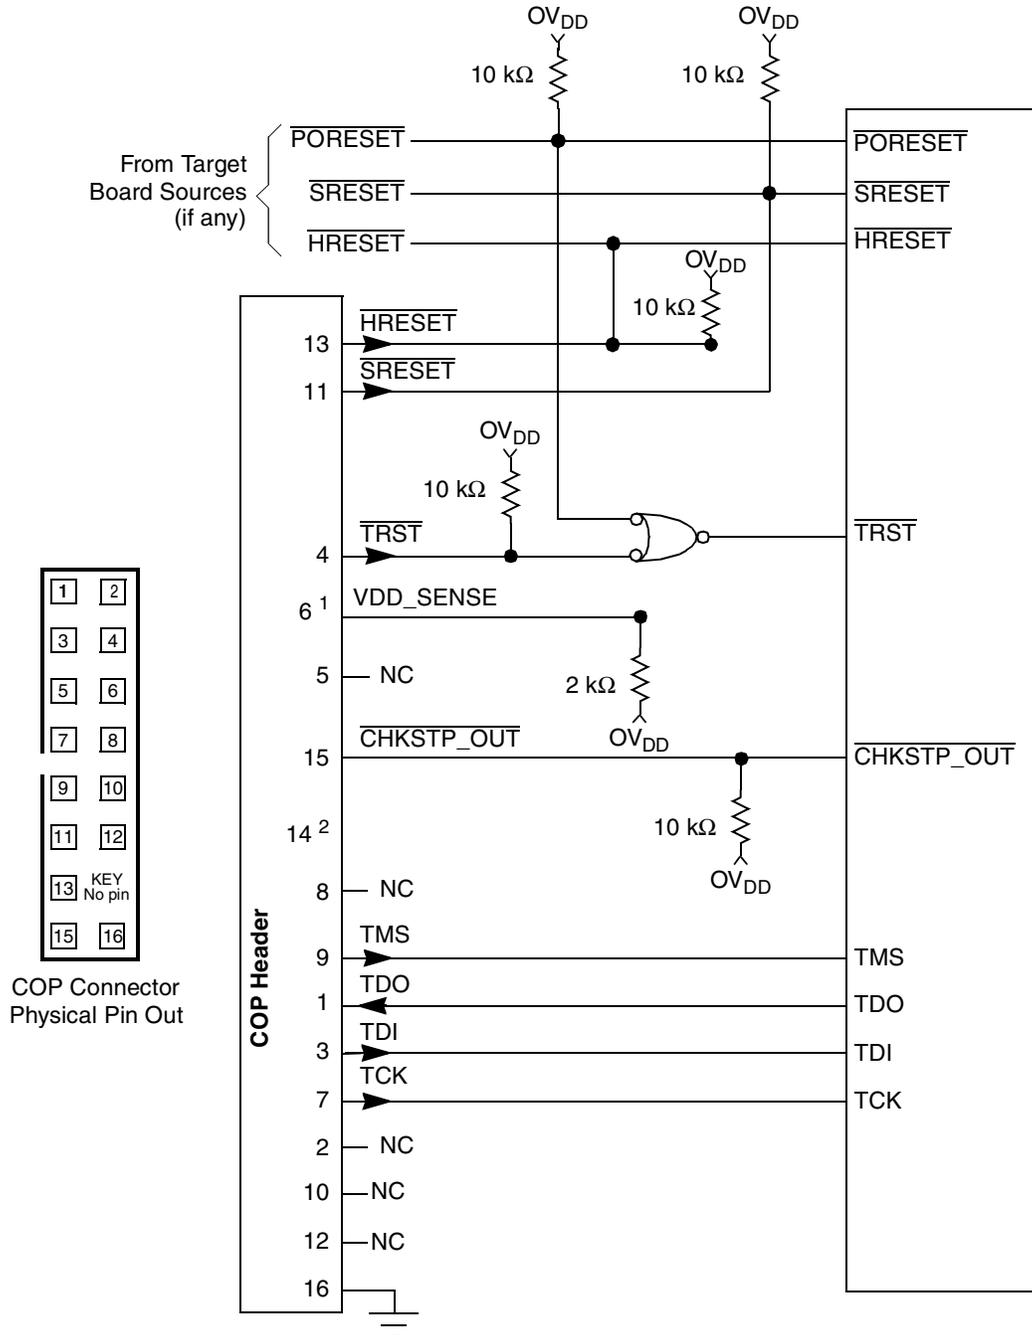
**Figure 2. COP Connections to PowerQUICC II Processors**

$\overline{\text{PORESET}}$  does not reset the CPU JTAG machine and, therefore,  $\overline{\text{TRST}}$  must be asserted during  $\overline{\text{PORESET}}$  in order for the CPU to work correctly.

For boards that require debugging capability, implement an external circuit as shown in [Figure 2](#).

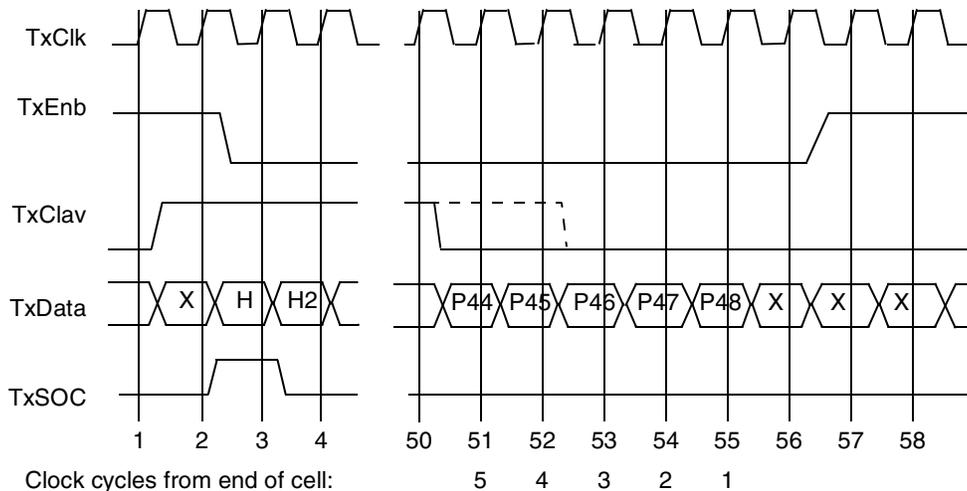
Figure 3. Transmit Timing for Cell-Level Handshake

FCC ATM receive UTOPIA slave mode. When the RxFIFO is full, RxClav is negated 2 cycles before the end of the cell transfer instead of 4. A master that polls RxClav or pauses 3 or 4 cycles before the end of the cell transfer may sample a false RxClav and an overrun condition may occur. The dashed line in the timing diagram below depicts the actual RxClav negation (2 cycles before the end of the cell transfer instead of 4 cycles). The signals in the timing diagram are with respect to the master, hence, Tx interface is shown.

- Master should not poll RxClav or pause cell transfer at 4 cycles before the end of cell transfer. Master should poll 2 cycles before the end of the current cell or later. This can be achieved by introducing a cell-to-cell polling (and transfer) delay, which is equal or larger then one cell transfer time. If this can be achieved, the impact on performance is minimal.
- Configuring ATM only on FCC1 and setting FPSMR[TPRI] ensures highest priority to FCC1 Rx. In addition, for CPM utilization lower then 80% (as reported by the CPM performance tool based on UTOPIA maximal bus rate) the CPM performance is enough to guarantee that the RxFIFO does not fill up.
