MPC8308 Chip Errata

This document details all known silicon errata for the MPC8308. The following table provides a revision history for this document.

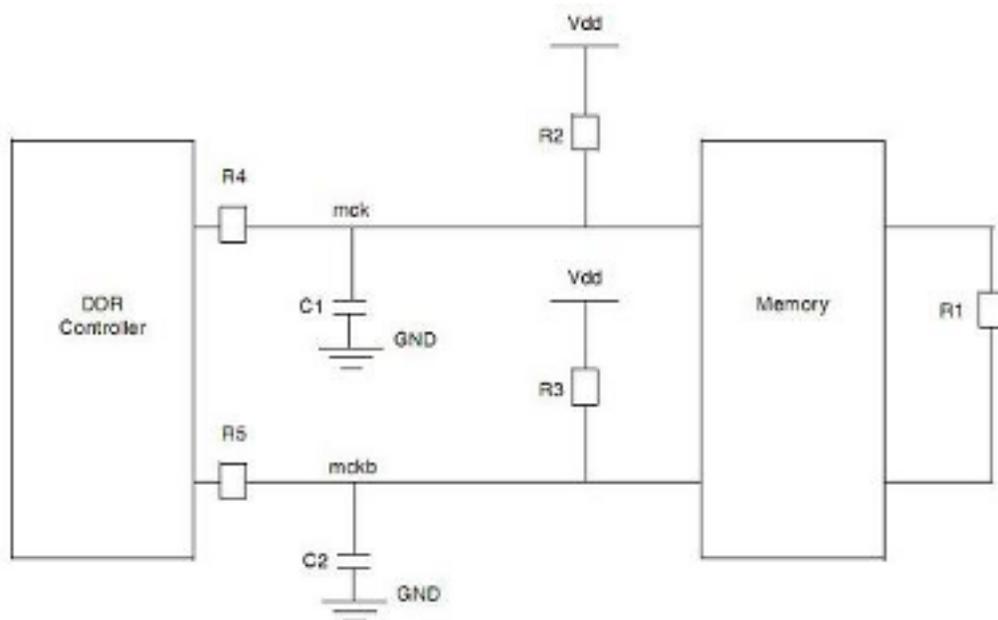
Figure 1. Recommended connections for DDR controller and memory

Impact: Disagreement with the JESD79-2C standard.

Workaround: To meet the JESD79-2C crosspoint voltage specifications, we recommend implementing the following connections between the DDR controller and DDR2 memory:

We recommend varying termination resistor R1 first. Lowering R1 can help increase the voltage levels up. The only disadvantage is that it may add up more reflections. Therefore, the user must decide accordingly. If it does not give sufficient margin, the user can add the pull-up resistor (R3 and R4) option to further increase the voltage levels.

Exact values of components vary from design to design and some of them may not be required for all designs. We recommend that you make provisions for all these options in your design.
